Department of Transport and Regional Development
Bureau of Air Safety Investigation

INVESTIGATION REPORT 9403314

Aero Commander 680F VH-SPP
33 km S Cloncurry, Qld
9 November 1994

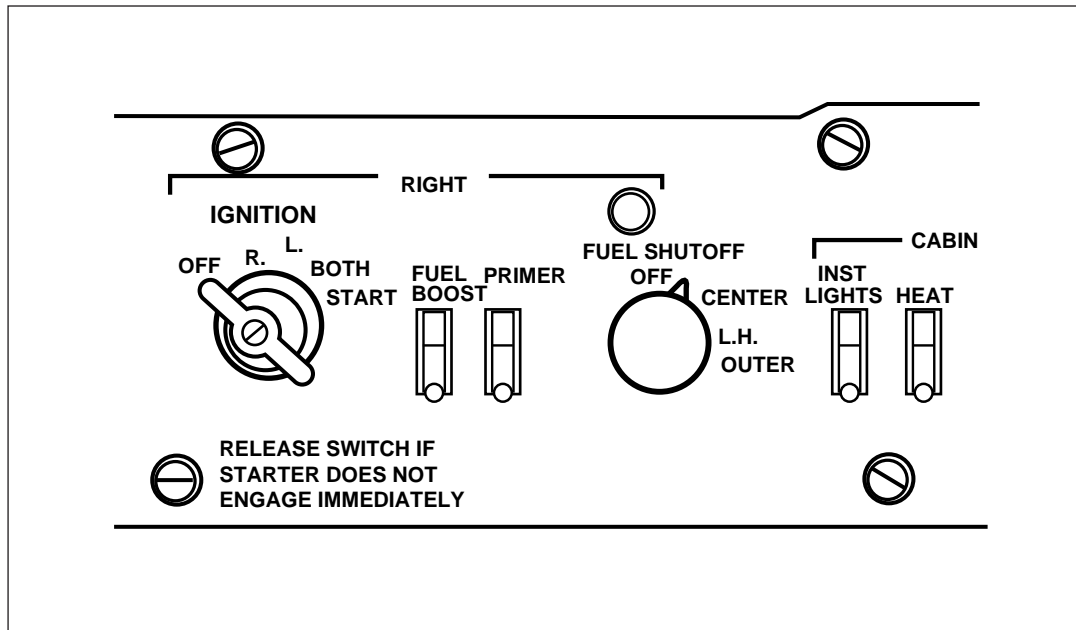
Rotary fuel selector switches located on the cockpit overhead switch panel control the flow of fuel to the engines from either the centre tank or the outboard tanks by way of electrically operated shut-off valves located in each main landing-gear wheel well. Rotating the switches to the right and left OUTBOARD positions (three o'clock and nine o'clock positions respectively) allows fuel from the outboard tanks to flow to the respective engine. At the same time, fuel flow from the centre tank is shut off. Fuel vapour return from the fuel injector pumps is fed to the centre tank.

Switching the selector switches to the CENTRE position (half-past ten o'clock position on the left switch and half-past one o'clock position on the right switch) allows fuel to flow from the centre tank to the respective engine and shuts off flow from the outboard tanks. Selecting the switch to OFF (twelve o'clock position on both switches) closes both shut-off valves and cuts off fuel flow to the engines. A sketch of the right fuel control selector panel is shown below.

The operator advised that the modification fed bypassed fuel to the centre tank. Advice from pilots who had flown SPP was that, during typical low-level survey operations, outboard tank transfer was complete in about 20 minutes. In other words, in excess of 5 L of fuel per minute was bypassed from each outboard tank to the centre tank. These pilots also indicated that the left outboard tank fed at a slightly higher rate than the right outboard tank so that, during typical low-level survey flight, it emptied 3–5 minutes quicker than the right tank.

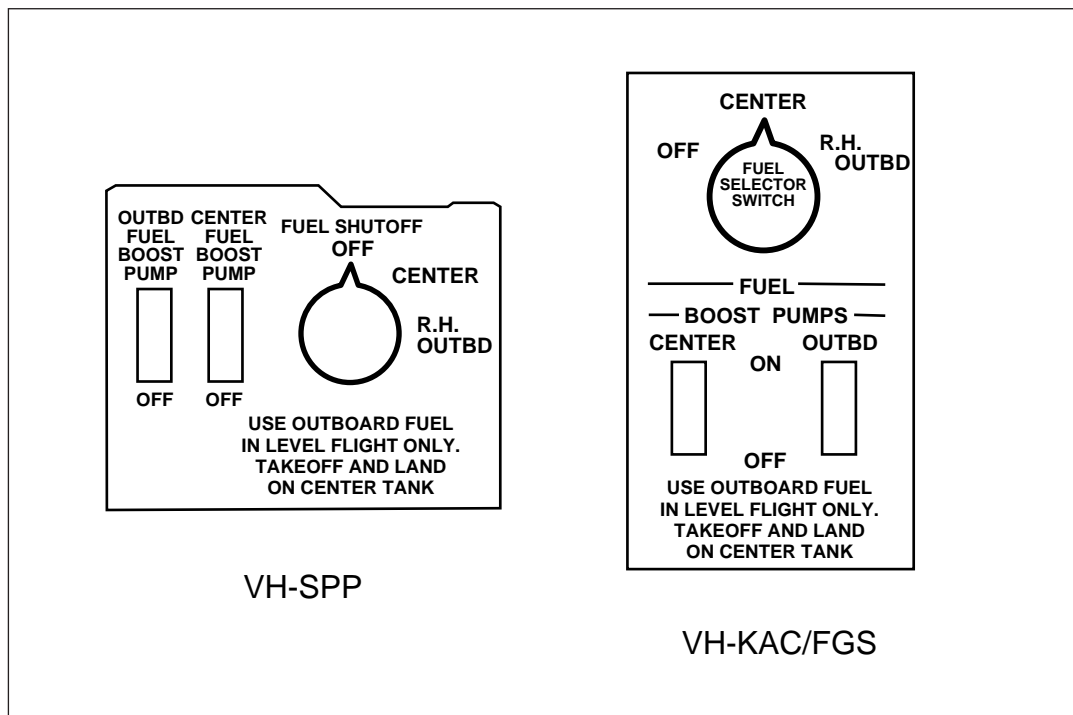
A sketch comparison of the fuel control panels for SPP and KAC/FGS is shown below.

A physical check of the fuel selector panels on KAC and FGS revealed that, in these aircraft, the CENTRE tank selections were at the 12 o'clock position. In turn, this meant that the left and right OFF positions were at half-past one/half-past ten o'clock, while the OUTBOARD positions were at half-past ten/half-past one o'clock. In other words, the orientation of the selector switches was different to that in SPP. The holder for STC SA-2826-SW advised that to maintain the selector switch OFF position at twelve o'clock would have required considerable rework.

Background relevant to the hypothesis centres on the accident flight being only the second time the pilot had flown SPP but the first time he had cause to feed fuel from the outboard tanks. Significant differences between SPP and other Aero Commander aircraft the pilot had flown involved the orientation of cockpit fuel tank selector switches and outboard tank fuel transfer time.
