Summary

At 0840 on 29 September 1994, the Russian container vessel Kapitan Serykh sailed from Brotherson Dock, Botany Bay under the direction of a pilot of the Sydney Ports Pilot Service and with the assistance of two tugs. The wind was from the north-west at 20-30 knots.

The incident

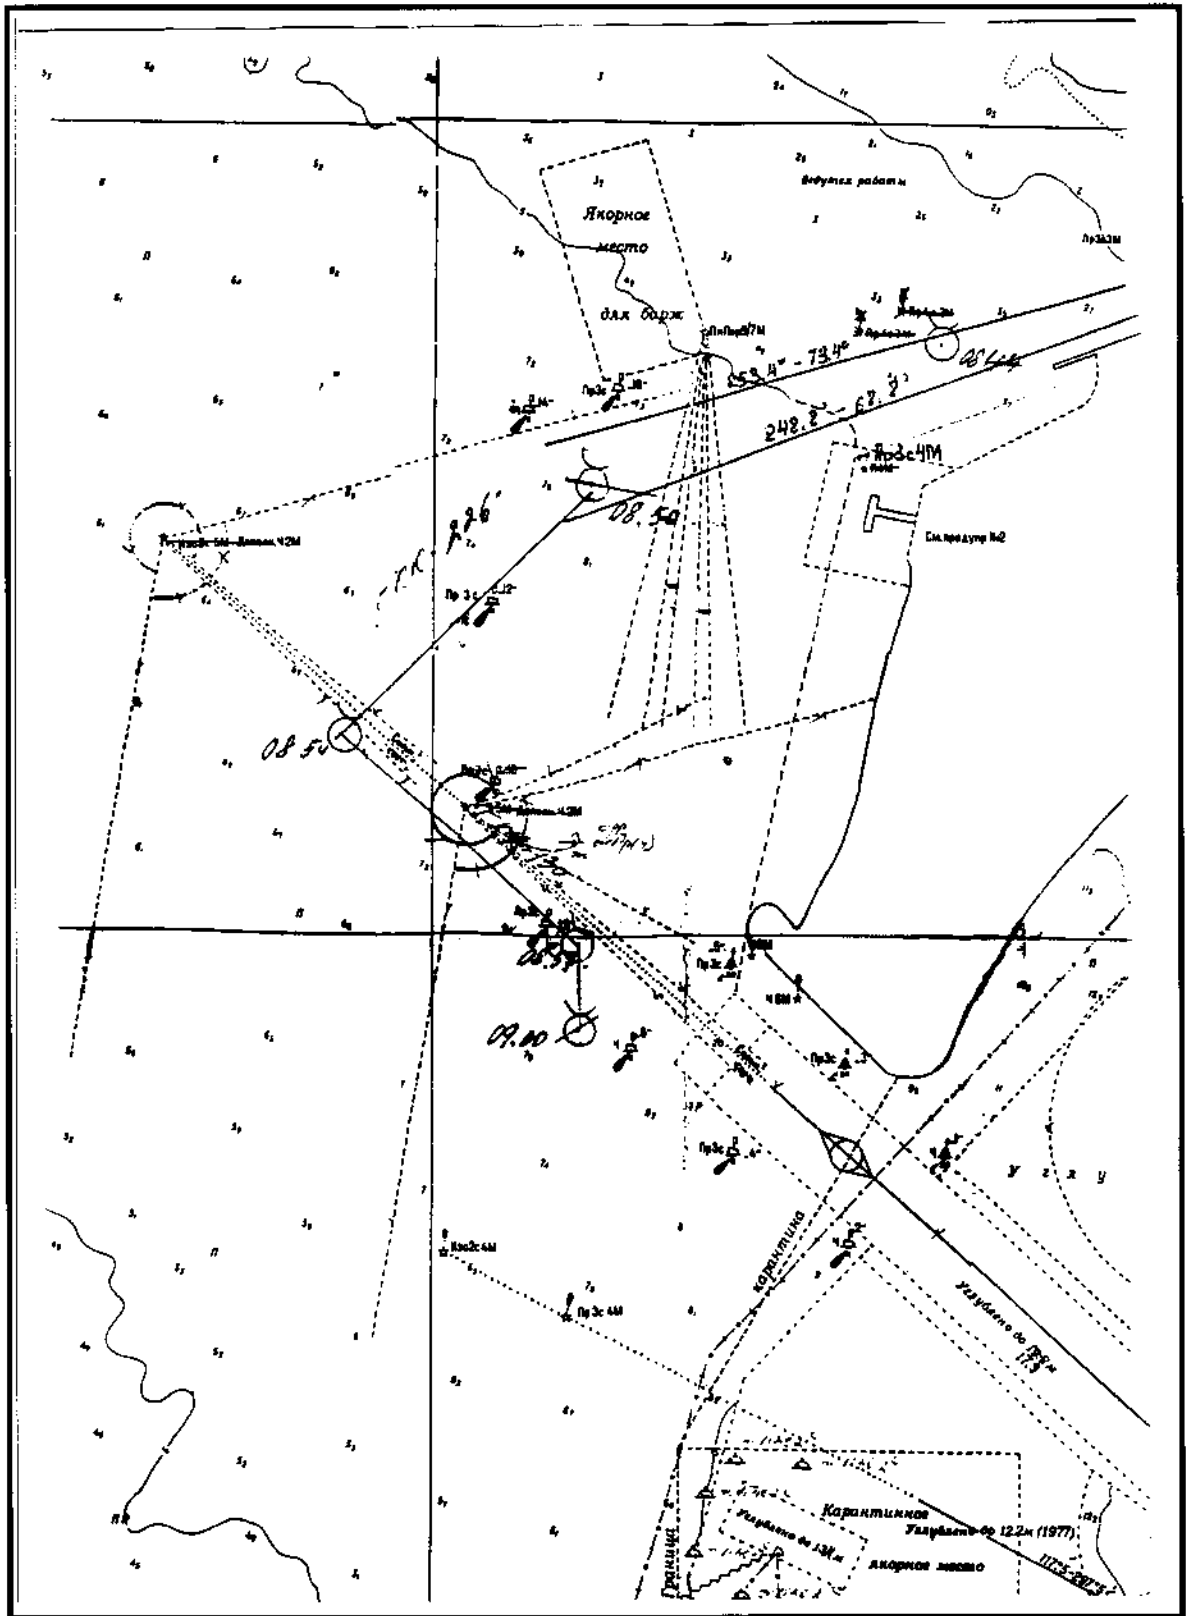
Portion of Russian chart No.59356 in use aboard Kapitan Serykh
on 29 September 1994

The positions plotted on the vessel’s navigation chart indicated the vessel had been steadied on 130° for some three minutes. Although both the Master and Mate of Kapitan Serykh were adamant the positions had been plotted at the times written on the chart, the positions also indicated the vessel had proceeded outside the turning area. It is worthy of note no positions were plotted on the chart when the vessel departed from the berth that evening, after being found to be seaworthy. Also, the chart in use on board was not the latest edition available, did not show the berths on the north side of Brotherson Dock and did not show the newly dredged area westward of the turning basin.

According to the accounts provided by the Master and Mate on 1 October 1994, the vessel executed a slow turn to port and was steadied on 130° at 0854. However, in a written statement signed by the Master on 29 September 1994, after the vessel had returned to the berth, he declared “At about 0853 the pilot ordered tugs lines to be let go. At 0854 the pilot ordered helm hard to port course 130° and both tugs were let go”. This written statement is more in keeping with the account as described by the Pilot.

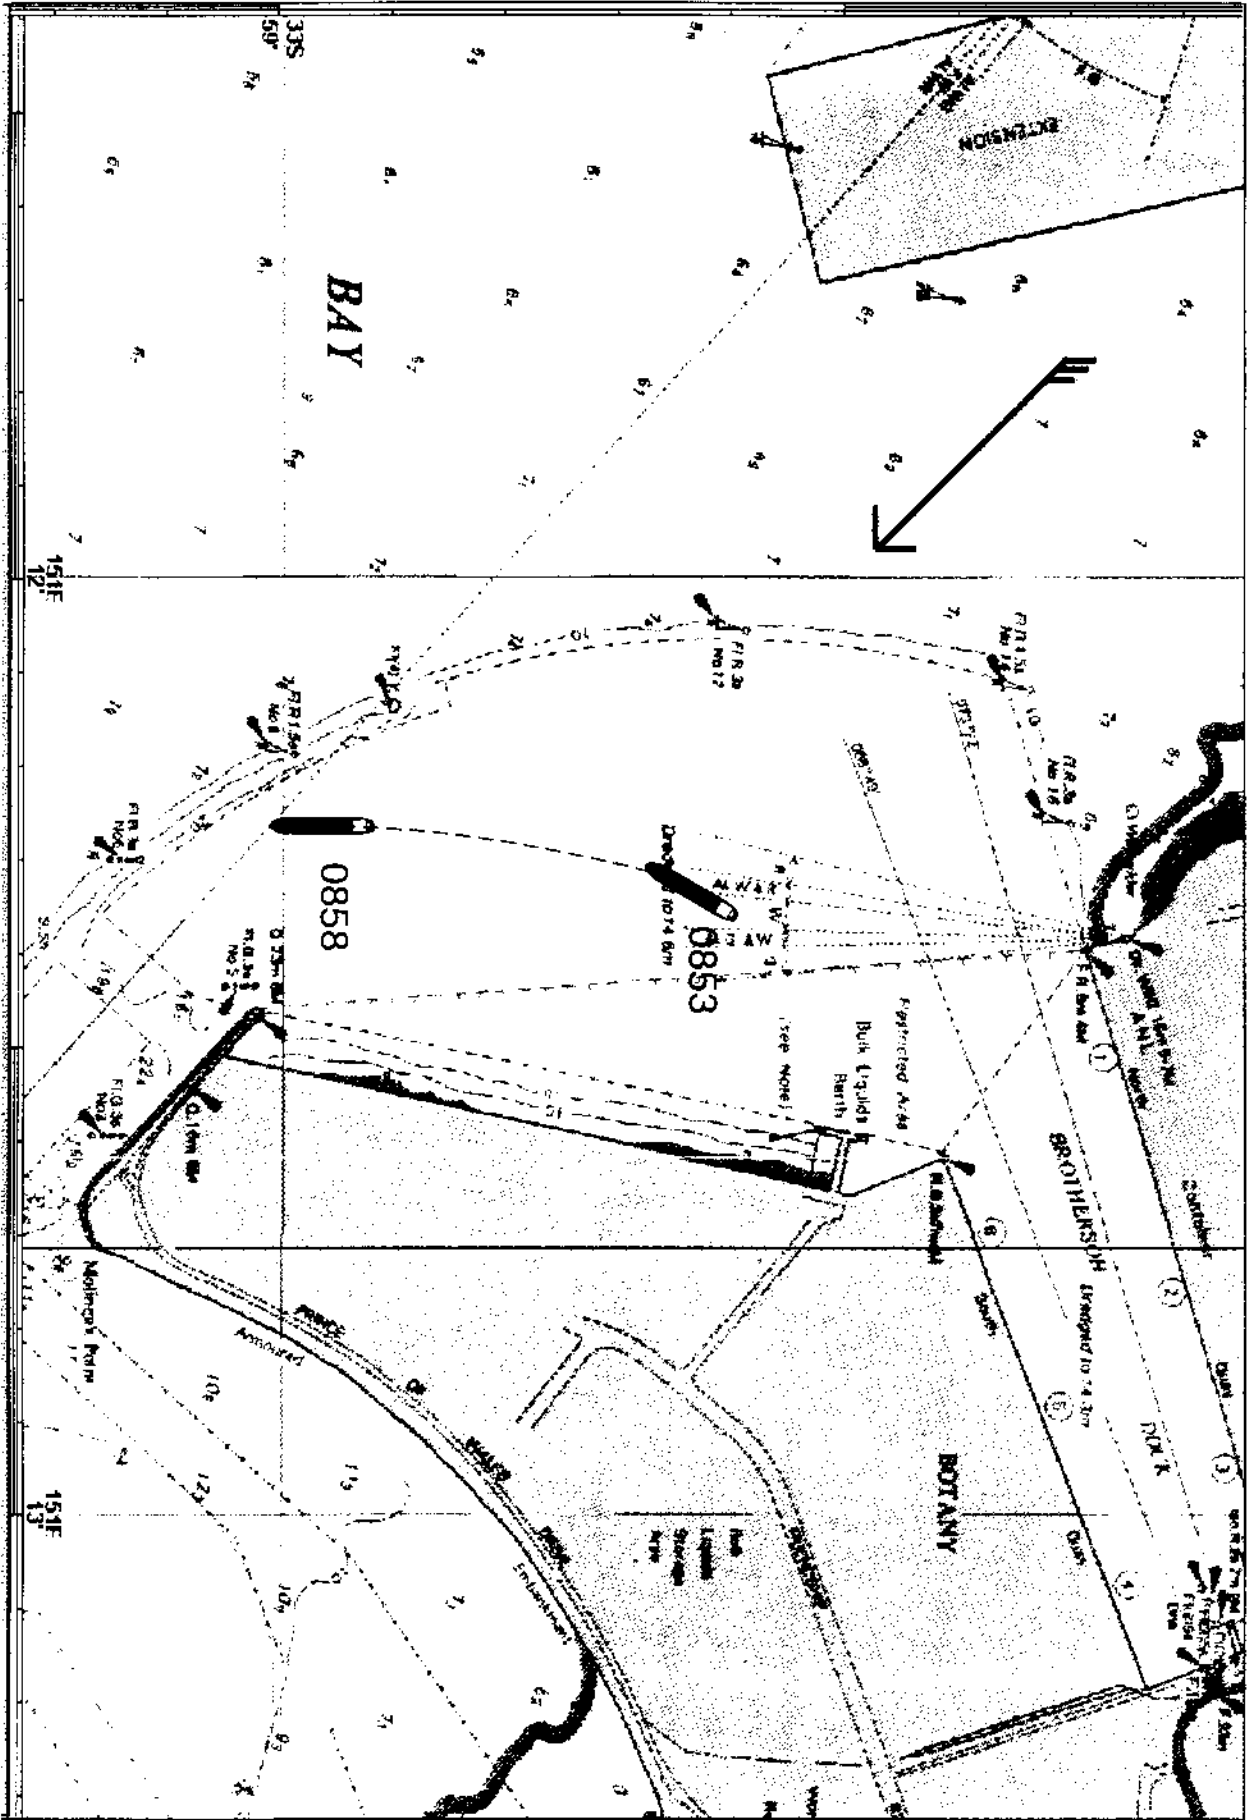
Portion of chart Aus 199
 showing probable track of Kapitan Serykh

The only independent evidence on what course Kapitan Serykh took after releasing the tugs is that provided by the Master and Pilot of Australian Advance. Their evidence is supportive of the account provided by the Pilot of Kapitan Serykh.

The Inspector is satisfied that the Pilot's account of the incident is the more accurate one and that Kapitan Serykh failed to make the turn required to bring it on to the line of the leads of the departure channel.

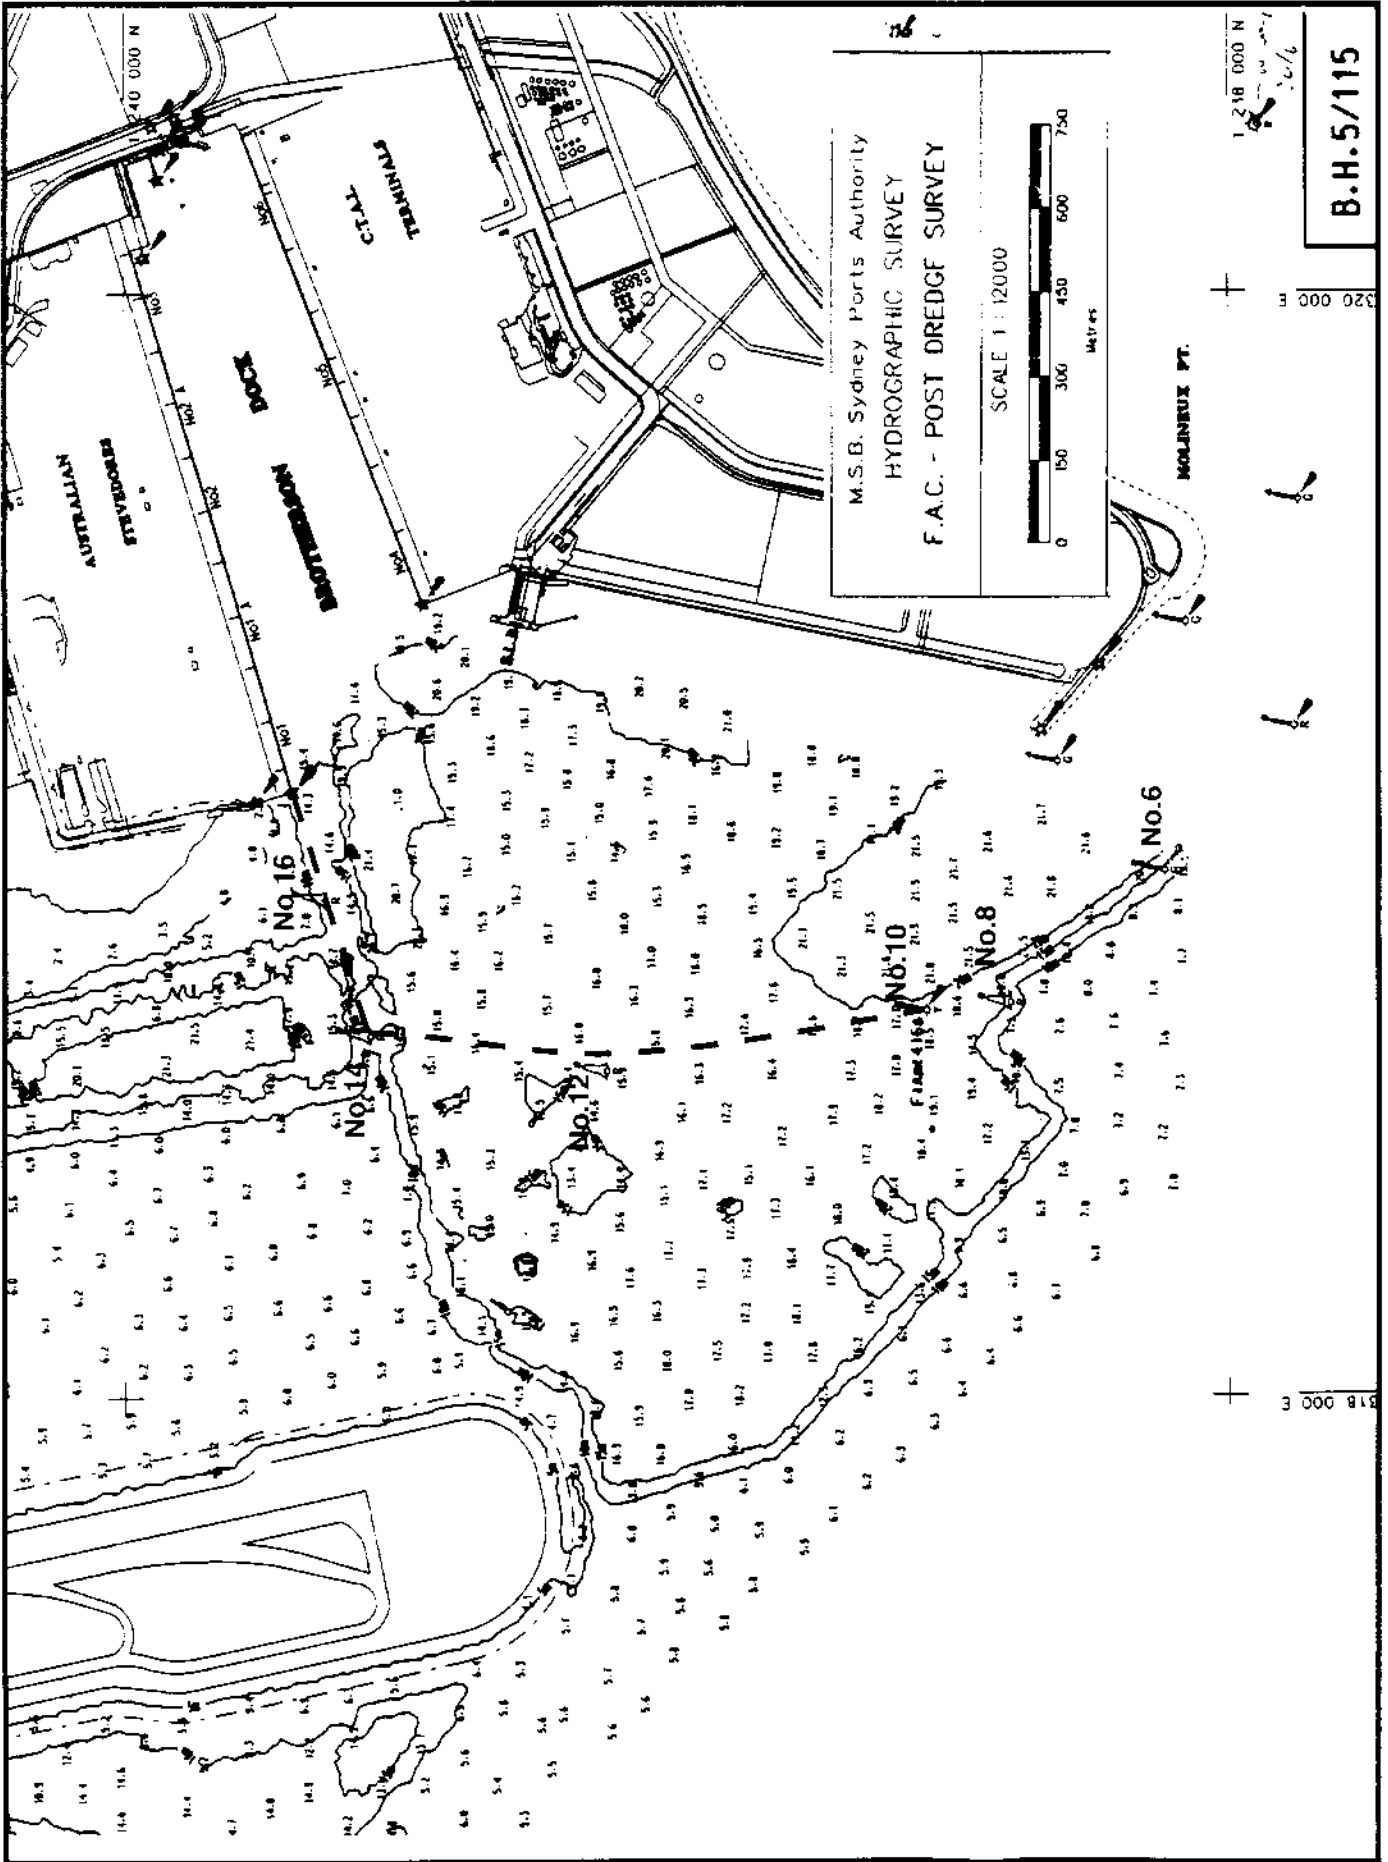
Portion of MSB Survey Chart
(Buoy numbers and turning area limit added)

The area outside the buoyed turning area to the west and south of no.14 buoy has been dredged to a greater depth, to provide infill for the Kingsford Smith airport new runway, but it is not the practice of the pilots of the Sydney Ports Pilot Service to take vessels outside the buoyed turning area.

turned in the area delineated by the two sets of Brotherson Dock leads and Nos. 14 and 16 buoys. A vessel turned in that area is turned to a heading of between 170° and 180°, providing a better approach to the departure channel and a turn of only 38 to 48 degrees on to the leads.
