OUTLINE OF INCIDENT

The Philippine registered bulk carrier SINGA SEA, a ship of 26586 tonnes deadweight and some 175 metres in length overall, loaded a mixed bulk cargo of mineral sands and copper ore at the West Australian ports of Geraldton and Bunbury between 27 June and 2 July. At 0915 hours Western Standard Time (WST)\* the ship sailed for Rotterdam via Cape Town, where it was expected to take on bunker fuel.

5. The ship sank after breaking in two in heavy seas at about 0300 GMT on 4 July 1988, in approximate position 35°00'S 106°00'E.
6. The reasons for the failure of the ship's structure are not known, but they are not considered to be attributable to the quality or physical characteristics of the cargo as loaded in Geraldton and Bunbury.

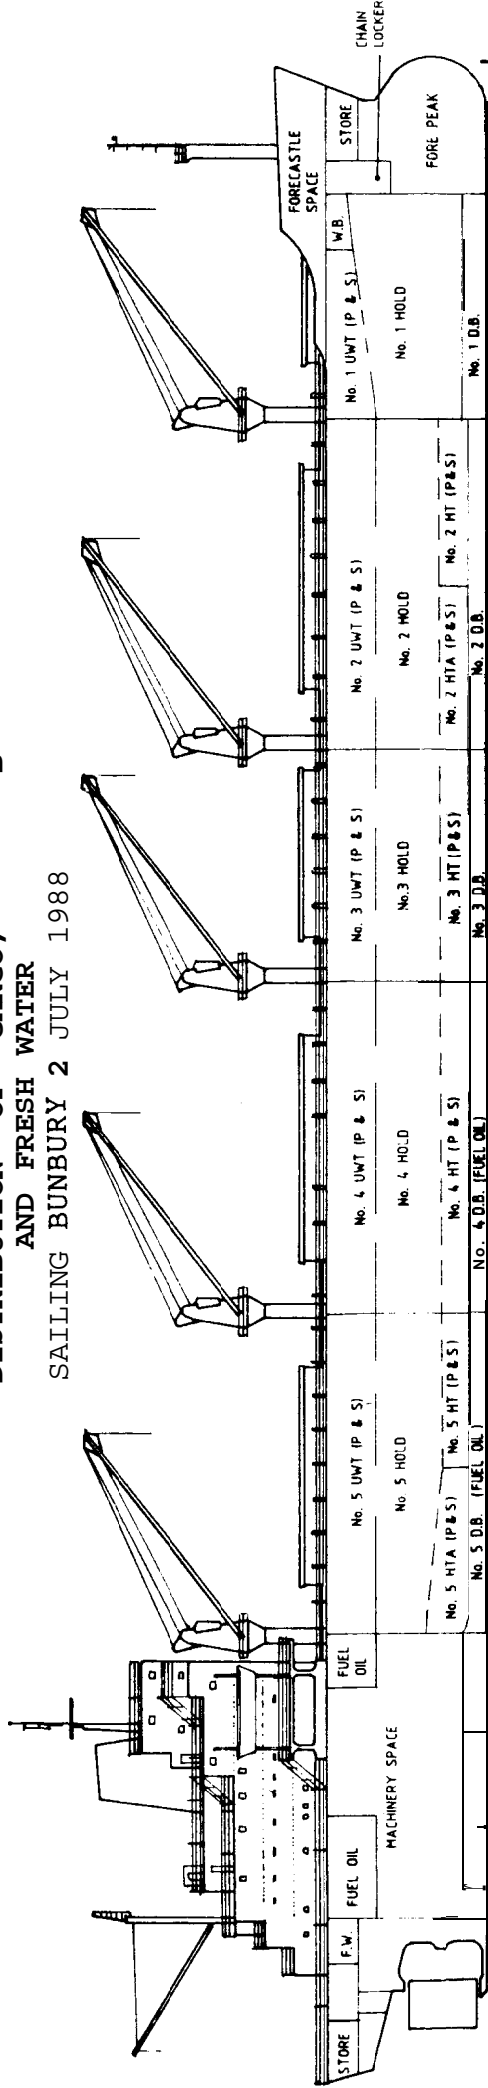
**DISTRIBUTION OF CARGO, FUEL, BALLAST  
AND FRESH WATER**  
SAILING BUNBURY 2 JULY 1988

In addition to the calculated weights, 422 tonnes of water ballast remained aboard as determined by the draught survey undertaken by Captain Douglas. 325 tonnes were distributed between ballast tanks forward of number 4 hold and 97 tonnes in number 5 forward hopper tank. It was noted that at the initial draught survey the ship was initially hogged by some 14.5 centimetres and sailed, trimmed slightly by the head, with a sag of 9.5 centimetres.

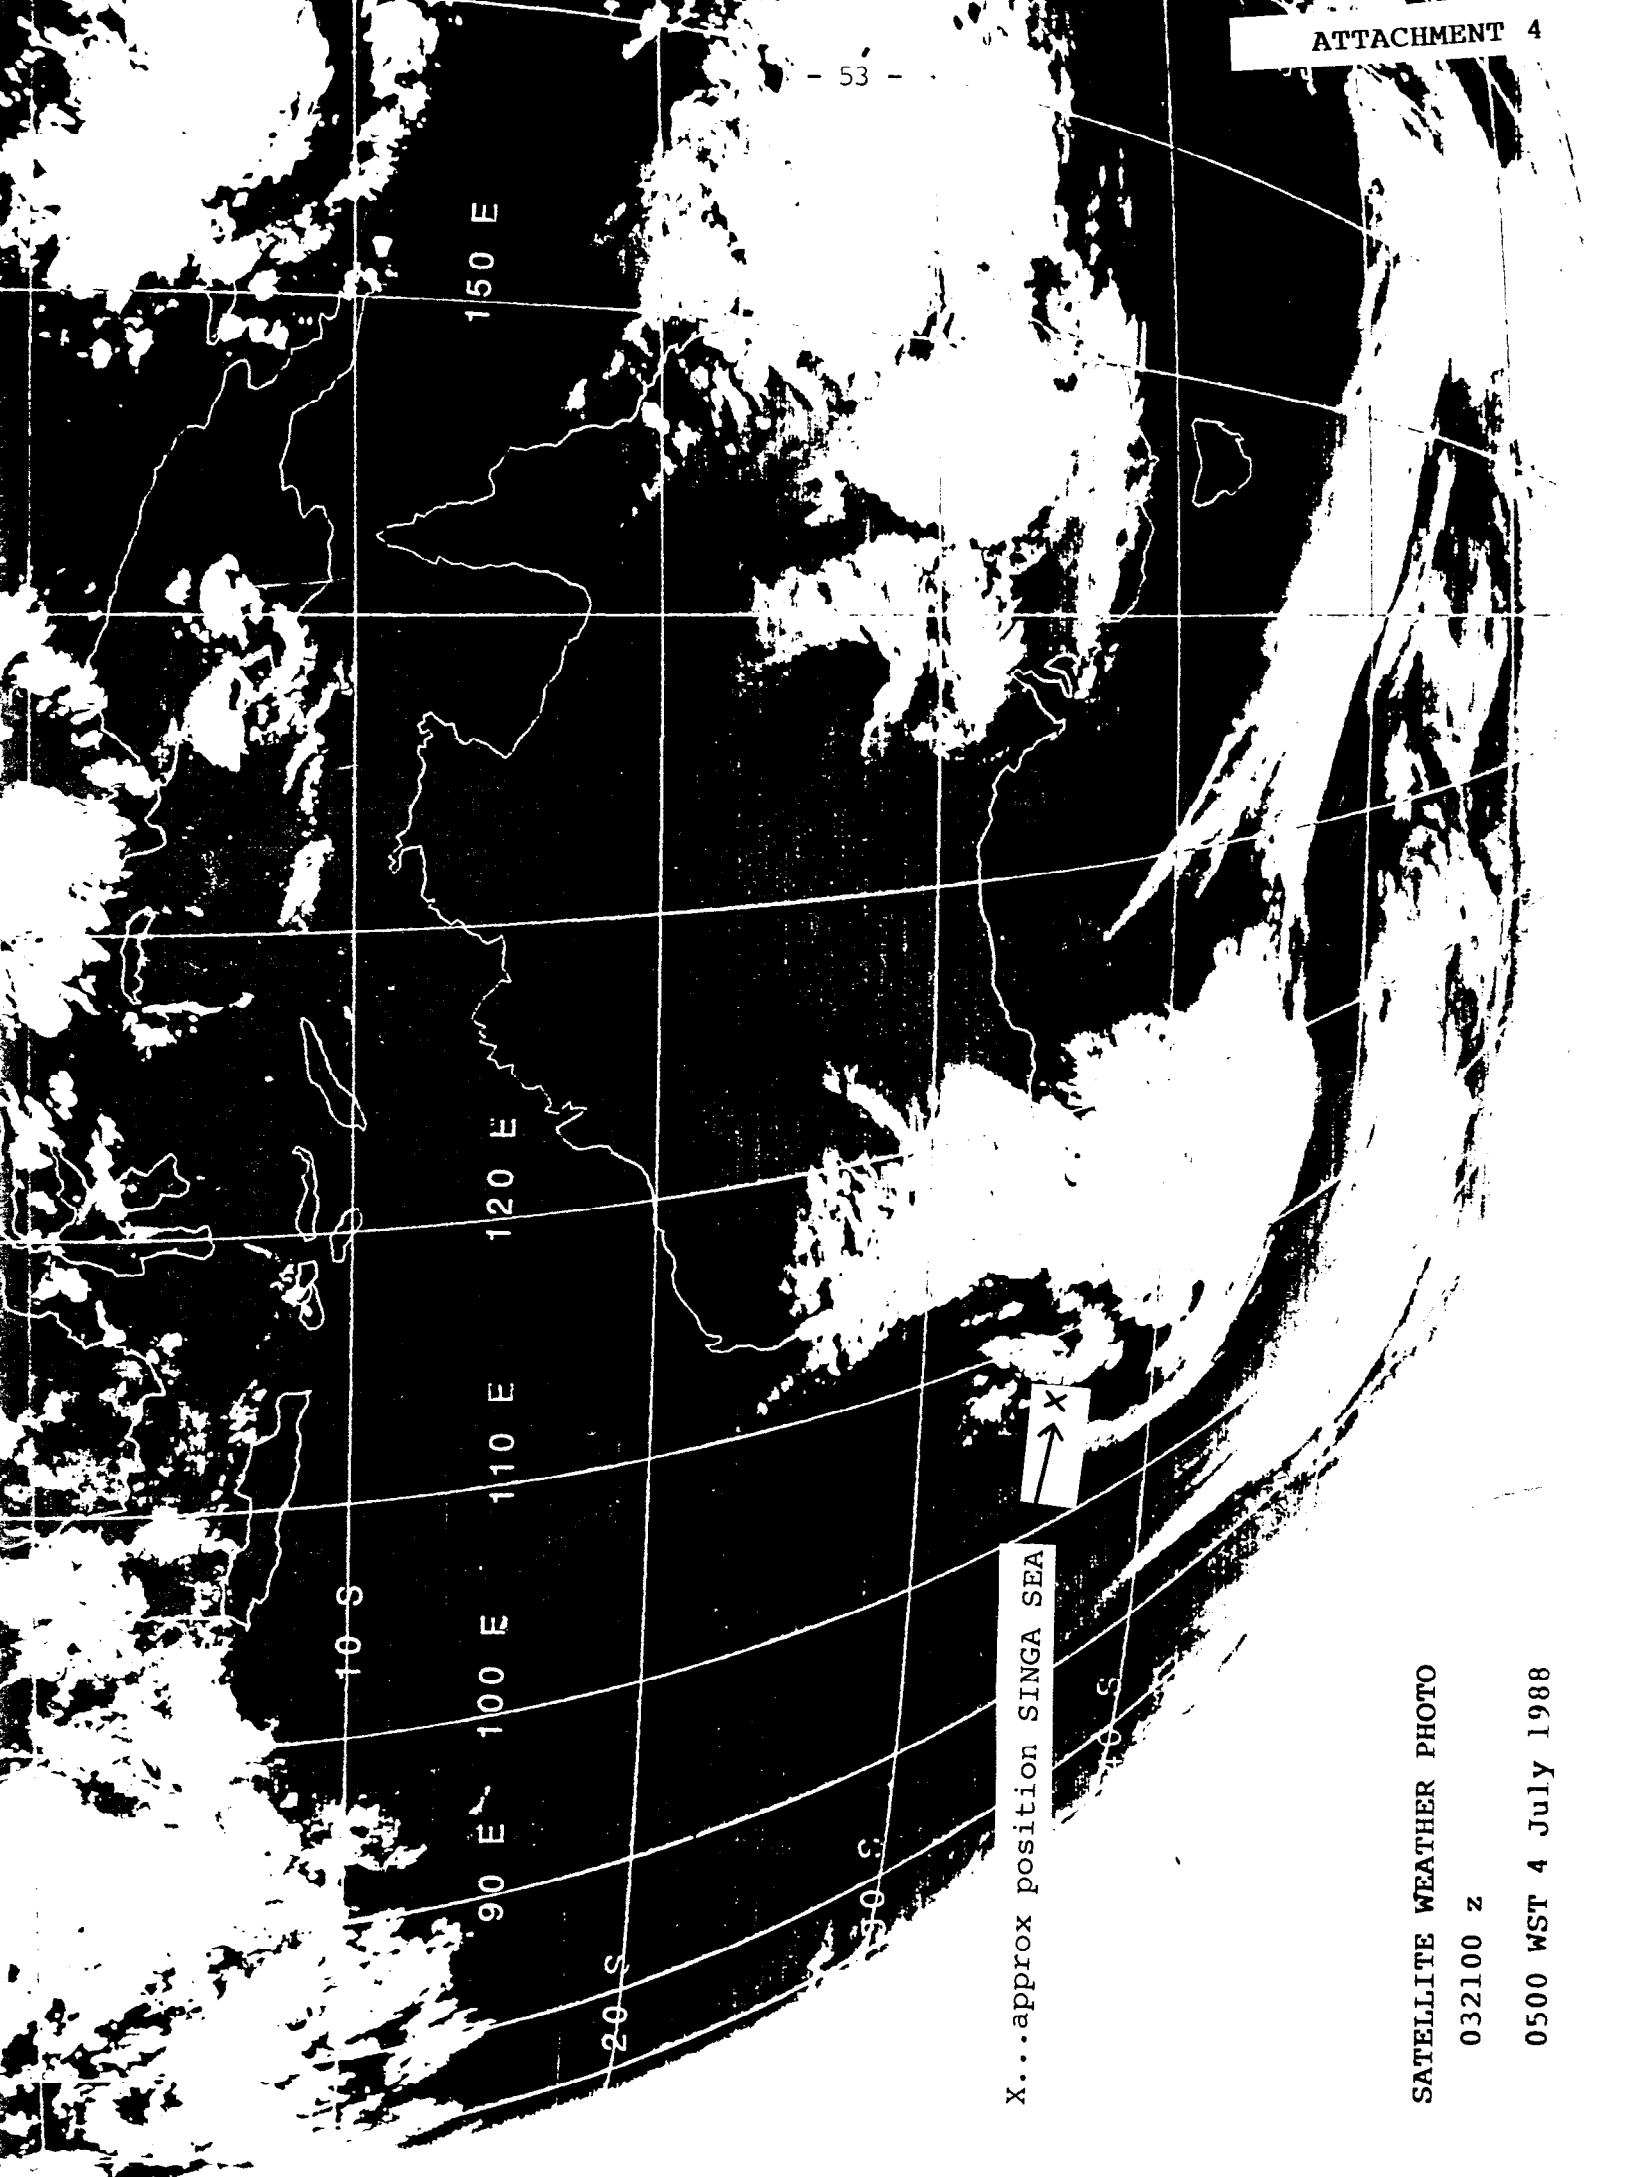
SATELLITE WEATHER PHOTO  
030900 Z  
1700 WST 3 July 1988

X...approx position SINGA SEA -> X

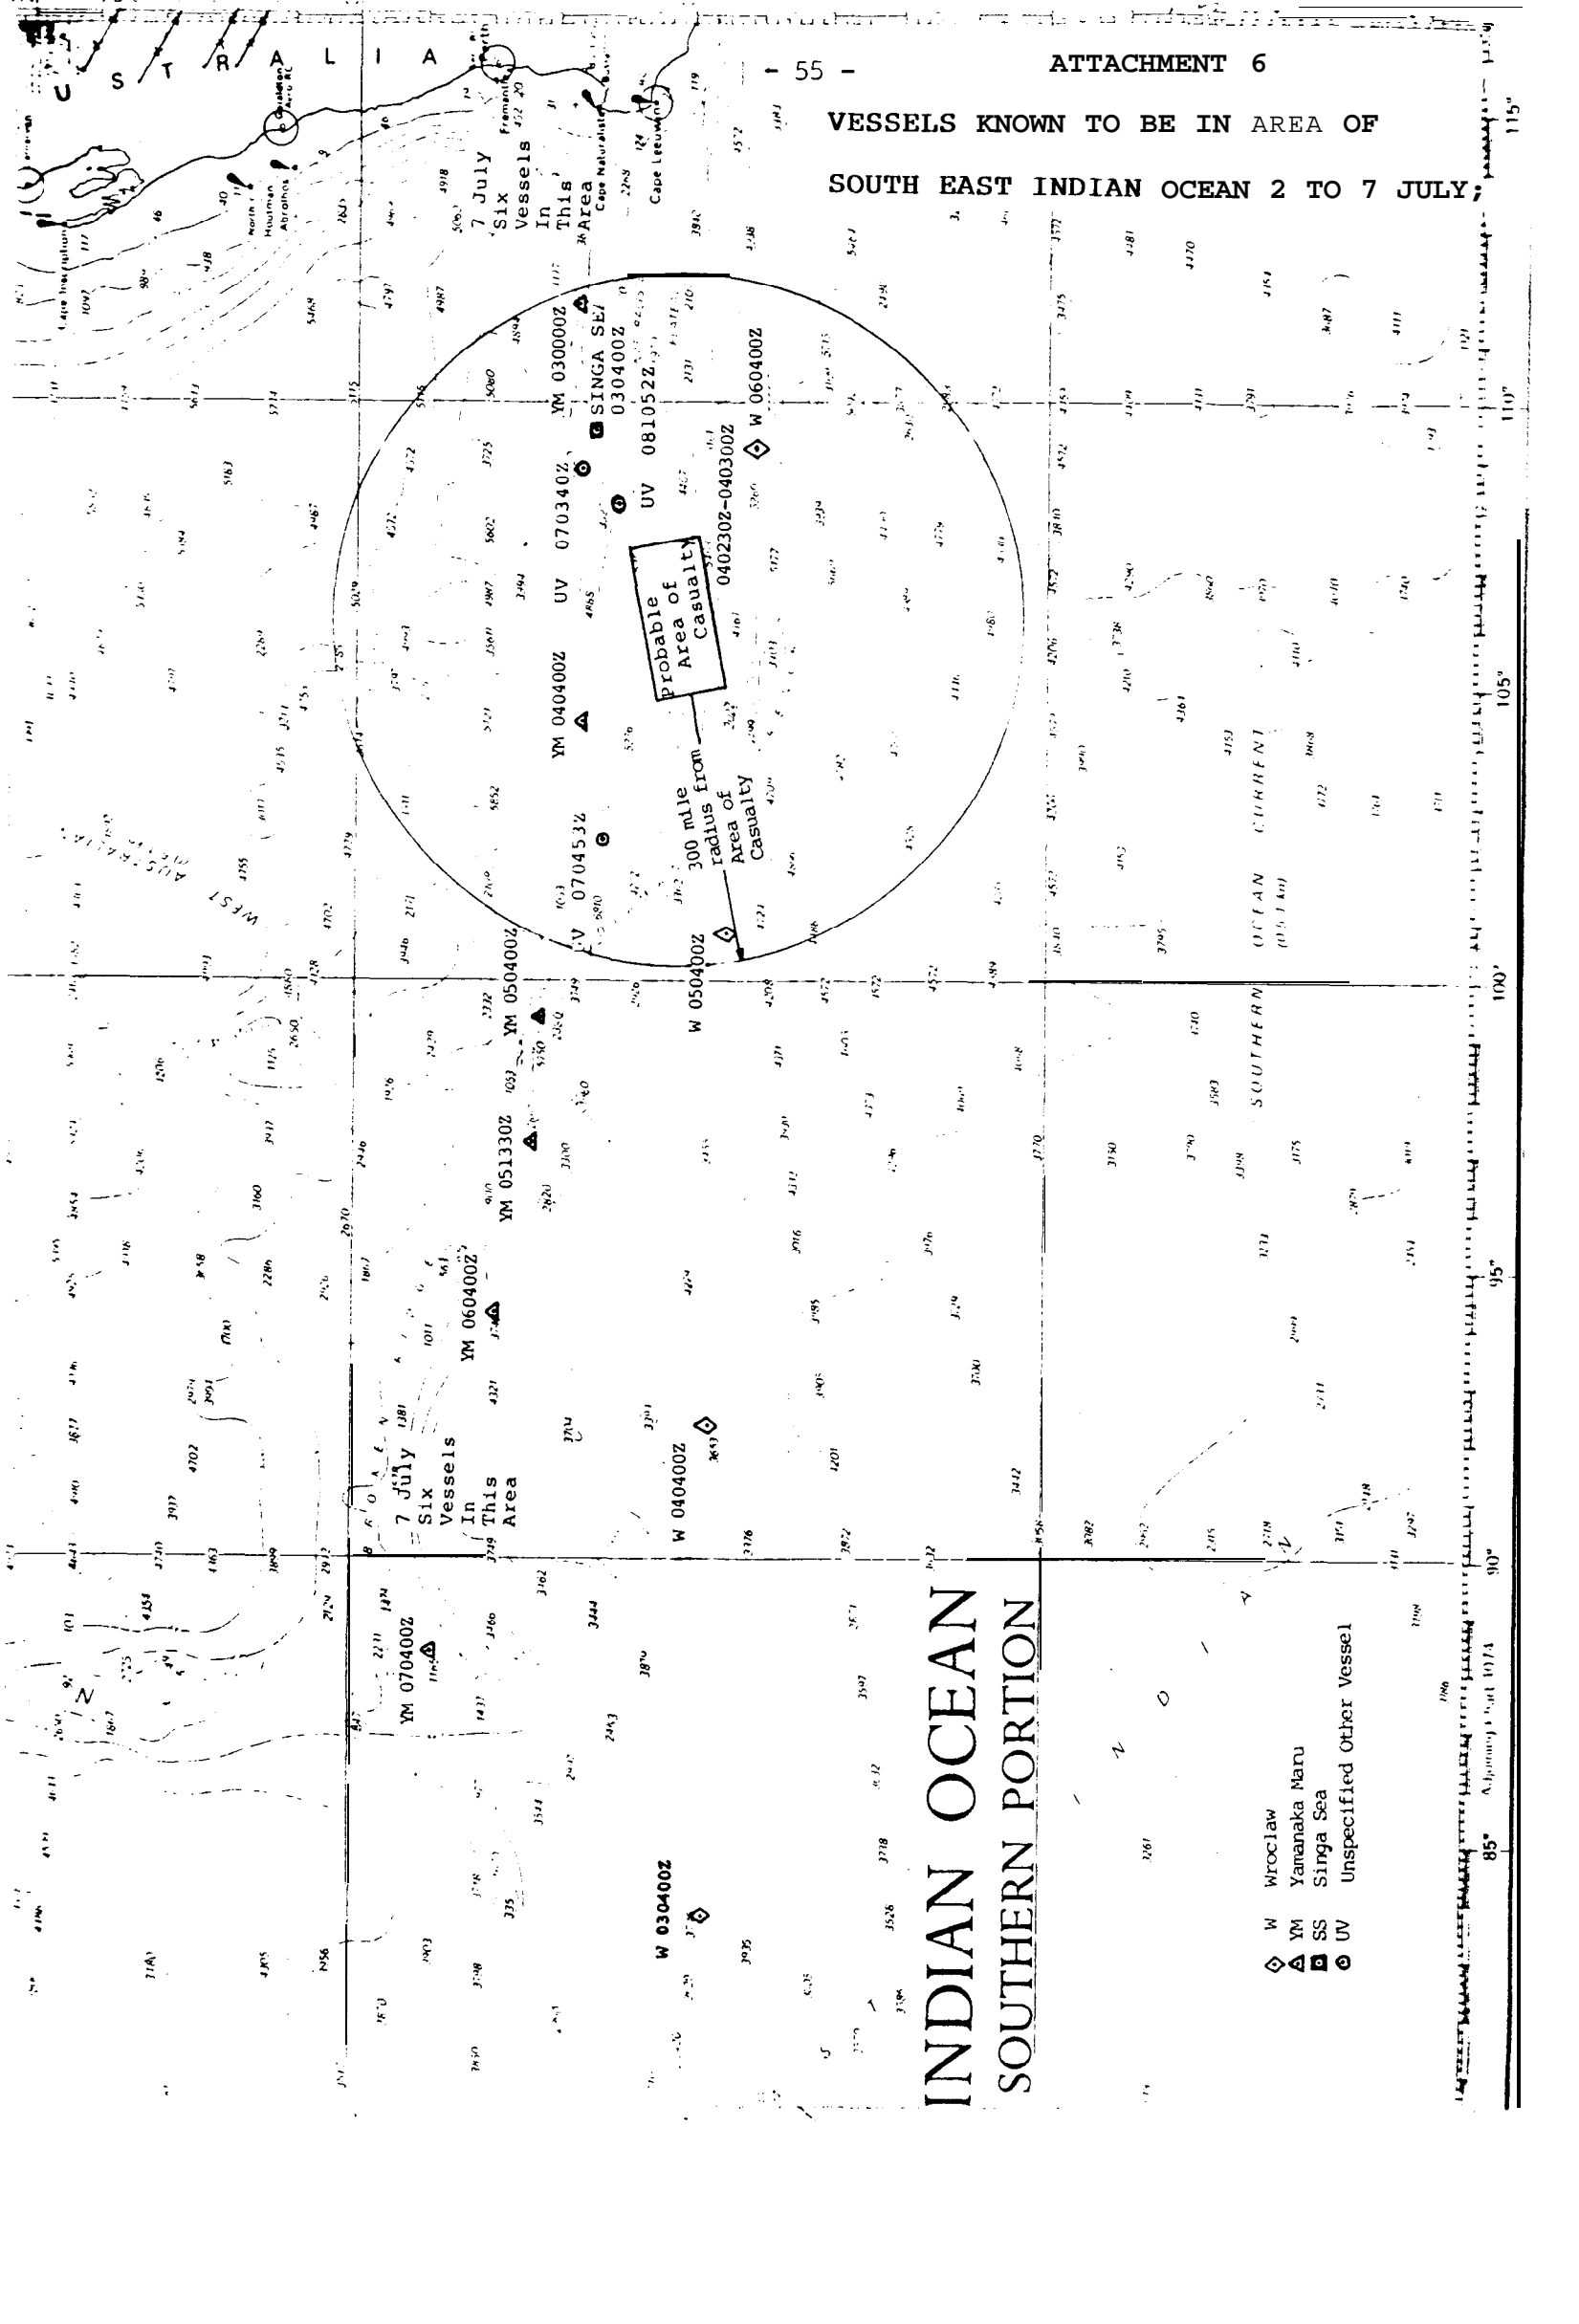
VESSELS KNOWN TO BE IN AREA OF

- ◊ W Wroclaw
- △ YM Yamanaka Maru
- ◼ SS Singa Sea
- ⊙ UV Unspecified Other Vessel

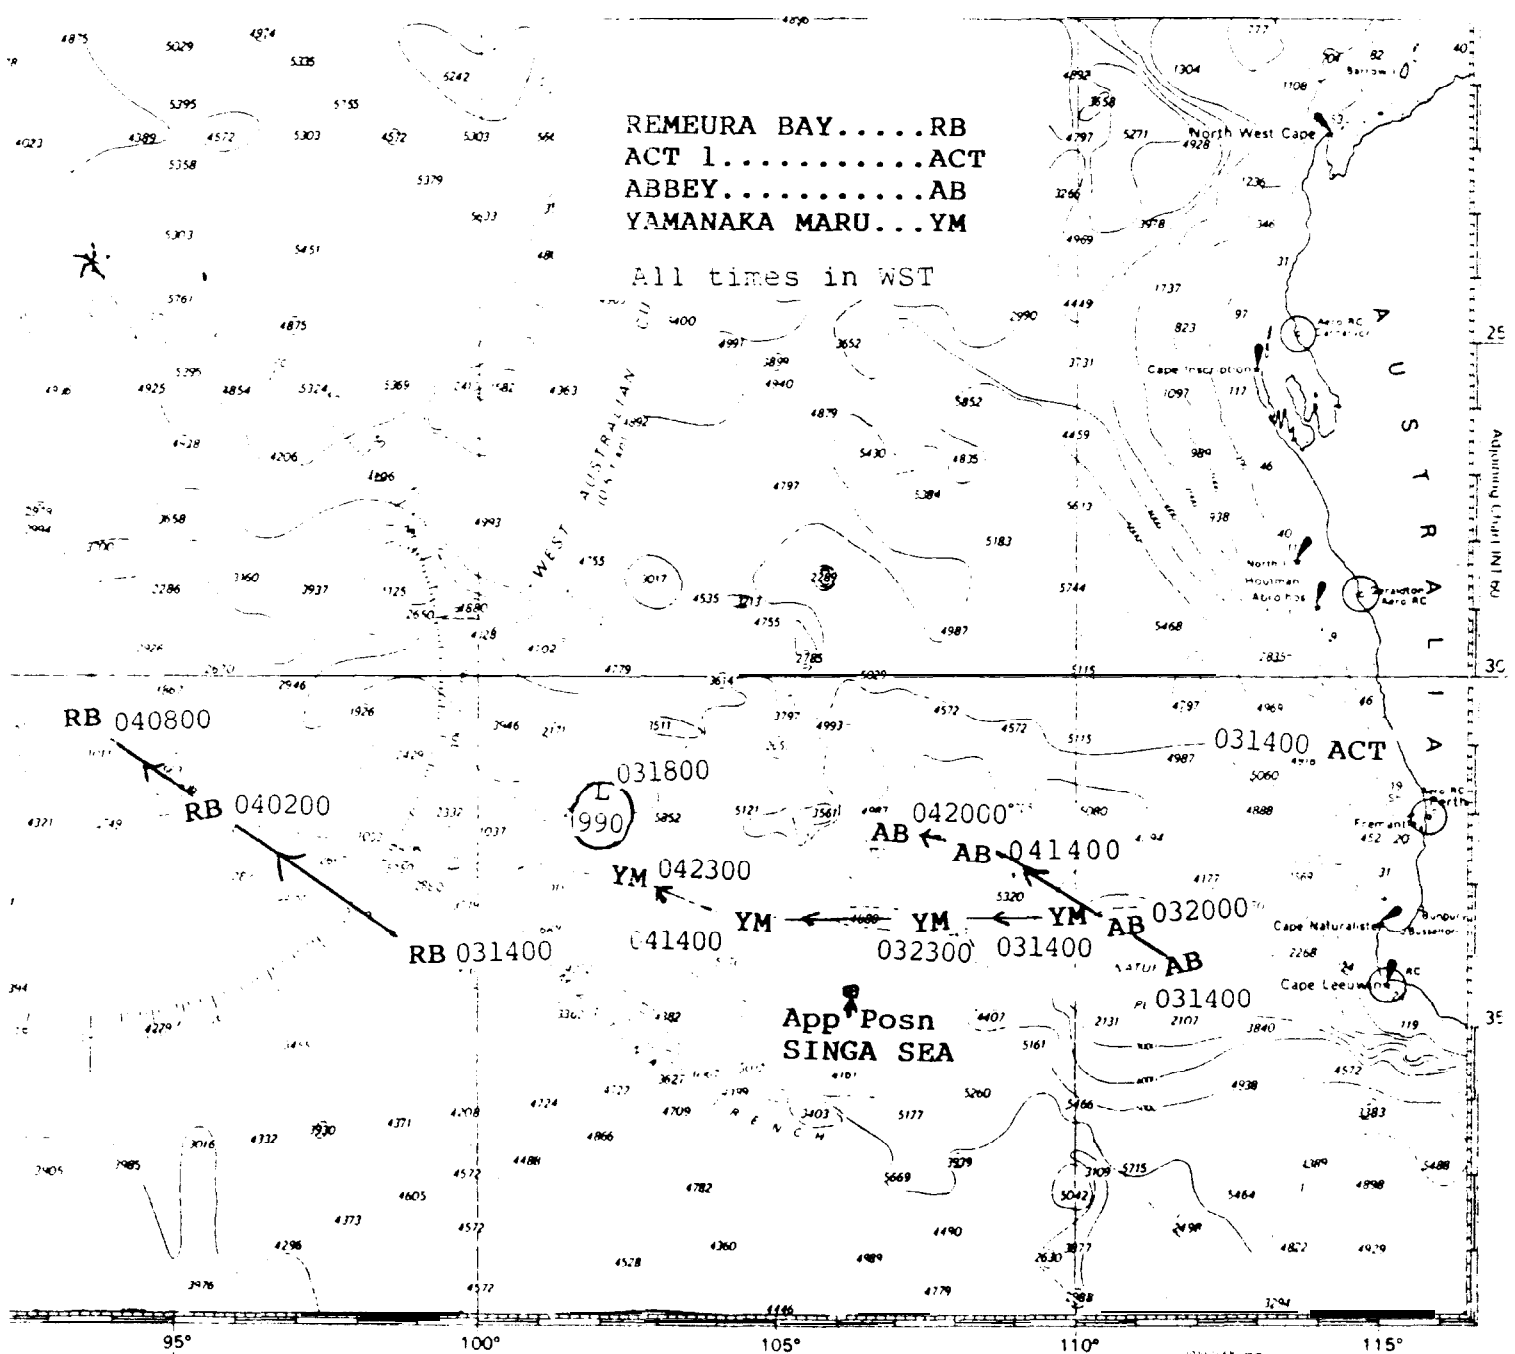
The REMEURA BAY to the west of the low pressure system was reporting southerly gale force winds of 44 knots at 1400 WST on 3 July. By early morning of 4 July the REMEURA BAY was reporting winds of 18 knots (see chartlet).

The remaining three ships were to the east of the system and were reporting gale force winds of up to 30 to 40 knots until the evening of 4 July when the wind strength was reported as falling to 21 knots.
