Australian Transport Safety Bureau

# Collision off Cape Moreton, Queensland – 11 April 2002

## Collision involving *Forum Samoa II* and *Seabreeze II*

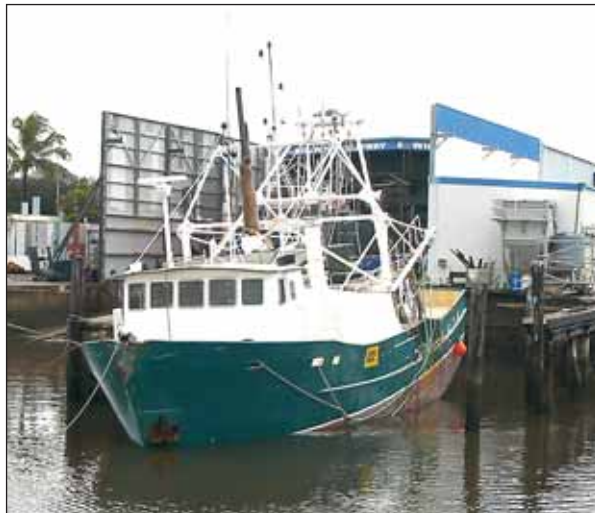
**FIGURE 1:**  
Fishing vessel *Seabreeze II*

At 0401 on 11 April 2002, the fishing vessel *Seabreeze II* collided, bow on, with the starboard side of the general cargo ship *Forum Samoa II*. There were no injuries to any person on either vessel, but the collision resulted in damage to the bow of the fishing vessel, which returned to port for repairs.

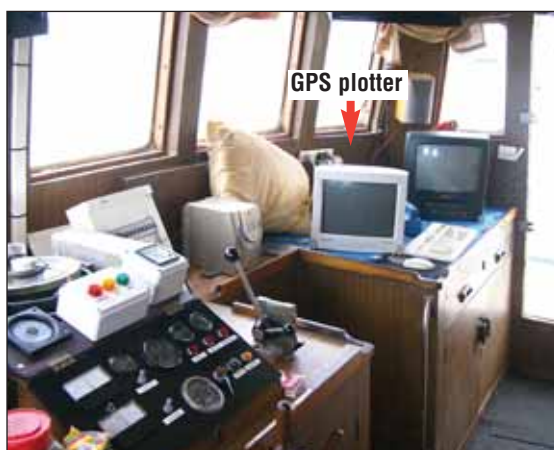
**FIGURE 2:**  
***Seabreeze II*: Wheelhouse**

The mate sat in the wheelhouse chair, looking at the GPS plotter. He neither used the radar nor attempted any visual lookout. At about 0400, he suddenly noticed a large dark shape crossing from port to starboard, immediately ahead. He pulled the throttle back and took the engine out of gear, but could not prevent the fishing vessel from colliding with the other vessel, at right angles, amidships on its starboard side.

The mate of *Seabreeze II*, who only became aware of the ship when a collision was inevitable, was using the GPS plotter to navigate and was neither keeping a visual lookout nor using the radar.

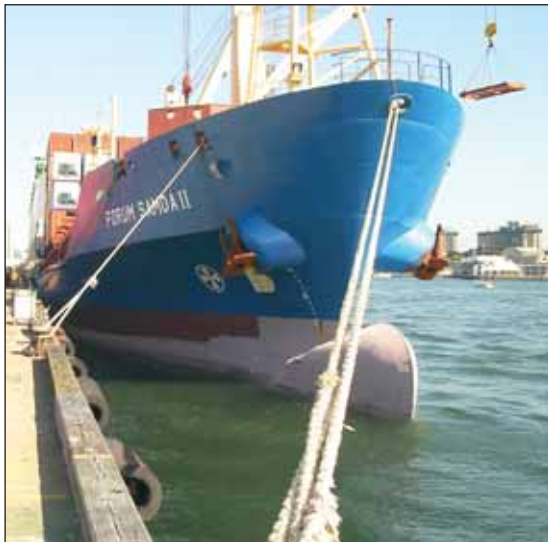
**FIGURE 3:**  
***Forum Samoa II***

The second mate was preoccupied with his radio conversation with his friend. He was not aware that the vessel to starboard was displaying the appropriate lights for a vessel engaged in trawling, and that the green light was not a sidelight. Neither was he aware that the other vessel was crossing from starboard to port.

It is probable that the second mate neither made visual checks on, nor did he take compass bearings of, the other vessel which would have alerted him to the possibility of a collision. If his claim that he acquired the

Shipowners, managers and masters of ships ensure that the requirements for a proper lookout are understood and practised by bridge watchkeepers.

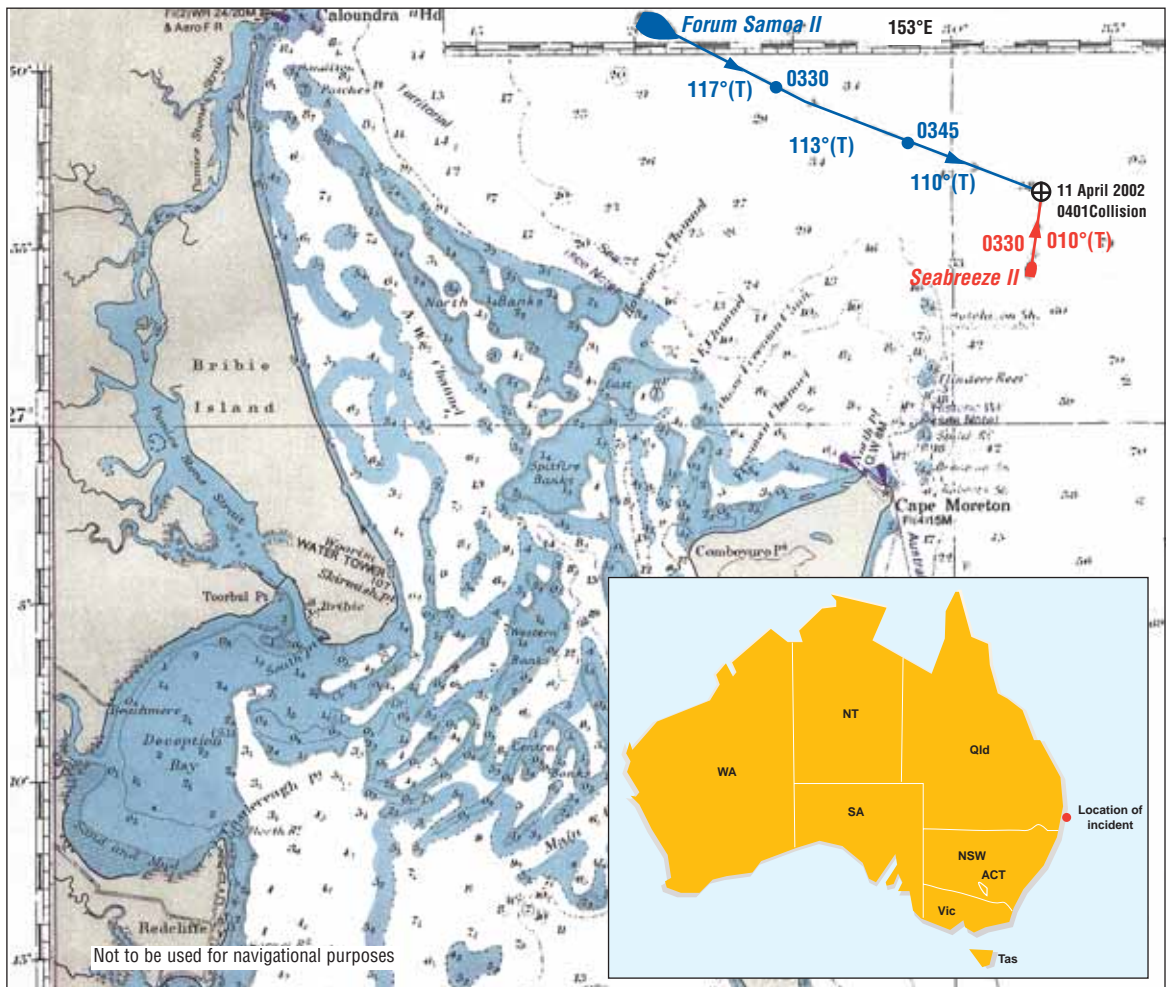
**FIGURE 4:**  
Portion of chart Aus 364 showing tracks of *Seabreeze II* and *Forum Samoa II*

*Forum Samoa II* was required to keep out of the way of *Seabreeze II* and, under Rule 16 (action by a give-way vessel) was required to take early and substantial action to keep clear of that vessel.
