Australian Transport Safety Bureau

Collision between *FV Ocean Odyssey* and *MV P&O Nedlloyd Taranaki*

April 2005

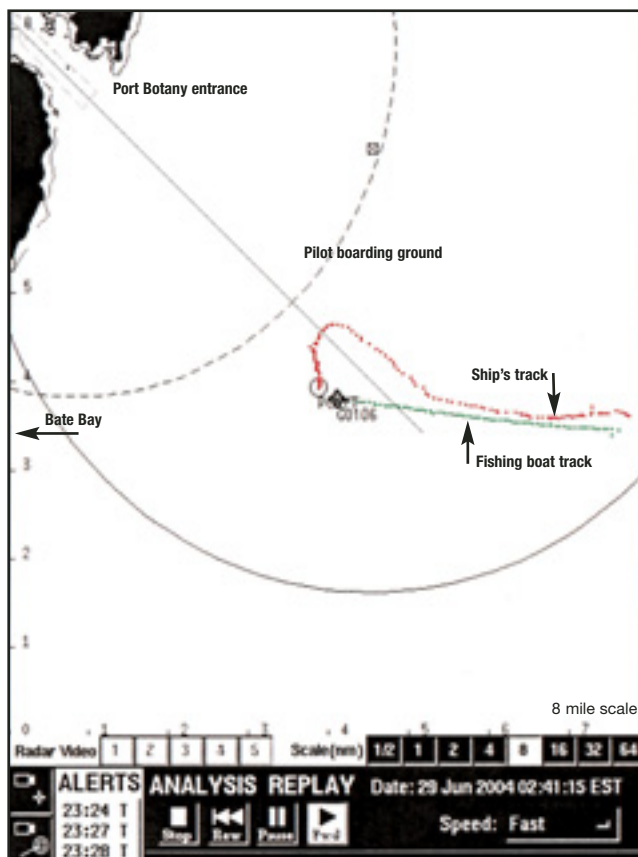
Replay of Vessel Traffic System display for the area off Port Botany showing the ship and boat tracks
