Australian Transport Safety Bureau

Crew fatality and injury while securing anchors

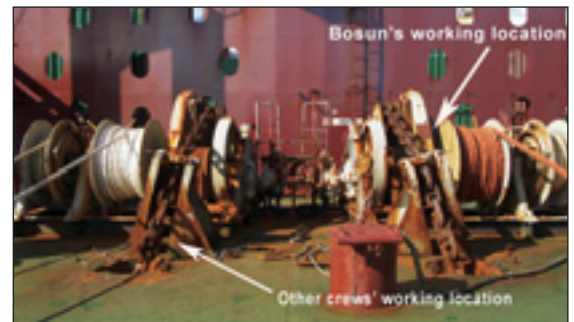
FIGURE 2: Forecastle head arrangement – looking aft

On the forecastle head, the bosun went behind the port windlass to fit a canvas cover over the spurling pipe³. The other seamen went to the forward side of the starboard windlass to secure cover plates over the hawse pipe⁴.

The force of the wave washed one of the men working near the hawse pipe onto, and then over the top of, the windlass and mooring equipment and onto the deck behind. When found later, he appeared unconscious but the full extent of his injuries were not readily apparent.

The other man working forward of the starboard windlass was swept onto the starboard side of the forecastle head, past the breakwater and aft to the top of the ladder leading onto the main deck. He suffered severe lacerations.

The bosun, working behind the port windlass, was protected from the main force of the water and escaped relatively unscathed.

The two men working on the hawse pipe were working on an exposed part of the forecandle head and when the wave hit, they were subjected to the full force of the wall of water.

All seafarers should remain actively cognisant of the prevailing weather and sea conditions when working in exposed areas.

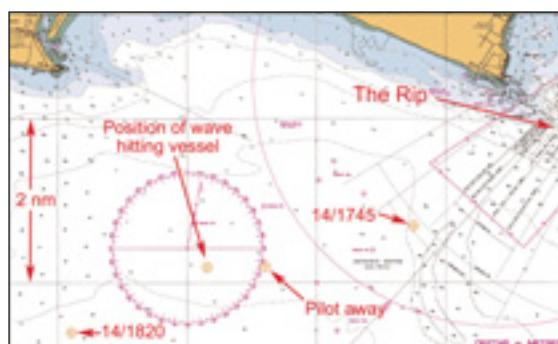
FIGURE 3: Portion of chart Aus 144 – area of incident

At the time of the incident, *Aotearoa Chief* was in shoaling water, which was still under the influence of the strong ebb tidal stream from Port Phillip Bay and the opposing southerly sea and wind.

It is therefore possible that the wave that broke over the forecastle head was what is known as an 'abnormal wave'. The Mariner's Handbook (NP 100, p.71) describes an 'abnormal wave' as likely 'when waves are distorted by meeting shoal water, a strong opposing tidal stream or current, or another wave system'. This type of wave is different from normal sea waves in that they are abnormally steep-fronted, higher and occur in a small geographical area.

Masters should carefully plan the course, speed and/or position of their vessel to minimise the risks to crew members working on exposed decks.
