ATSB TRANSPORT SAFETY INVESTIGATION REPORT

Aviation Occurrence Report – 200501977

Interim Factual Report No. 2

**Collision with Terrain
11 km NW Lockhart River Aerodrome
7 May 2005
VH-TFU
SA227-DC (Metro 23)**

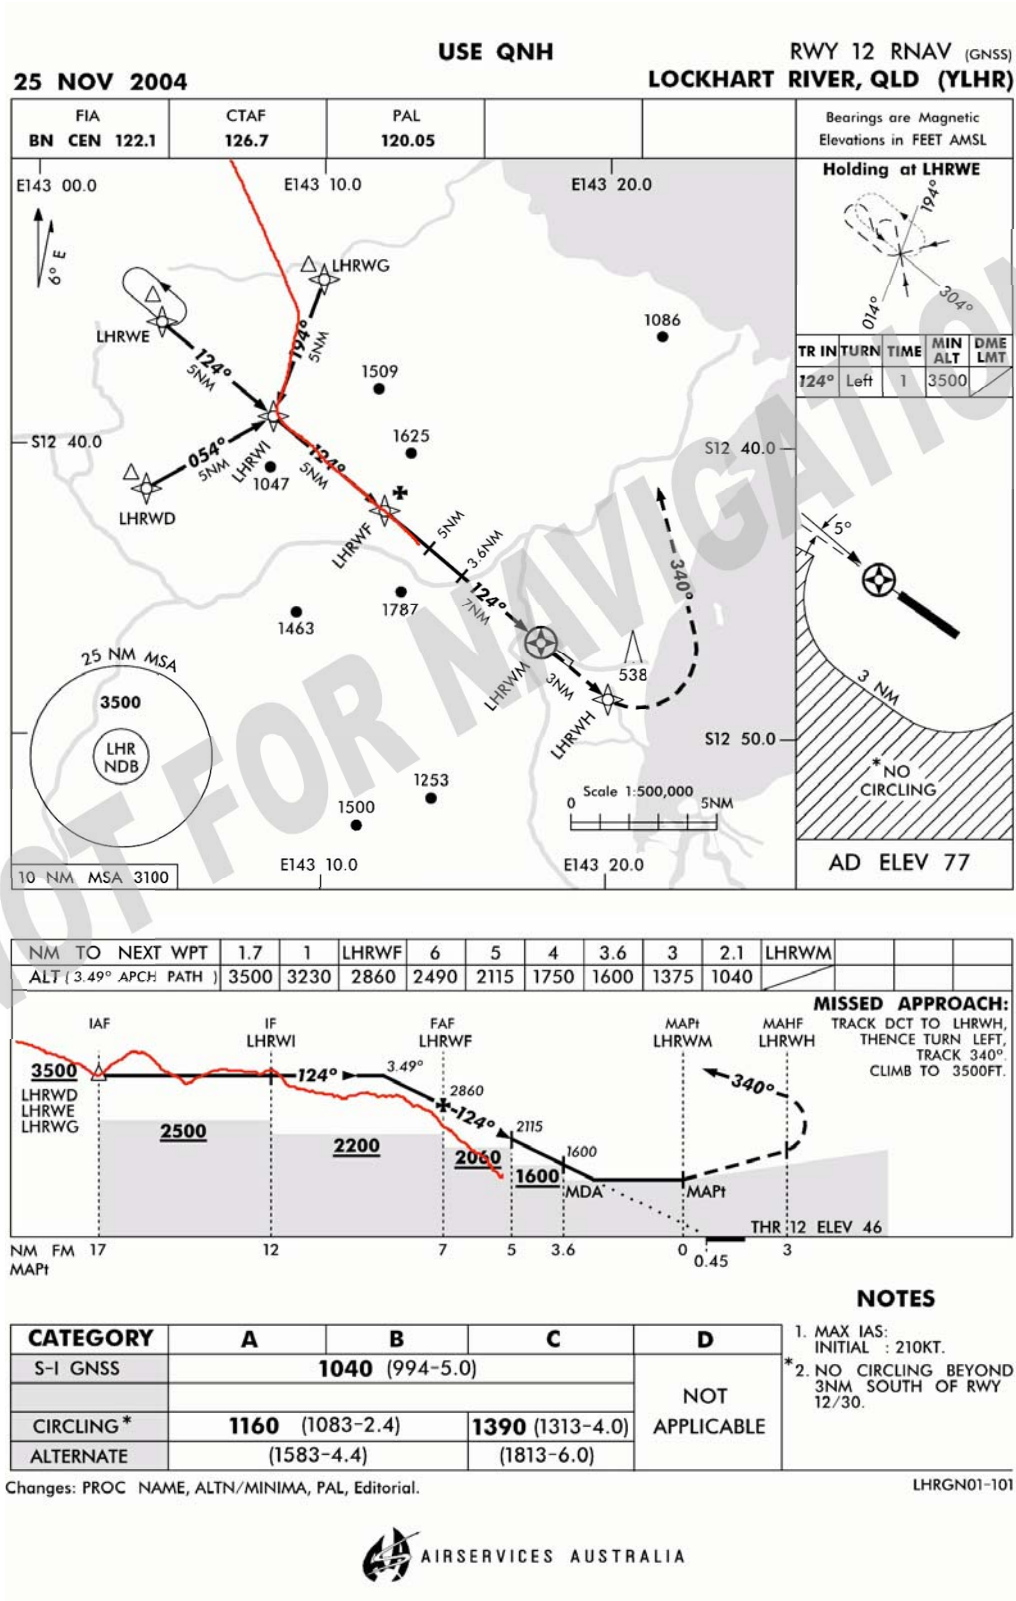
Figure 4: Approach track and profile (in red) derived from FDR data overlaid on an extract of the Airservices Australia Runway 12 RNAV (GNSS) approach chart

After 1142:29 the aircraft rate of descent was greater than that required to achieve the recommended descent profile for the published approach procedure. The aircraft descended at an average rate of 1,500 ft/min, with some turbulence evident, over the 70 seconds prior to the impact.			
1142:58	Aircraft over the LHRWF waypoint.	Altitude: 2,397 ft	IAS: 174 kts
1143:11	Aircraft descends through the segment minimum safe altitude of 2,060 ft.	Altitude: 2,057 ft	IAS: 177 kts
1143:22	Aircraft 229 ft below the minimum segment altitude of 2,060 ft.	Altitude: 1,831 ft	IAS: 176 kts
1143:38	Minimum altitude recorded on the FDR.	Altitude: 1,292 ft	IAS: 158 kts
1143:39	Aircraft 5.5 NM prior to LHRWM waypoint. End of recorded data.

Figure 4 on page 6 shows an Airservices Australia Runway 12 RNAV (GNSS) instrument approach chart for Lockhart River overlaid with the FDR derived flight profile of the aircraft. It is apparent that the crew was accurately tracking after the LHRWG waypoint. Some excursions from the recommended vertical profile can be seen after passing LHRWG. After passing LHRWF waypoint, the aircraft descended below the segment minimum safe altitude of 2,060 ft.

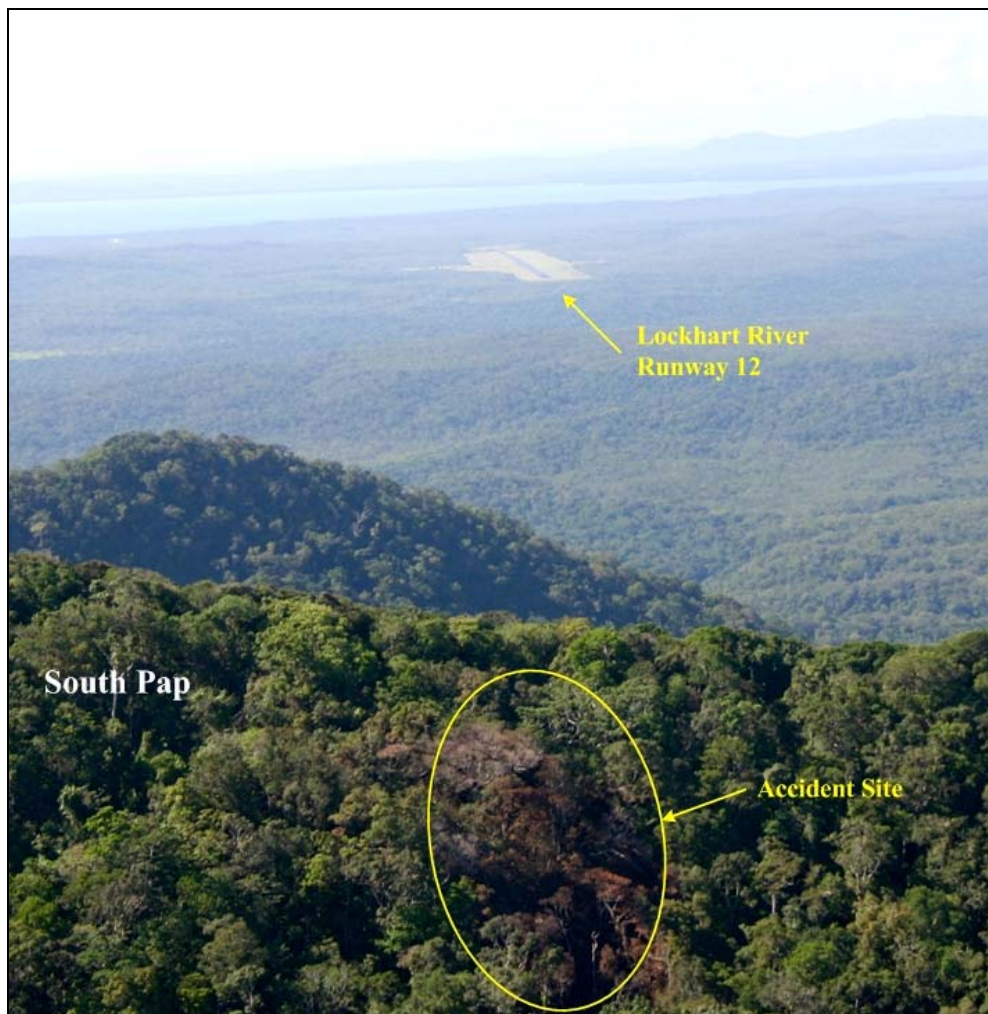
Figure 14: General view of the accident site looking toward the south east

The accident site was located on the north-west side of South Pap, a ridge in the Iron Range National Park. The wreckage lay in dense tropical rainforest, at an elevation of 1,210 ft (369 m), on a bearing of about 304 degrees magnetic from the threshold of runway 12, at a distance of 11 km (Figure 14). The height of the initial impact with trees was about 90 ft below the crest of the ridge.

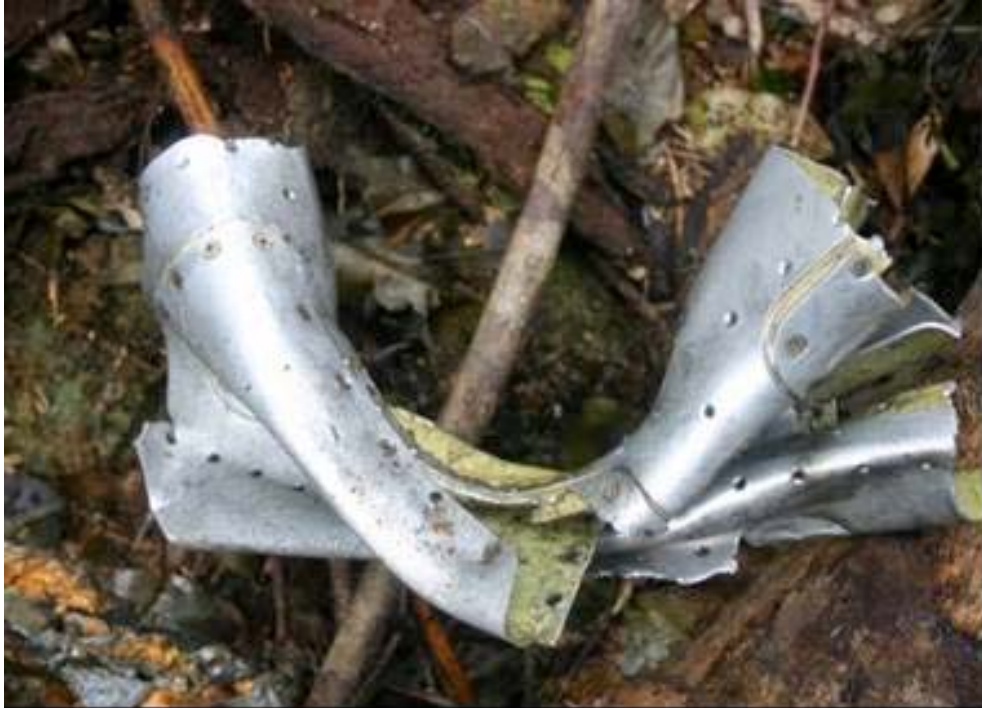
Figure 15: Wing section showing impact damage with a tree trunk or branch

As the aircraft flew through the crowns of the trees, the outboard sections of both wings and the blades of both propellers were separated from the aircraft (Figure 15).

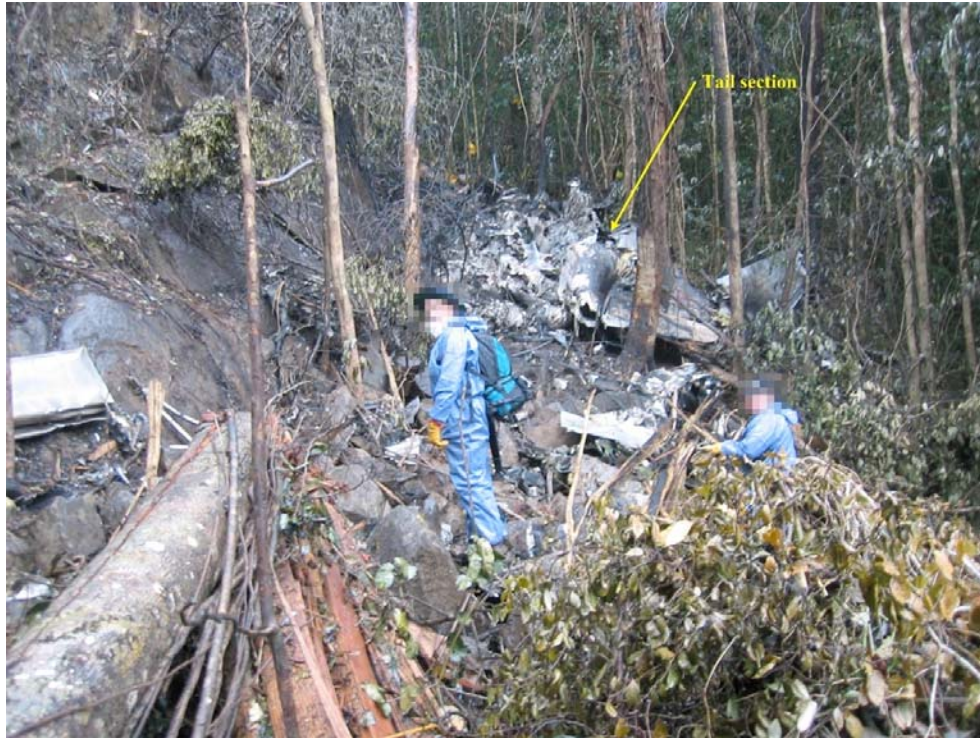
Figure 16: View along the direction of travel showing the rock outcrop and main wreckage in the background

The aircraft continued along a descending flight path contacting tree trunks and branches. This resulted in further sections of both wings, the engines and sections of the horizontal stabiliser and elevators being torn off. The nose of the aircraft then contacted boulders and broke up. The remaining left wing structure then impacted a rock outcrop causing the fuselage to roll to the right approximately 50 degrees (Figure 16).

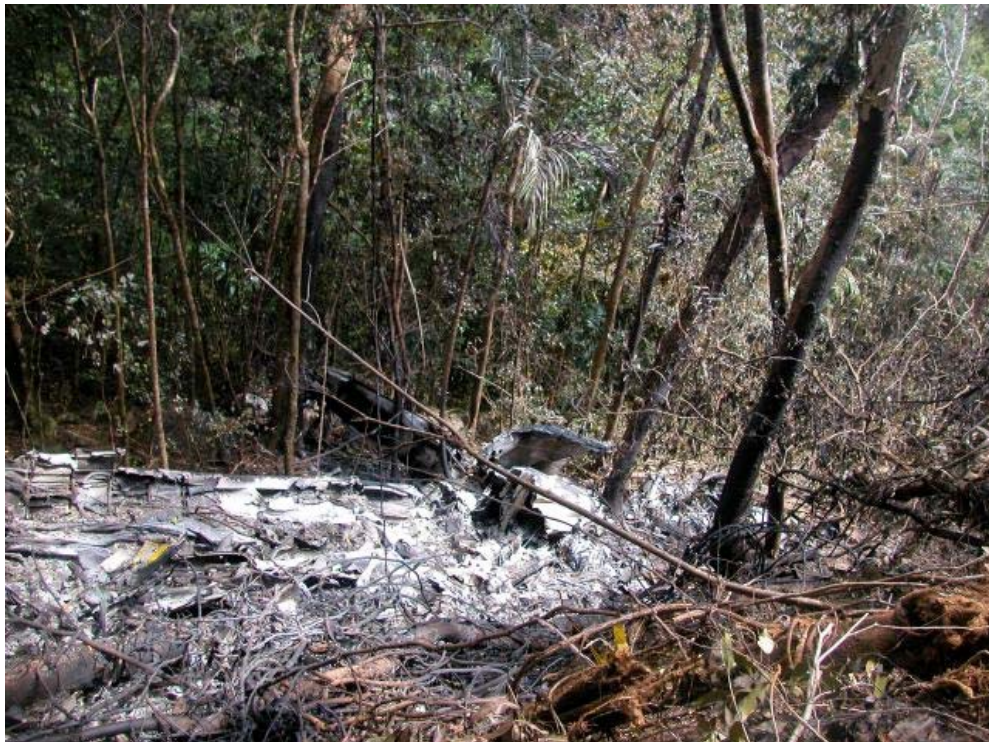
Figure 17: The rear fuselage section

The remaining wreckage then continued about 20 m up the steeply sloping ground before stopping, and was then consumed by an intense, fuel-fed, post-impact fire (Figure 17).

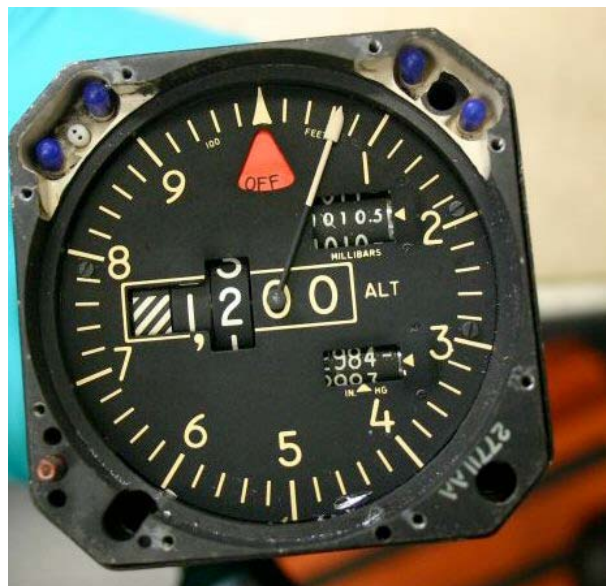
Figure 19: Pilot in command's encoding altimeter

The pilot in command's altimeter was impact damaged with the glass face broken but still attached to the unit. The drum scale indicated an altitude of 1,200 ft and the pointer 63 ft. The barometric pressure scale setting was 1010.5 hPa (Figure 19).

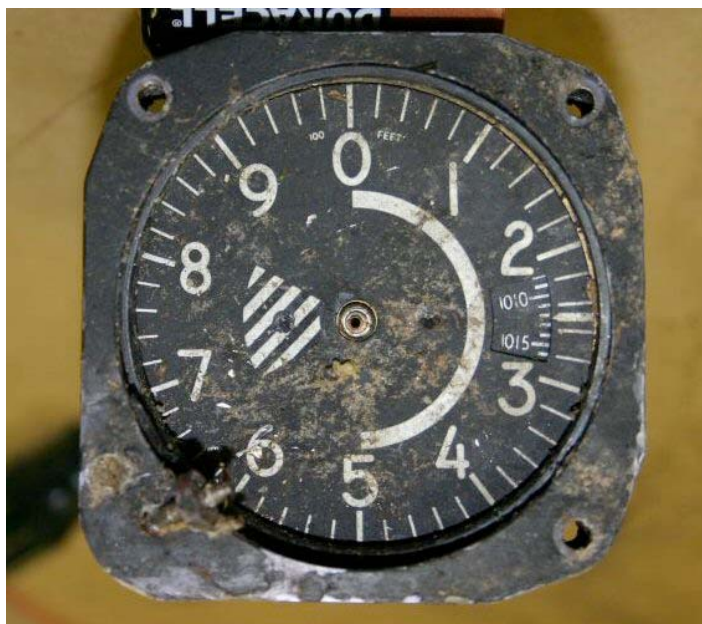
Figure 20: Copilot's altimeter

The copilot's altimeter was severely damaged by the impact, with the glass face destroyed, the instrument face depressed inward and the three pointers missing from the spindle. There were numerous marks on the face, including two marks near the numeral marking '2' which may have been contact marks from the 'hundreds' pointer. The barometric pressure scale setting was 1012 hPa (Figure 20).

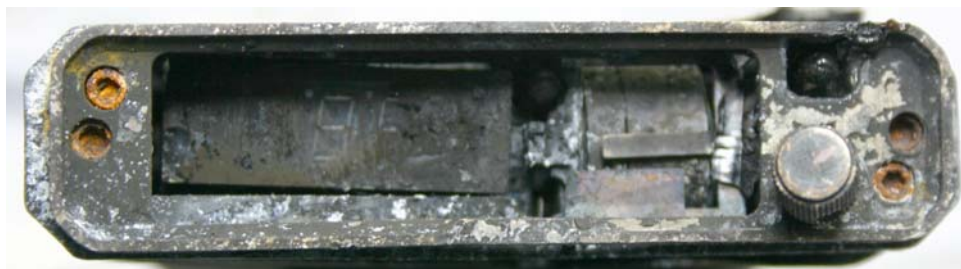
Figure 21: DRI-55 digital radio altimeter indicator

Examination of the digital radio altimeter indicator unit (Figure 21) showed that the decision height setting was about 920 ft, with the warning flag in view. Examination of the light globes from the decision height annunciator and circuit card was inconclusive.
