**ATSB TRANSPORT SAFETY REPORT**  
Aviation Occurrence Investigation – AO-2010-089  
Preliminary

**In-flight uncontained engine failure  
overhead Batam Island, Indonesia  
4 November 2010  
VH-OQA  
Airbus A380-842**

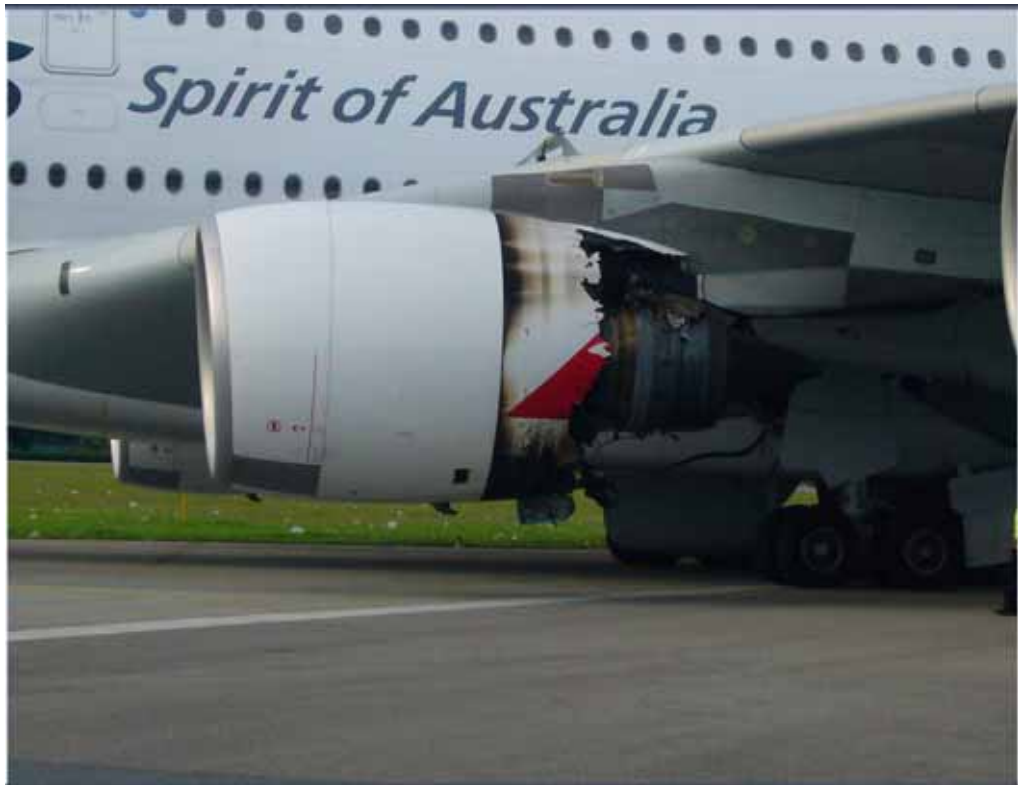
**Figure 1: VH-OQA showing the damaged No 2 engine**

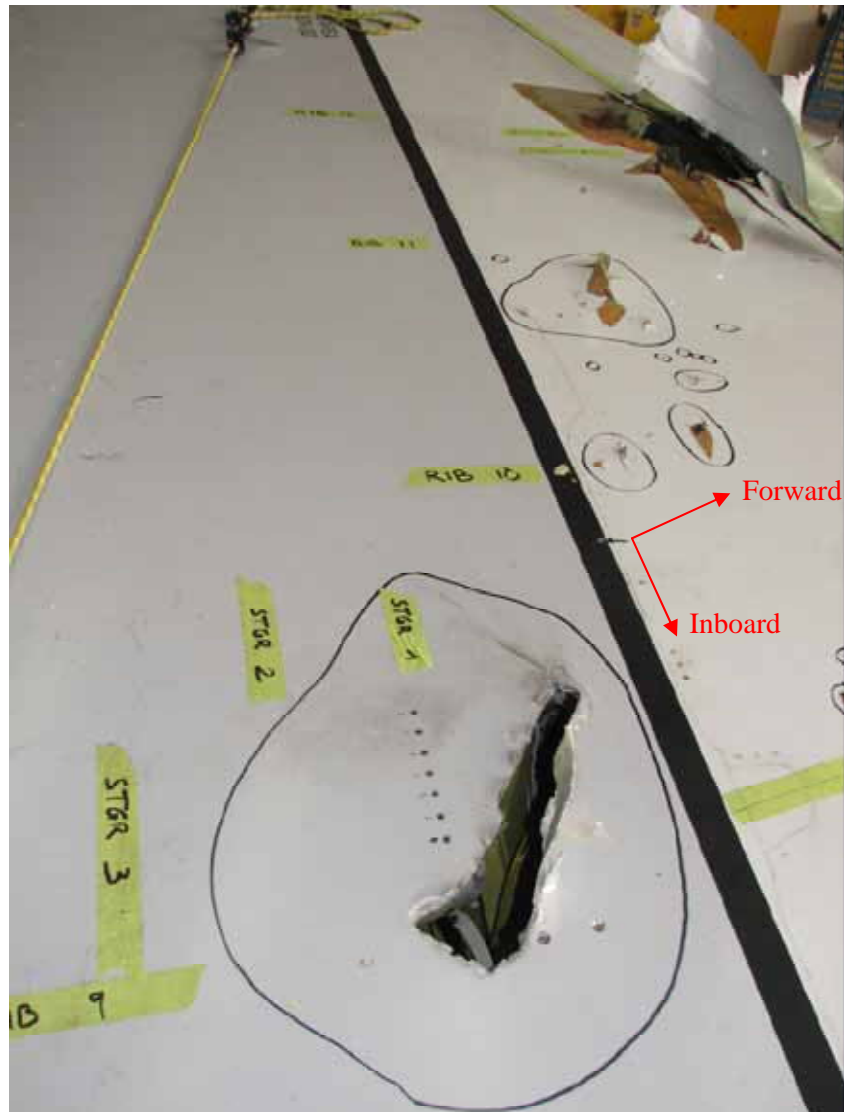
The failure of the No 2 engine ejected a number of engine components that struck the aircraft or were liberated overboard. Sections of the intermediate pressure (IP) turbine disc penetrated the leading edge of the left wing inboard of the No 2 engine, resulting in damage to the leading edge structure, the front wing spar and the upper surface of the wing (Figure 3). A small section of liberated turbine disc penetrated the left wing-to-fuselage fairing, resulting in damage to numerous system components, the fuselage structure and elements of the aircraft's electrical wiring. Released debris also impacted the left wing's lower surface, resulting in a fuel leak from the Number 2 engine fuel feed tank and left wing inner fuel tank.

**Figure 3: Damage to left wing upper surface**

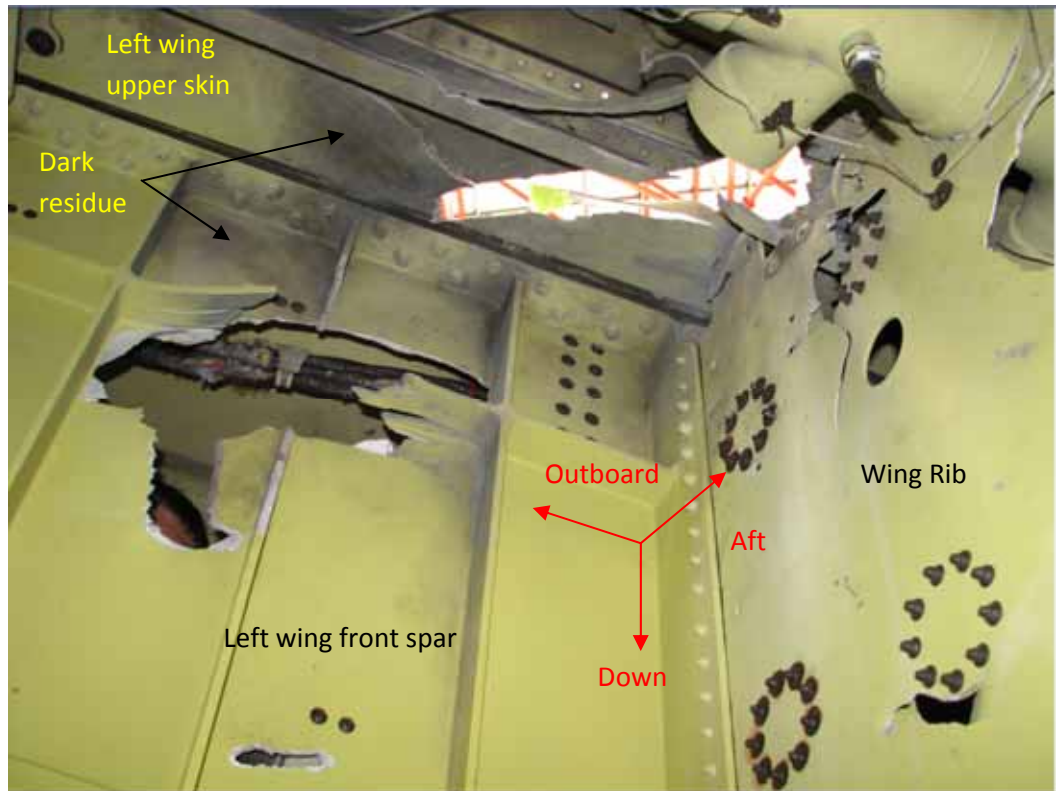
A dark residue was observed inside the left wing inner fuel tank between ribs 8 to 10 (Figure 4). The residue will be subject to further technical examination.

**Figure 4: Dark residue observed in the left wing inner fuel tank**

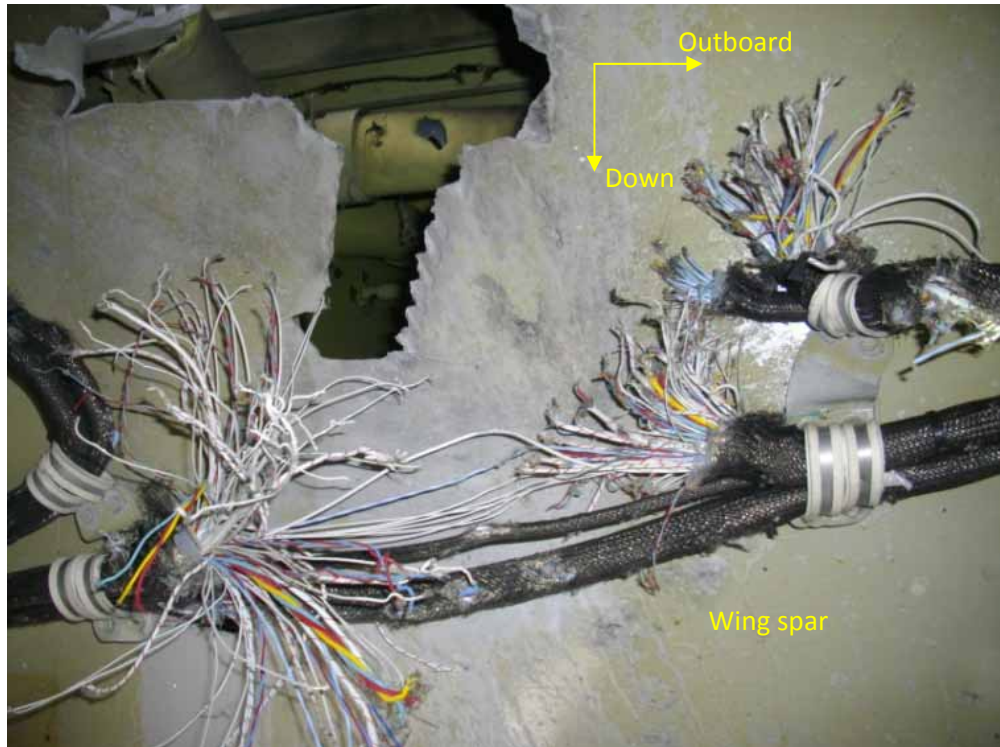
Impact damage from the liberated engine debris affected a number of aircraft systems. Damage was observed to: elements of the aircraft's electrical wiring that affected the operation of the hydraulic system, landing gear and flight controls; a number of fuel system components; and the leading edge slat system (Figure 5).

**Figure 5: Damage to electrical wiring located in the leading edge of the left wing**

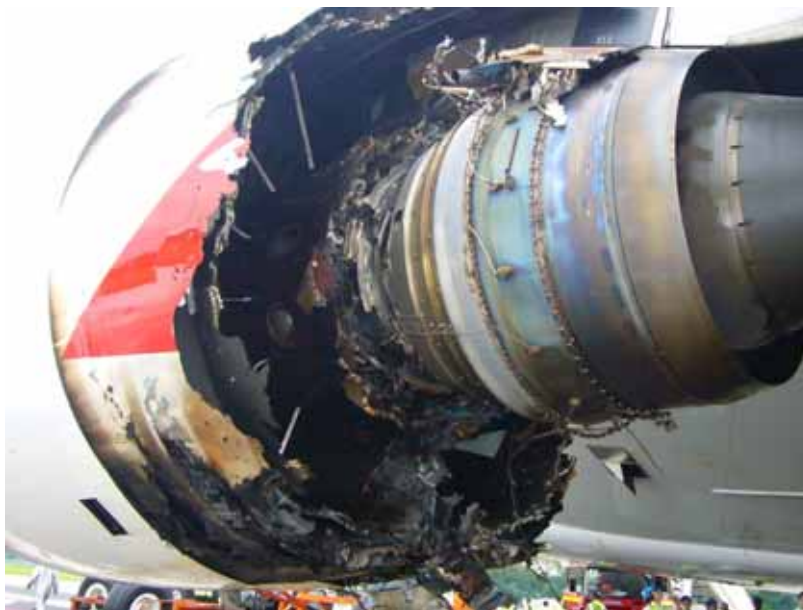
Examination of the failed No 2 engine indicated that it had sustained an uncontained failure of the IP turbine (Figure 7). The turbine disc, blade and nozzle guide vanes separated into a number of sections, rupturing the surrounding IP turbine casing and damaging the engine's thrust reverser.

Damage was also evident to the engine cold stream duct and outer cowl panels. The No 2 engine thrust links were severed and extensive damage was evident to the LP turbine nozzle guide vanes and stage-1 LP turbine blades.

**Figure 7: Damage to the No 2 engine**

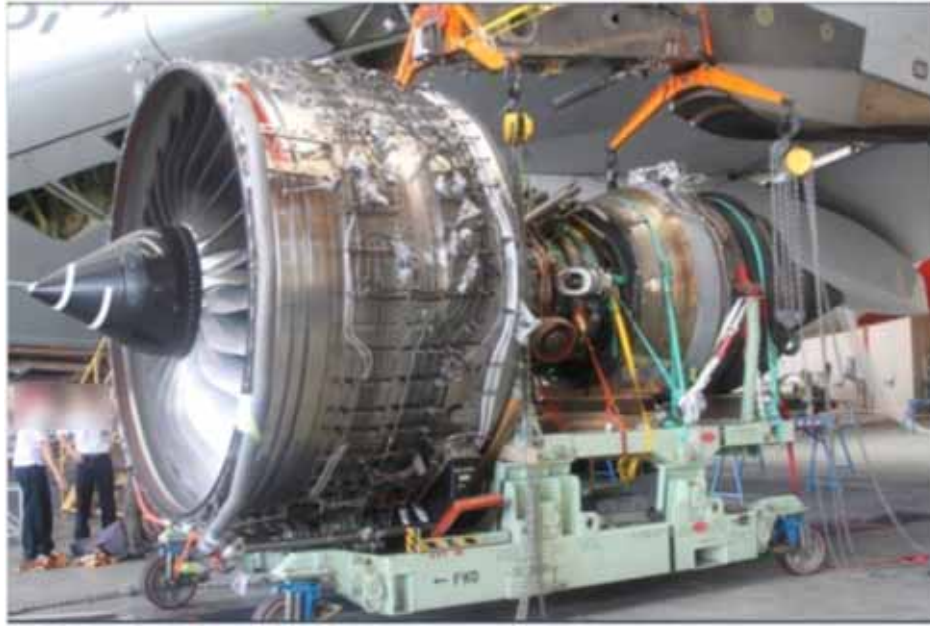
The No 2 engine was removed from the aircraft and taken to a certified Trent 900 engine maintenance, repair and overhaul facility in Singapore. The engine has been examined and disassembled, under the supervision of the ATSB, and relevant components have been forwarded to the Rolls-Royce plc facility in Derby, in the UK for technical examination (Figure 8).

**Figure 8: No 2 engine after removal from the aircraft**

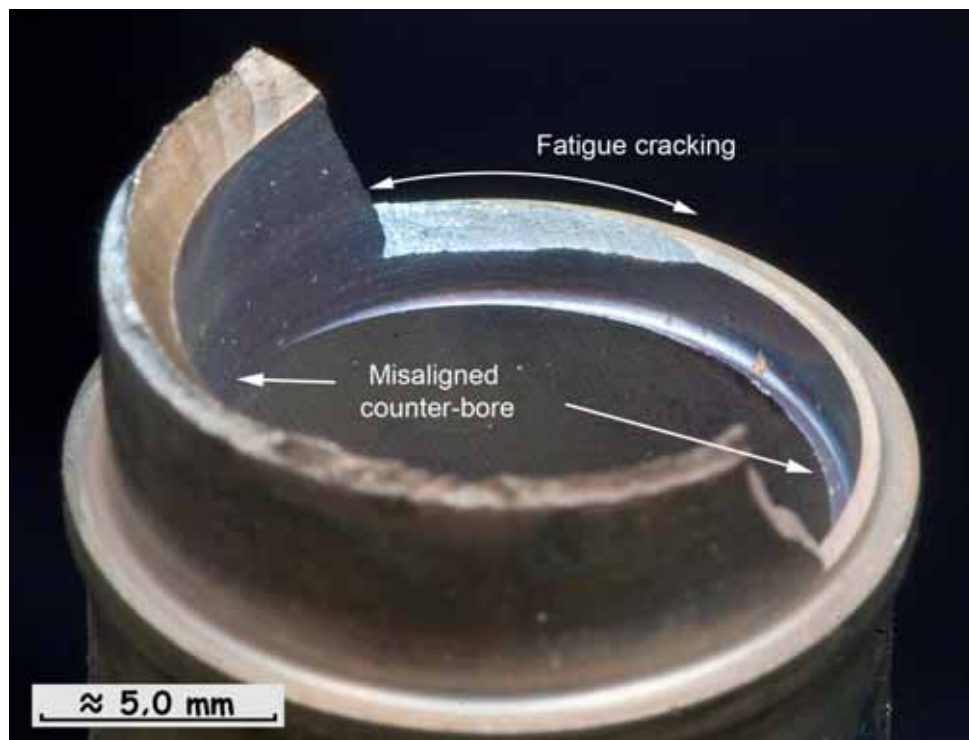
A recent key finding from those examinations was the presence of an area of fatigue cracking within a stub pipe that feeds oil to the HP/IP bearing structure. That cracking was associated with a misaligned region of counter-boring within the stub pipe outlet. The misaligned counter-boring had produced a localised thinning of one side of the pipe wall (Figure 9).

**Figure 9: Detail of stub pipe showing misaligned counter-bore**

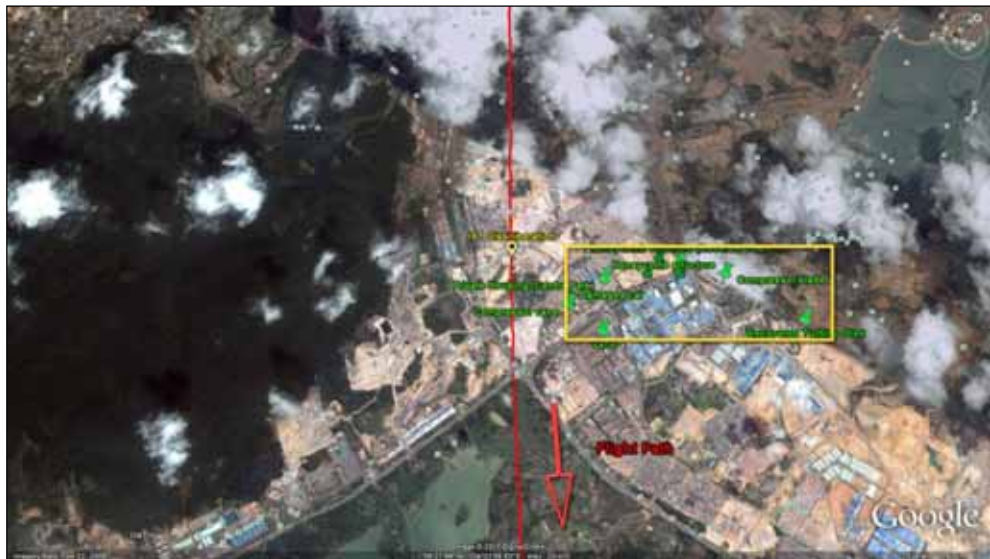
The components that were located on Batam Island were all to the left of the aircraft's flight path. A large segment of IP turbine disc was located about 2.5 km from the aircraft's location at the time of the failure (Figure 10).

**Figure 10: Area of recovered components**

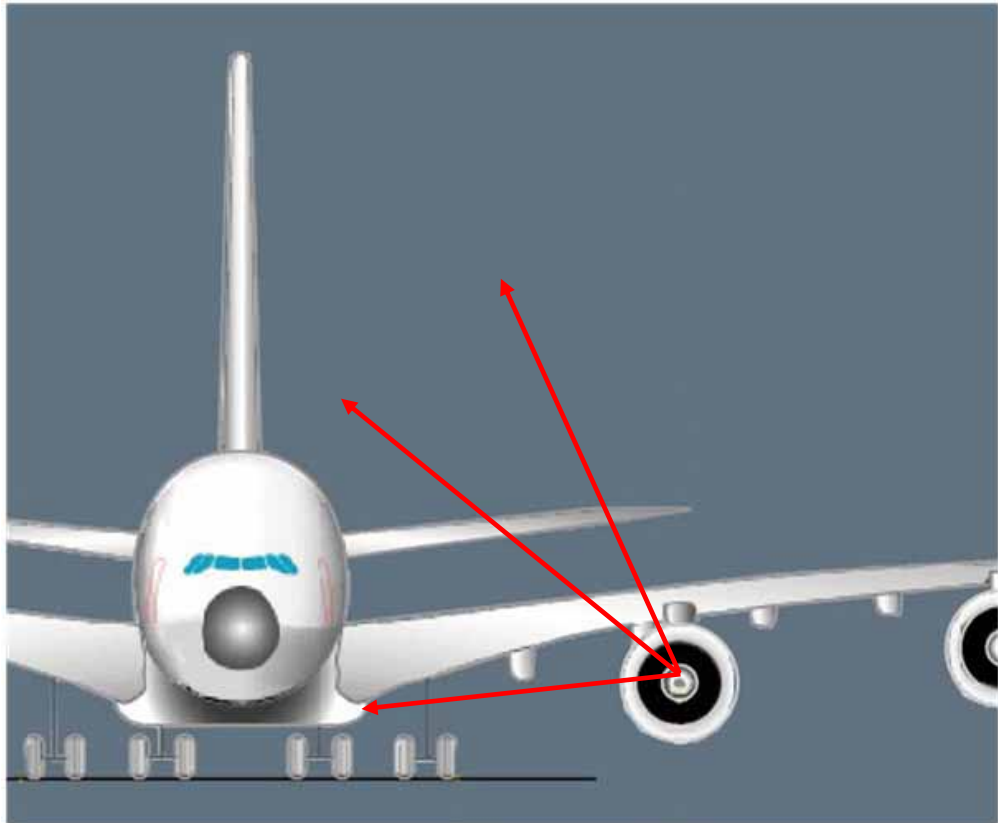
Damage to the aircraft's left wing and the wing-to-fuselage fairing indicated that several IP turbine disc segments were liberated inboard (Figure 11).

**Figure 11: Known direction of travel of some of the liberated engine segments**

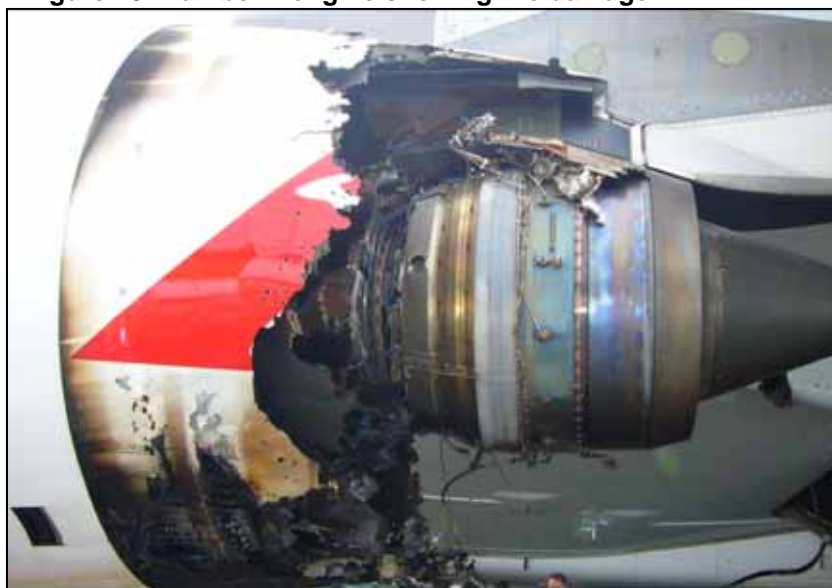
The rear section of the No 2 engine and cowling was damaged by fire (Figure 13). Some components forward of the engine firewall were heat affected.

**Figure 13: Number 2 engine showing fire damage**

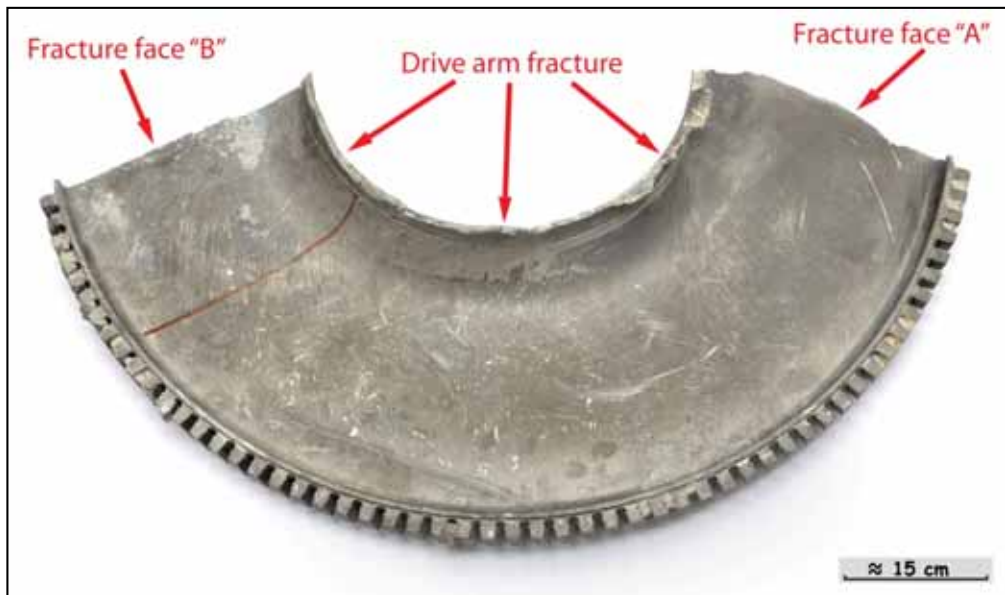
The recovered section of IP turbine disc approximated one-third of the total disc (Figure 14).

**Figure 14: Recovered section of IP turbine disc (as viewed from the rear of the engine)**

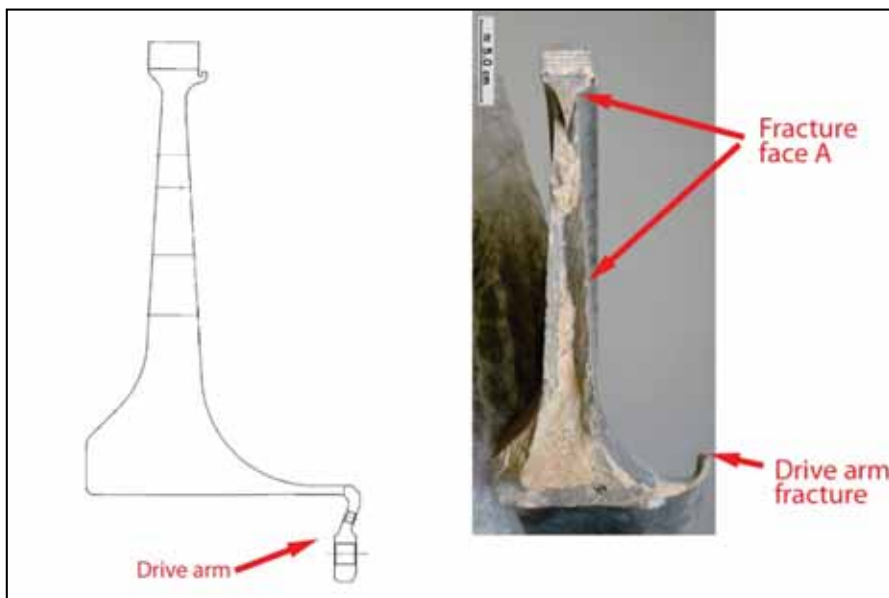
The mass of the recovered IP turbine disc section was almost 70 kg. The section exhibited three distinct fracture faces; two radial fractures from the bore to the external diameter (labelled 'A' and 'B' in Figure 14), and a circumferential fracture face in the region adjacent to the drive arm (the central cylindrical connection to the intermediate pressure spool shaft). The remaining section of the drive arm presented considerable plastic deformation, having bent outward by about 90° (Figure 15). The arm failed at the R850 holes and a section of the drive arm is still missing.

**Figure 15: Cross section of the recovered portion of the IP turbine disc**

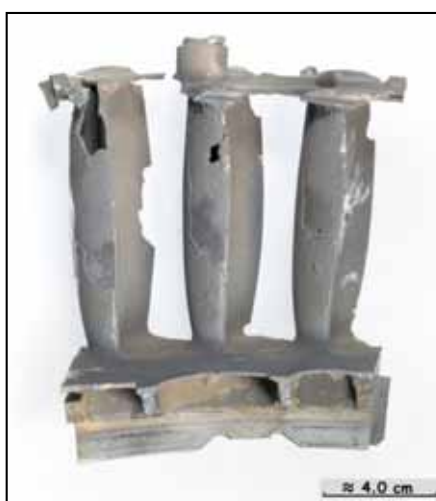
Three triple segments of the LP1 NGV were received. One of the segments was almost complete, with all three vanes present along with the inner platform and some areas of the outer platform (Figure 16). The remaining two NGV segments retrieved contained the remains of the inner platform only, and the vanes exhibited significant damage.

**Figure 16: Portion of LP turbine first stage nozzle guide vanes that was recovered from Batam Island, Indonesia**
