TECHNICAL ANALYSIS REPORT No: 02/02

OCCURRENCE No: 199905562

Examination of Aircraft Wreckage

**Cessna Aircraft Co. U206A
VH-XGR**

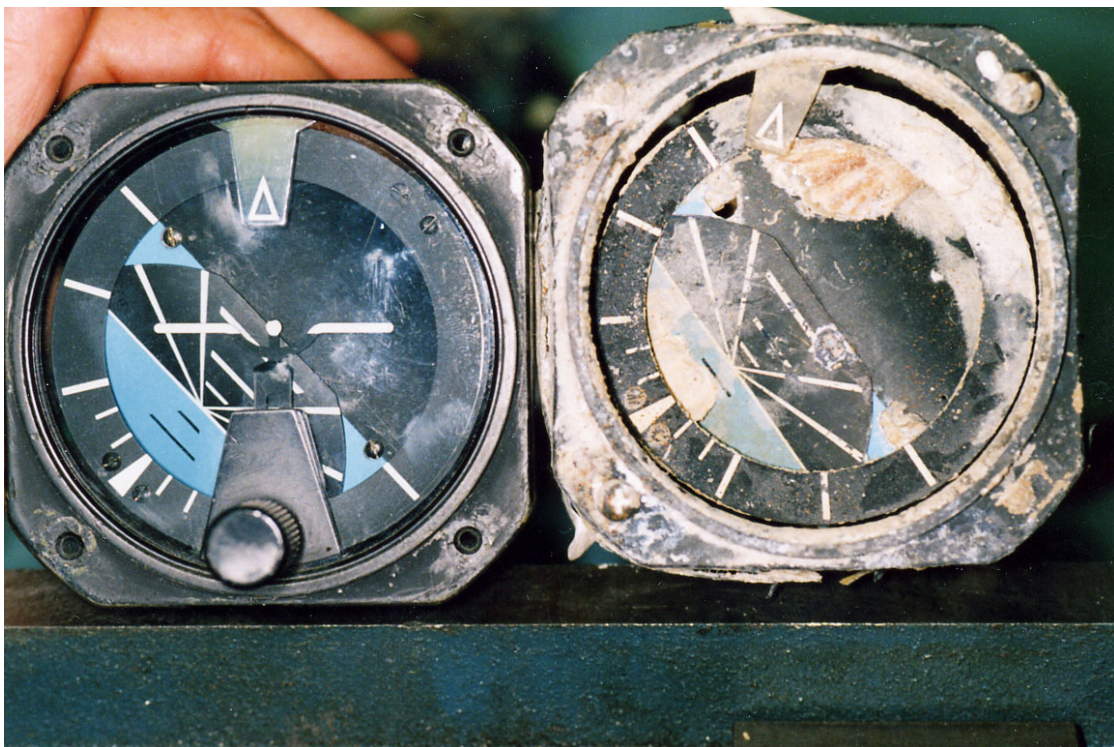
On receipt, initial inspection confirmed the indication presented by the attitude indicator sphere and bezel was the same as that shown in the original photographs. When viewed face-on and compared with an identical, undamaged instrument (figure 1), the indication represented a bank angle of 135 degrees right wing down (ie. 45 degrees inverted) and 35 degrees nose down. Other than in aerobatic manoeuvres, that attitude was not consistent with normal controlled flight.

Figure 1. Attitude Indicator instrument recovered from the aircraft (right), compared to a similar demonstration instrument (left). The indication on the demonstration instrument has been set to match that shown on the recovered unit.

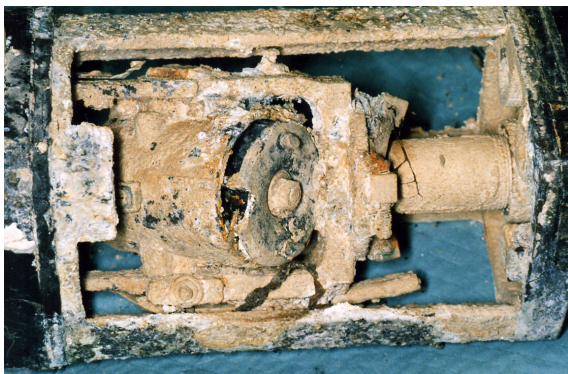
Removing the case from the instrument showed that the rear cap of the gyroscope housing had moved out of position, trapping the movement against the base of the fork mount (figure 2). Both pendulous arms, normally sitting behind the gyro housing (figure 3), were recovered loose within the instrument case. Close inspection of the gyroscope revealed a small fragment of glass lodged within the housing; between the end plate and the rotor (figure 4). The glass was similar to that used on the face of the instrument. Further disassembly of the gyro housing found the rotor shaft fractured at a point adjacent to the rear bearing, allowing the end cap to move outward. The rotor itself had also been displaced axially by several millimetres (figure 5) and evidence of rotational contact against the inside edges of the end cap was clearly observed after cleaning and microscopic study (figures 6 and 7). Evidence of rotational scoring was also found around the outer end of the gyro rotor (figure 8).

Figures 2 & 3. Internal gyroscope from the recovered instrument (left) and the demonstration instrument (right).

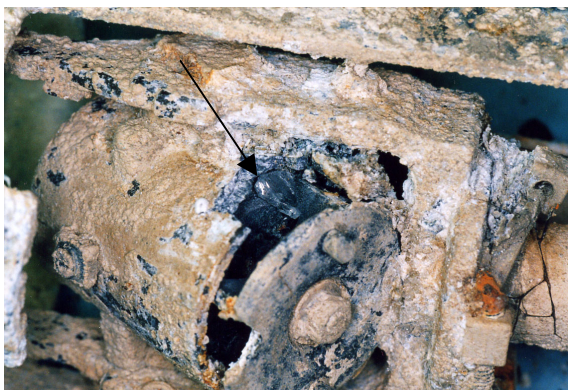
Figure 4. Gyro housing, showing the fragment of instrument glass inside

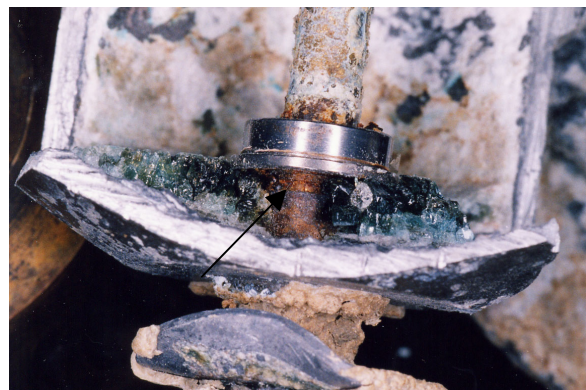
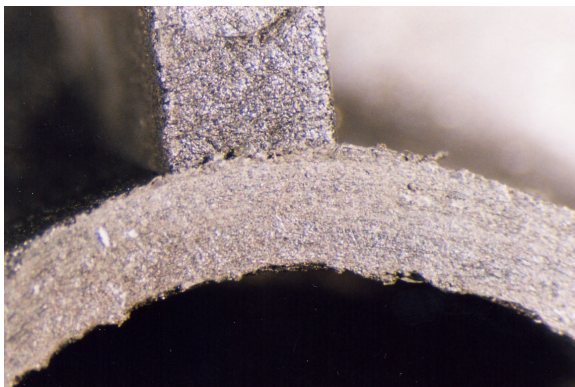
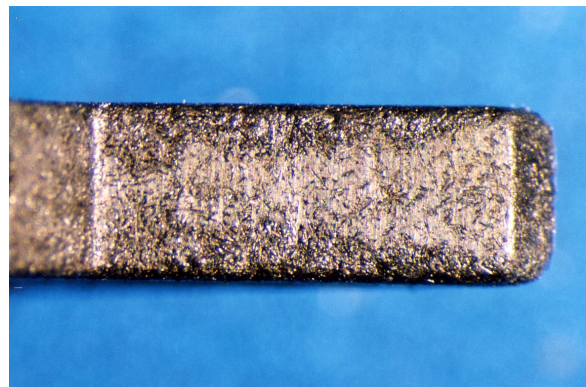
Figures 6 & 7. Rotational damage on the housing end plate and ribs – evidence that the rotor was spinning at impact.

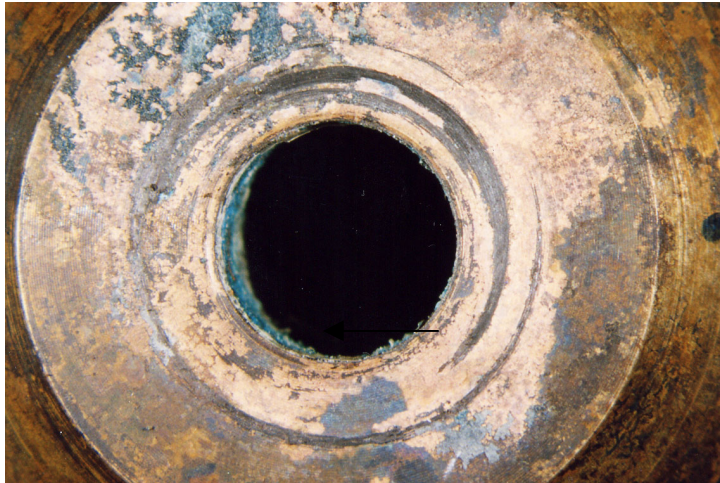
Figure 8. Gyro rotor end face, also showing evidence of rotational scoring.

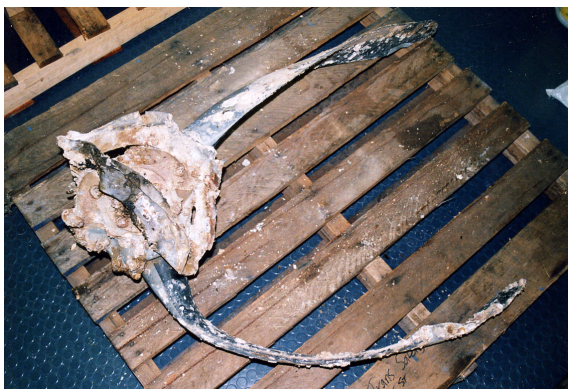
The propeller unit was extensively damaged, having one fractured blade and the remaining two severely bent (figure 9). Remnants of the spinner mounting plate remained on the hub and all surfaces were covered by an accretion of marine growth and deposits (figure 10). Examining the hub rear face after cleaning found that several of the mounting-bolt holes had sustained sideways distortion damage, consistent with the separation of the propeller hub from the engine crankshaft under bending loads (figure 11). One of the two locating dowels set into the hub had also broken away in a similar manner. The internal threads of all mounting-bolt holes were stripped. Both blades remaining within the hub were loose and able to be rotated by hand. The most severely bent blade had rotated through approximately 180 degrees in its mount, with the leading edge facing backward. The separated blade had fractured in an angular manner immediately above the thrust-bearing seat and entirely within the hub mount (figure 12). Fractures of that nature are typical of gross, out-of-plane bending overloads.

Figure 9. Propeller unit as-received.

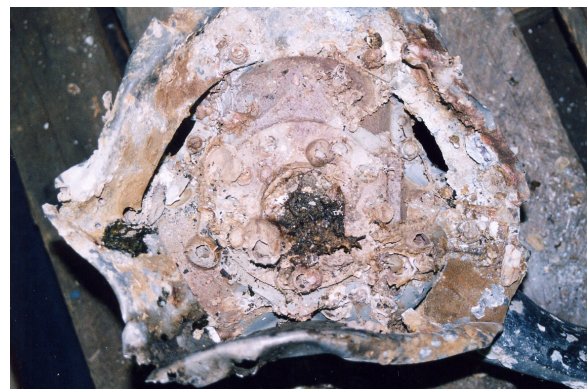
Figure 10. Level of marine growth and accretions typically present over the entire unit.

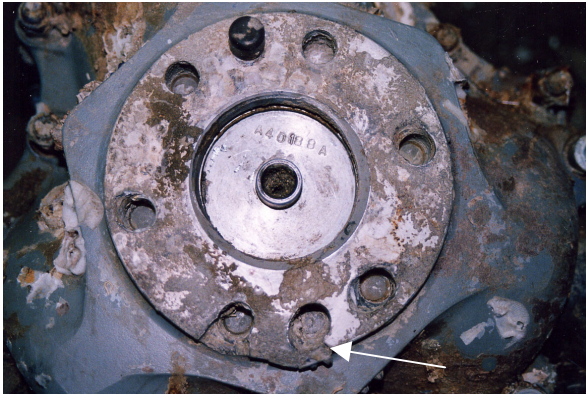
Figure 11. Propeller hub mounting face (after cleaning), showing lateral distortion of the mounting bolt holes.

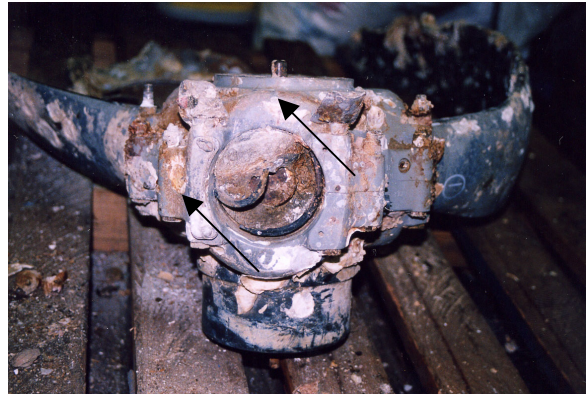
Figure 12. Blade fracture surfaces, giving some indication of the direction of failure.

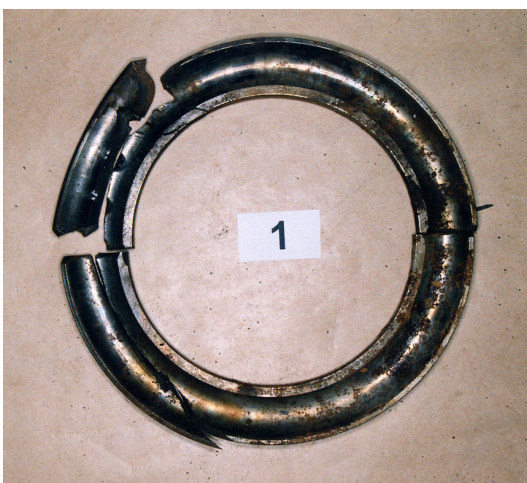
A third-party organisation carried out the disassembly of the propeller hub in the presence of a representative from the ATSB. During the disassembly, it was evident that the thrust bearings and hubs from all blades had sustained heavy impact and bending damage. The thrust bearing races exhibited multiple fractures and roller indentation (brinelling) over one-half of the circumference (figure 13), while the blade hubs displayed the partial shear fracture of the lip beneath the bearing seat (figure 14). The obvious bias in the damage toward one side of the blade hubs was indicative of severe bending loads between blades and hub. The position of the damage with respect to the hub axis suggested that the bulk of the bending forces acted to bend the blades backward; that is, to displace the plane of rotation in a rearward direction. Flattening of an edge around the base of each blade supported this finding, with the size of the flattened area proportionate to the degree of bending sustained by the blade aerofoil sections (figures 15,16 & 17). The largest area of flattening (greatest bending loads) was found on the base of the fractured blade. All three pitch-change lugs on the base of the blades had fractured under shear loads, with the direction of fracture consistent with the blades being forcibly twisted to a finer pitch.

Figure 13. Thrust bearing race from the fractured blade. The crushing damage was found on the forward-facing side.

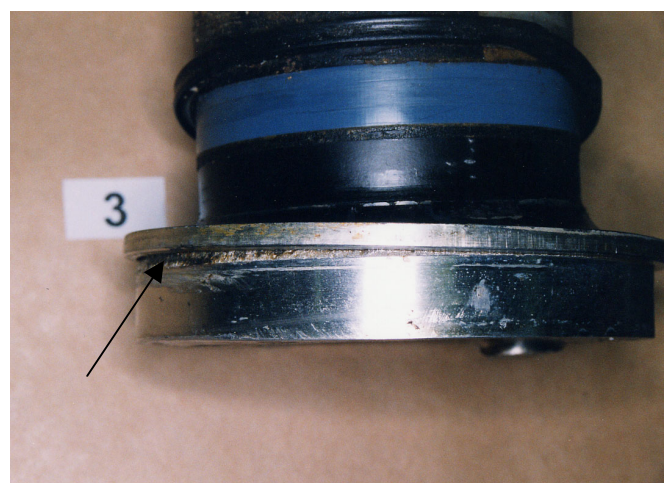
Figure 14. Blade base flange, showing the shear failure of the rim edge under bending loads.

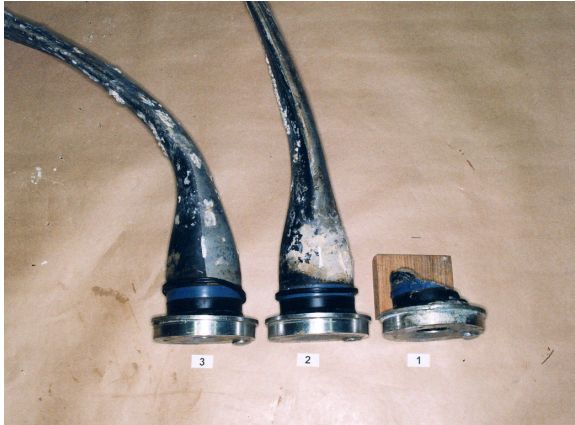
Figure 15 (top L). Three blades as removed from the hub – note the variation in bending.

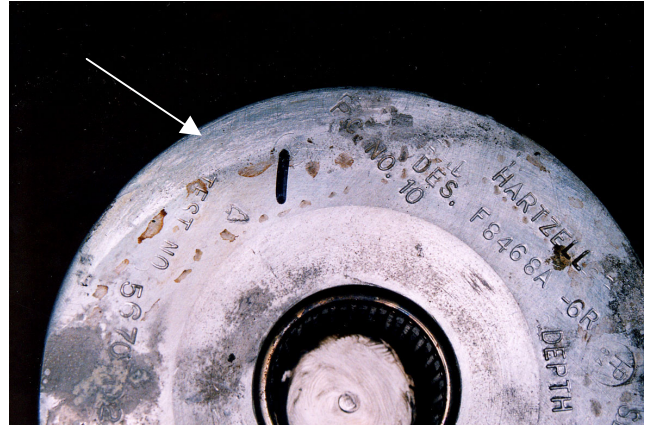
Figure 16 (top R). Blade 1 end face, showing the flattening damage typical of excessive blade bending loads.

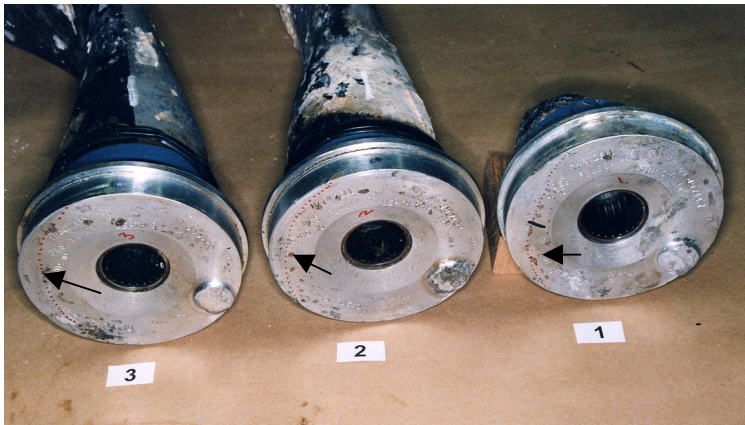
Figure 17 (left). Base of the three blades showing the variation in the extent of the flattened area on each (red dot outline).

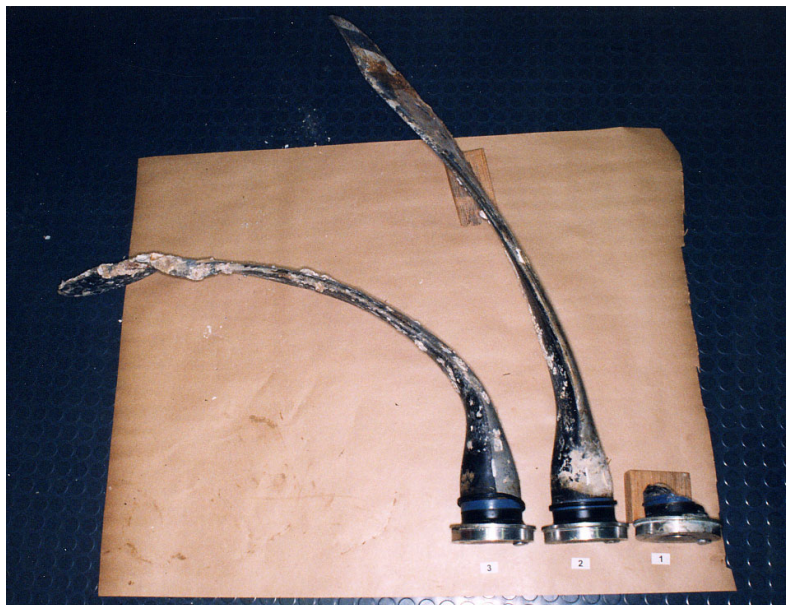
Examining the three blades along their axial plane (figure 18) allowed comparison of the extent of out-of-plane distortion. The examination showed that the degree or severity of bending decreased with the sequence of rotation. Given that blade number-one had fractured under bending loads and also showed the greatest degree of base flattening, it was likely that the blade had experienced the most severe bending loads. Blade number-three was the next most severely bent and blade number-two the least. These findings were consistent with propeller rotating at the time of impact.

Figure 18. A Comparison of the extent of bending, with all blades in the same axial orientation. The failed blade probably sustained the greatest level of bending and fractured as a result.

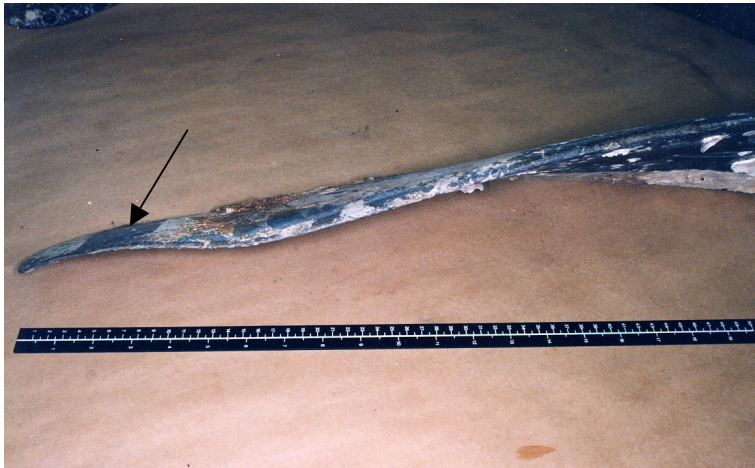
Blade number-two showed a region of shallow forward bending at the tip (figure 19). The forward bending of blade tips is sometimes indicative of the engine developing power at the time of impact. In this case, however, the bending was considered insufficient to represent a positive indication of the aircraft being under power at the time of the accident.

Figure 19. Forward bending of the immediate tip of blade 2.

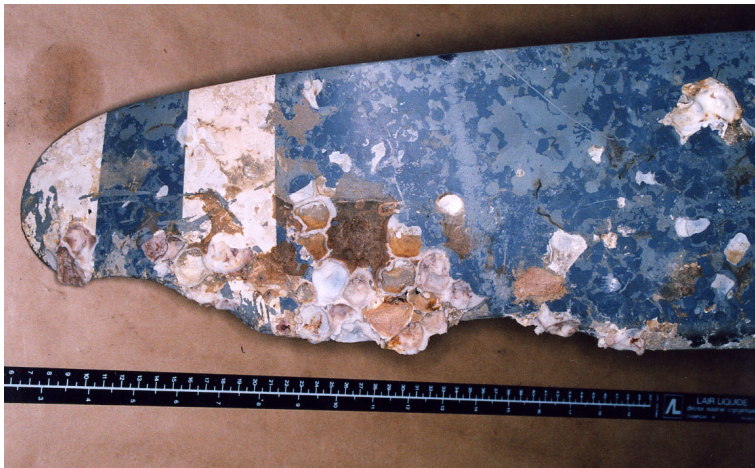
The outer leading edge of blade number-three showed a region of missing material and associated evidence of rotational impact against a solid object (figure 20). Given the degree of rearward blade bending, it was likely that this impact was with the engine or fuselage of the aircraft.

Figure 20. Impact damage and material loss from the leading edge of blade 3.
