Australian Transport Safety Bureau

QF32—a test of ATSB communications

Investigation briefs

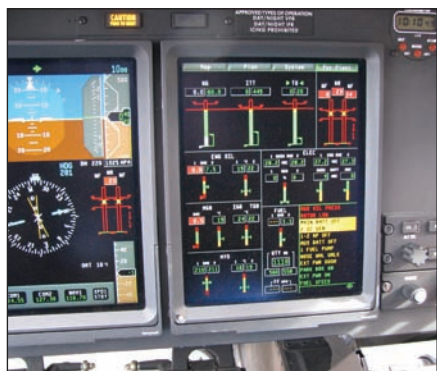
ATSB investigation AO-2009-004

The investigation identified two technical problems: one associated with water and particulates corrupting the avionics system and the second related to the probable susceptibility of the air data system to turbulence. It also identified problems relating to workload and task management by the crew, and monitoring of the aircraft by air traffic services. This included the lack of an altitude deviation alert within the Australian Defence Air Traffic System (ADATS).

As a result of the occurrence and the ATSB investigation, CASA, the helicopter manufacturer, and the operator implemented safety actions to address the issues. Also, a replacement for ADATS and the civilian air traffic system has been announced by the Government. ■

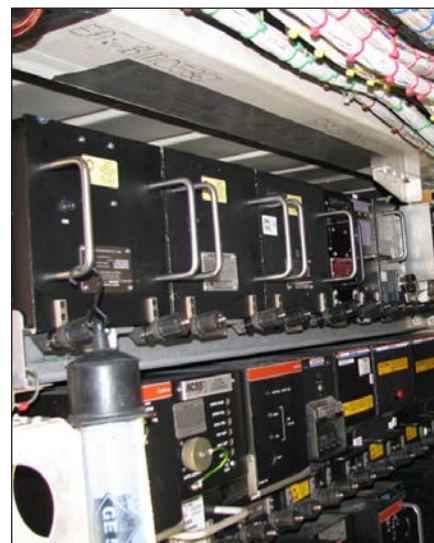
ATSB investigation AO-2008-003

An electrical systems failure onboard a Boeing 747 aircraft near Bangkok on 7 January 2008 has prompted extensive safety actions from Qantas, Boeing and the United States Federal Aviation Administration (FAA). The aircraft lost electrical power to many of its onboard systems as a result of drain water entering units that control the distribution of electrical power.

The ATSB investigation report describes how a drain line heater had failed, causing an ice blockage that led to the drain line overflowing in the galley. The water flowed through a gap in the aircraft's floor, then through a dripshield and into three of the aircraft's four generator control units, causing them to malfunction and shut down. The loss of power affected the aircraft's cabin lighting and many of the aircraft's communication, navigation, instrumentation and flight guidance systems, including the autopilot. Many systems were subsequently powered by the aircraft's emergency batteries. The aircraft's engines, hydraulic system, and pneumatic systems were largely

The ATSB found that the FAA's regulatory and guidance information did not fully address the potential harm to flight safety posed by liquid contamination of electrical system units in transport aircraft. In addition, the information provided to 747 400 flight crews regarding standby power operations was limited. The ATSB has made recommendations to the FAA and Boeing to address those safety issues.

Safety actions in response to the occurrence included the reinforcing of protective dripshields above electrical equipment, improving maintenance practices and pilot training and installing advanced standby flight instruments in all Qantas 747 aircraft. The generator control unit manufacturer has increased its monitoring of returned units for signs of liquid contamination.

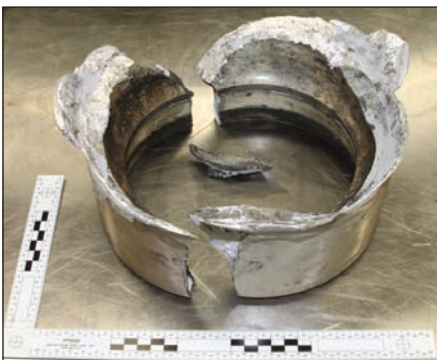
ATSB investigation AO-2009-062

On 20 October 2009, the crew of a Boeing 737 reported that the aircraft was difficult to taxi, requiring more power and steering input than usual. A visual inspection revealed the number-4 wheel was at an angle to the axle. Following disassembly, it was discovered that the inner wheel hub and bearing mount had broken away from the wheel assembly. The inner hub had failed from fatigue cracking that had initiated in the area adjacent to the bearing cup.

Fatigue cracking of the inboard bearing cup bore was an emerging issue for the 737 wheel type at the time of the failure. In May 2009, the wheel manufacturer had issued a temporary revision to the Standard Practices Manual, with an updated inspection method for the susceptible area, and the aircraft manufacturer had issued a service letter in August 2009 with a periodic inspection requirement. The operator was in the process of reviewing and incorporating the changes into their own maintenance schedules at the time of the incident.

Immediately following the occurrence, the operator performed a fleet-wide examination, identifying those wheels potentially at risk of a similar failure.

Subsequently, ten wheels were removed from service for immediate inspection. The operator also implemented an ultrasonic inspection program for wheels with over 4,000 cycles at every tyre change.

The aircraft and wheel manufacturers both released updated information to operators and maintainers in early 2010, including a revision to the recommended inspection interval. ■
