TECHNICAL ANALYSIS REPORT No: 8/01

OCCURRENCE No: *200100445*

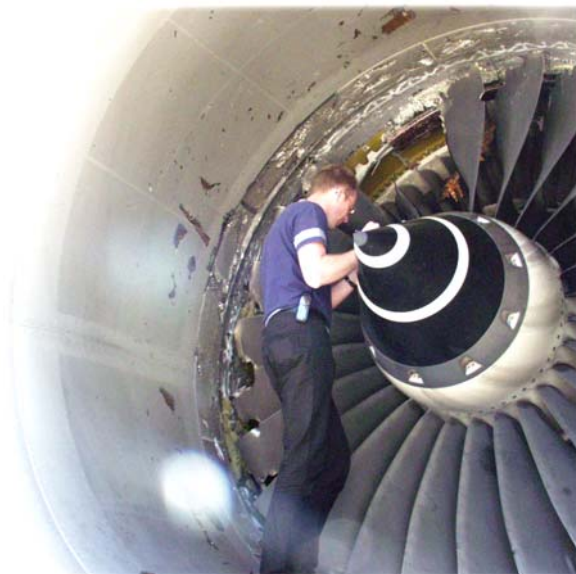
EXAMINATION OF A FAILED FAN BLADE ROLLS-ROYCE RB211 TRENT 892 TURBOFAN ENGINE BOEING 777, A6-EMM

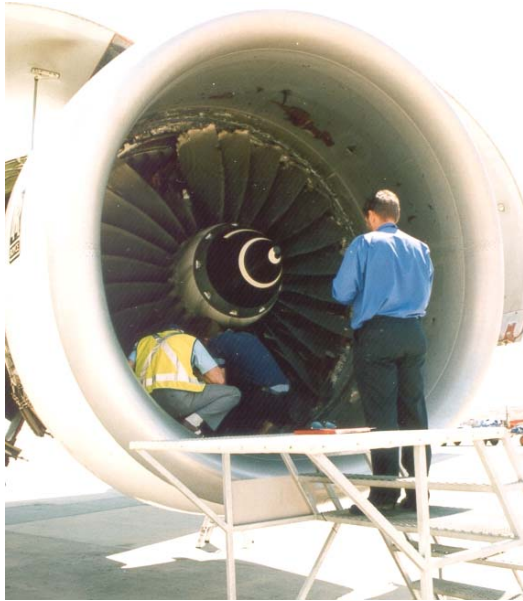
Figure 1 (Left) Intake of the failed engine.

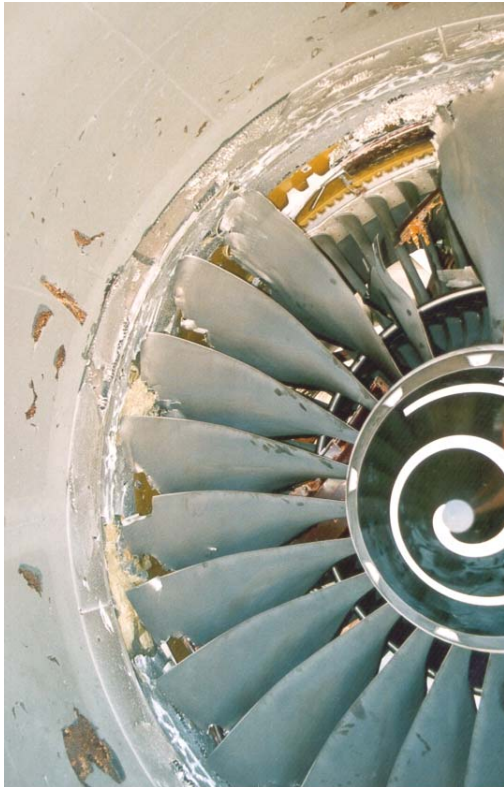
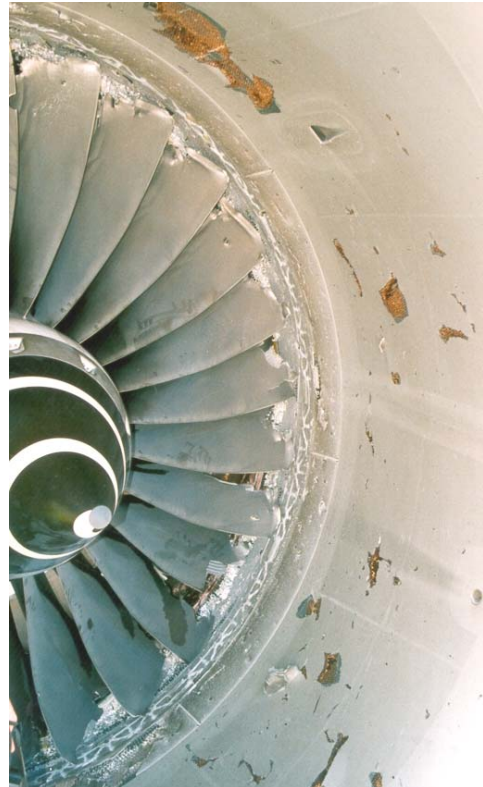
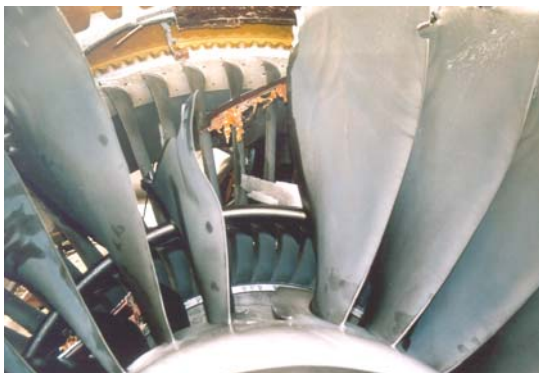
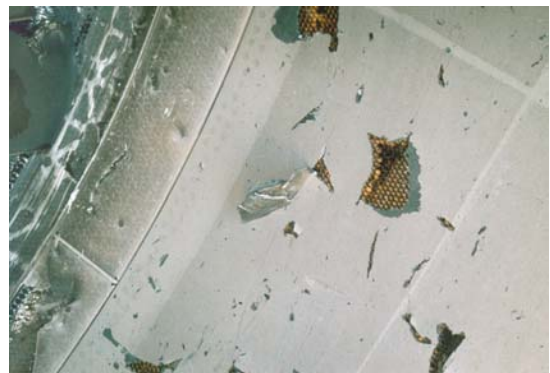
Figure 5 (Bottom Right) Blade debris embedded within the intake cowl.

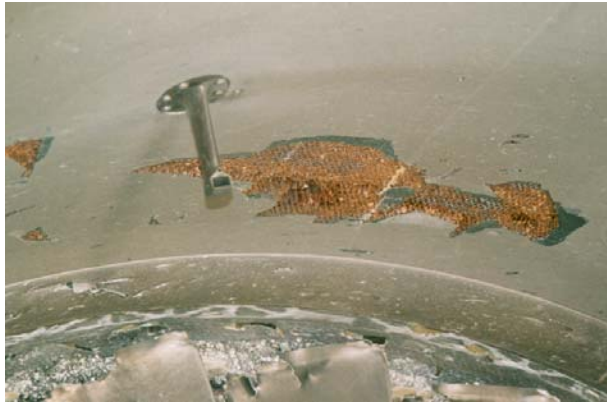
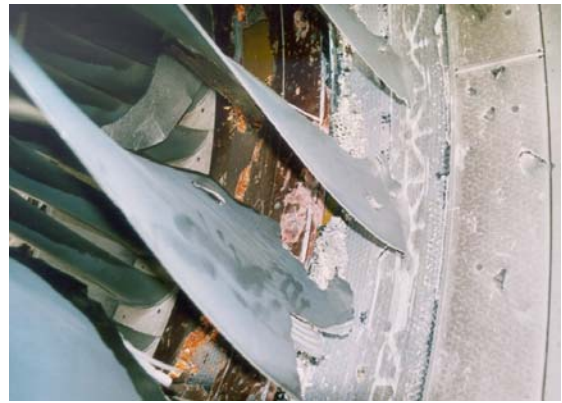
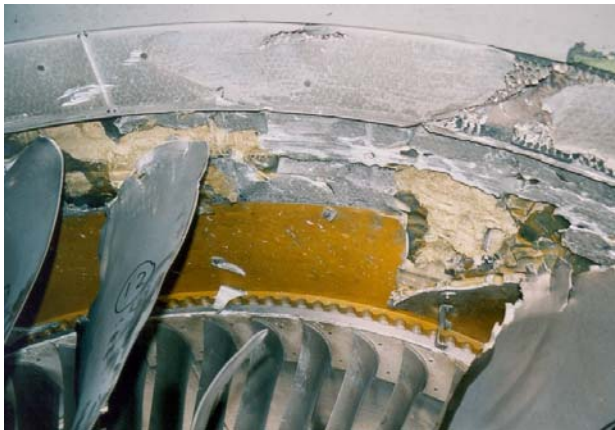
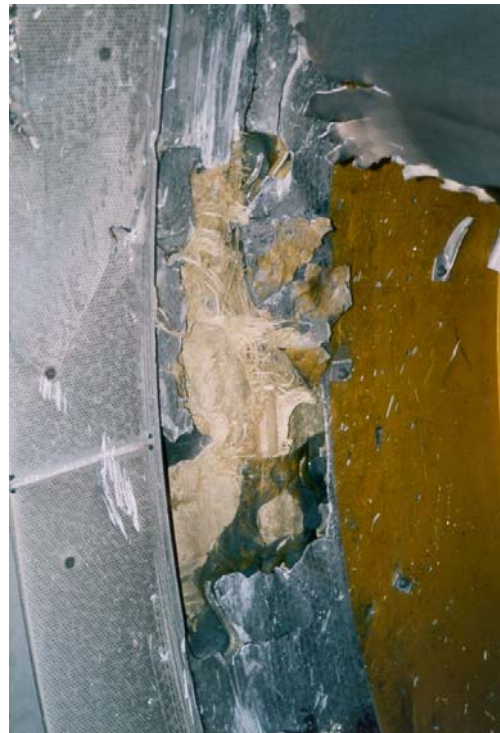
Figure 6 (Top L) Stripping of the cowl lining, exposing the honeycomb matrix.

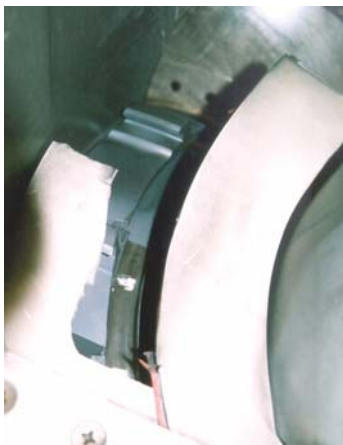
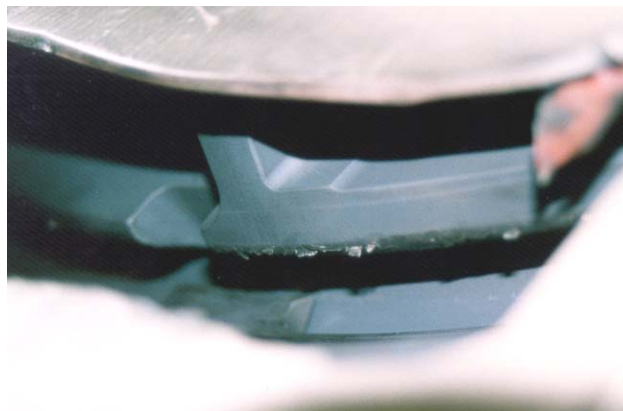
Figures 10 & 11 Fan disk slot showing damage to the annulus fillers and slot edges.

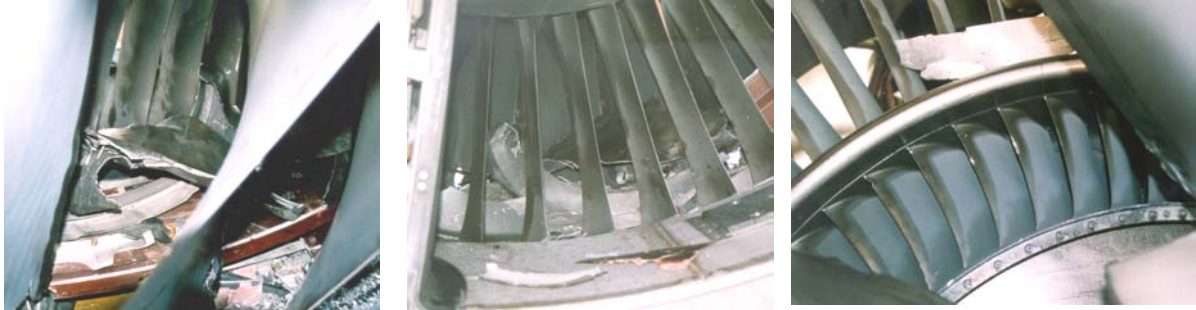
Figures 12, 13 & 14 Debris accumulated behind the fan (including the liberated blade). Damage also shown by the core intake vanes.

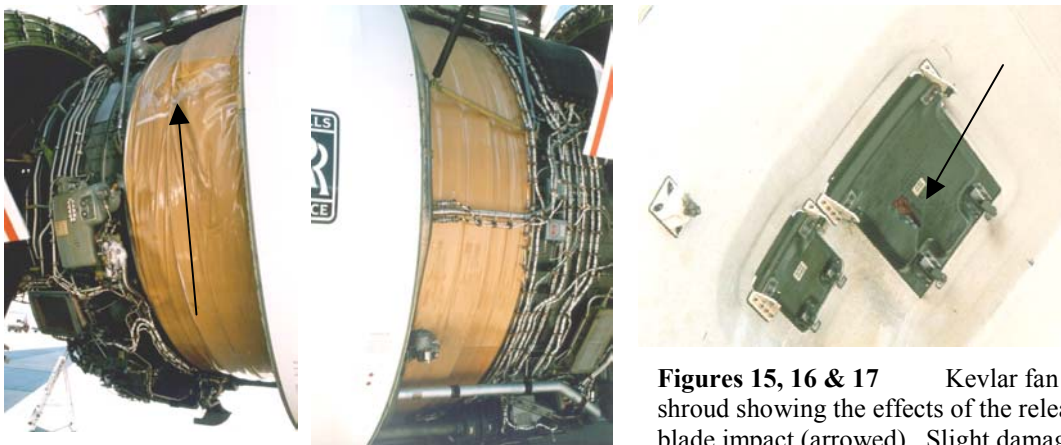
Figures 15, 16 & 17 Kevlar fan shroud showing the effects of the released blade impact (arrowed). Slight damage also to the interior of the cowl opposite the impact area.

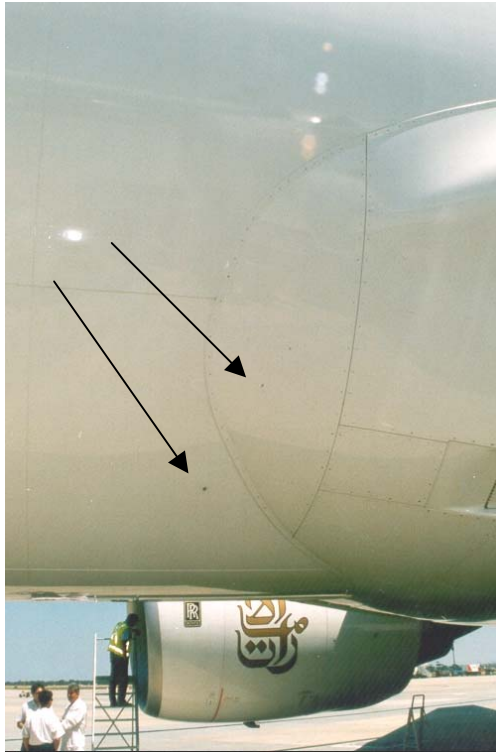
Figure 18 (L) Locations of fuselage damage from released debris.

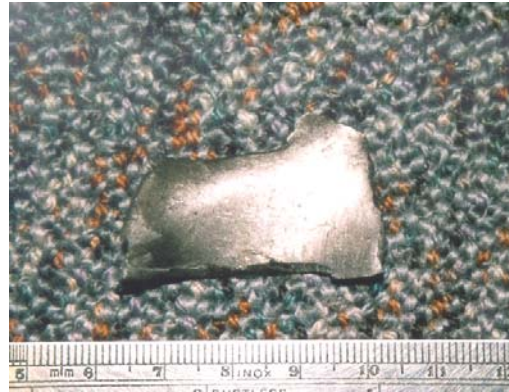
Figure 19 (Above) Debris fragment removed from the fuselage.

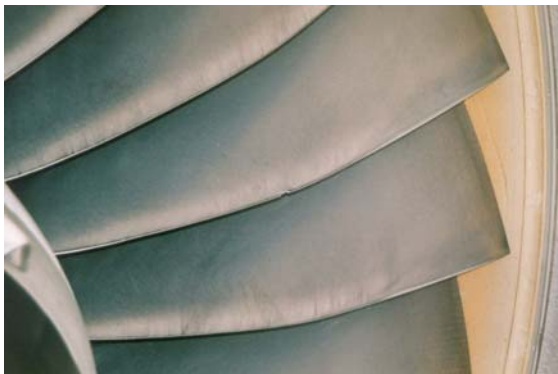
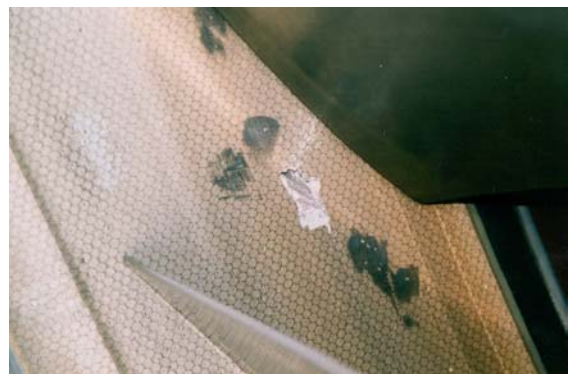
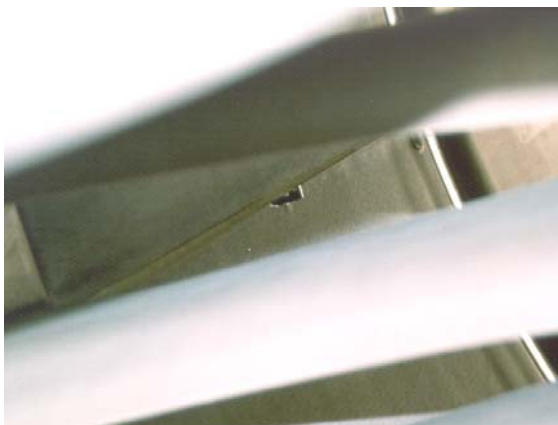
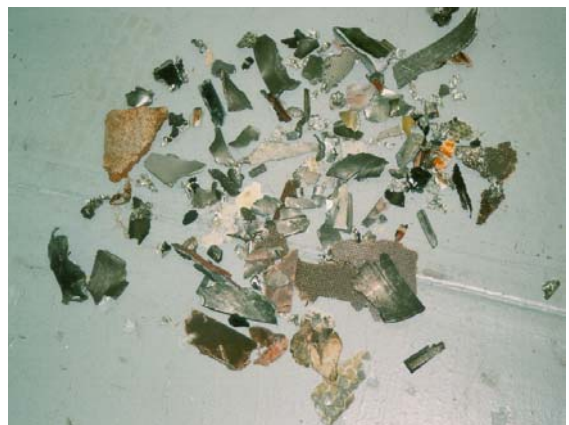
Figure 23 (Bottom R) Typical debris as recovered from the runway surface.

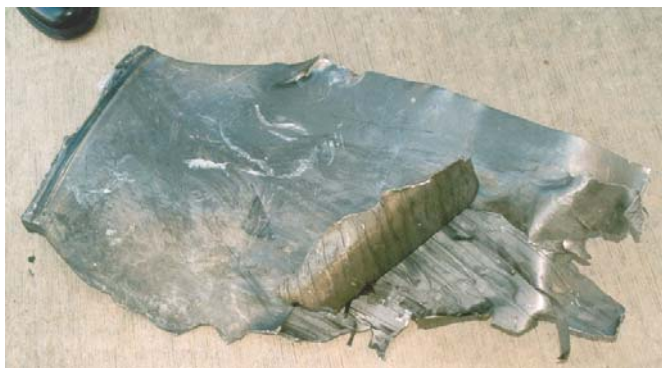
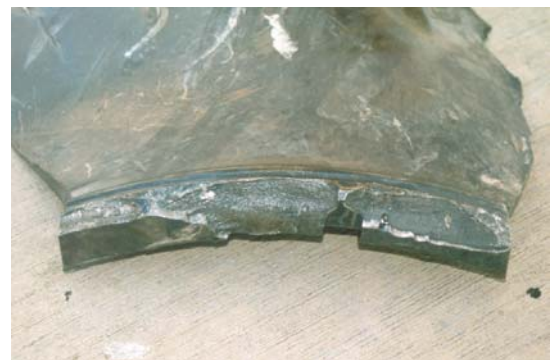
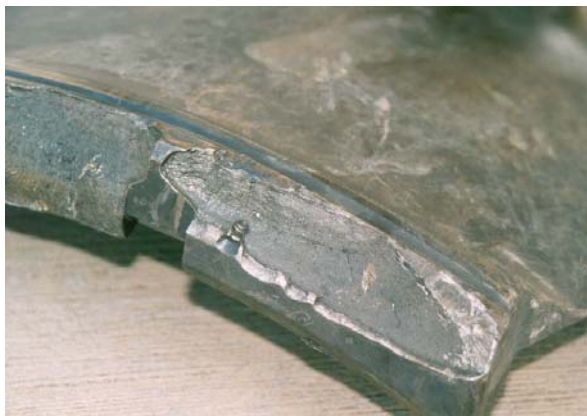
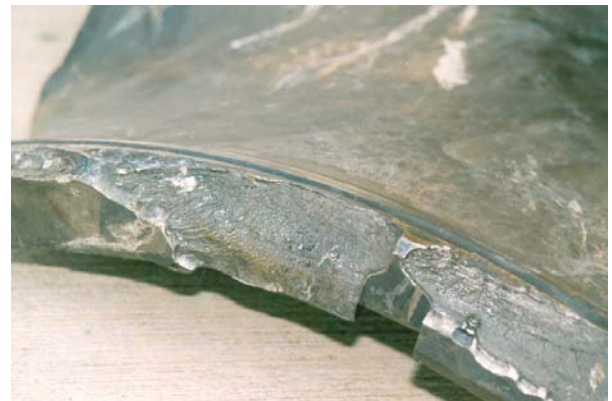
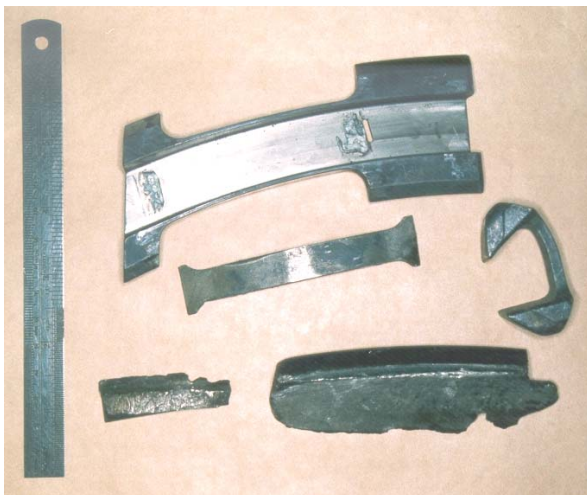
Figure 24 (Top L) Released blade as recovered from the engine cowl.

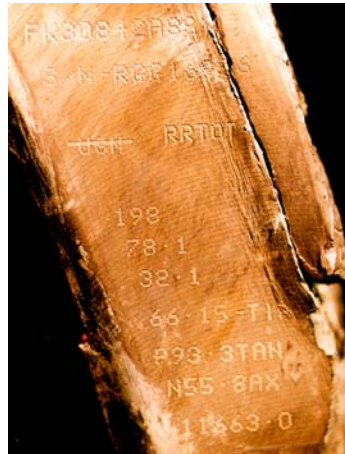
FK30842ASSY
 S/N-RGG16936
 USN RRTOT
 1 98
 78.1
 32.1
 66.1S-TIP
 P93.3 TAN
 N55.8 AX
 11663.0

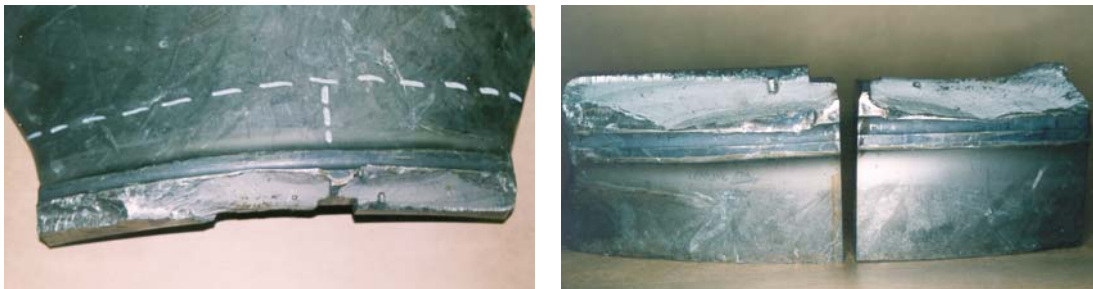
Figures 30 & 31 Preparatory sectioning of the blade to facilitate laboratory examination.

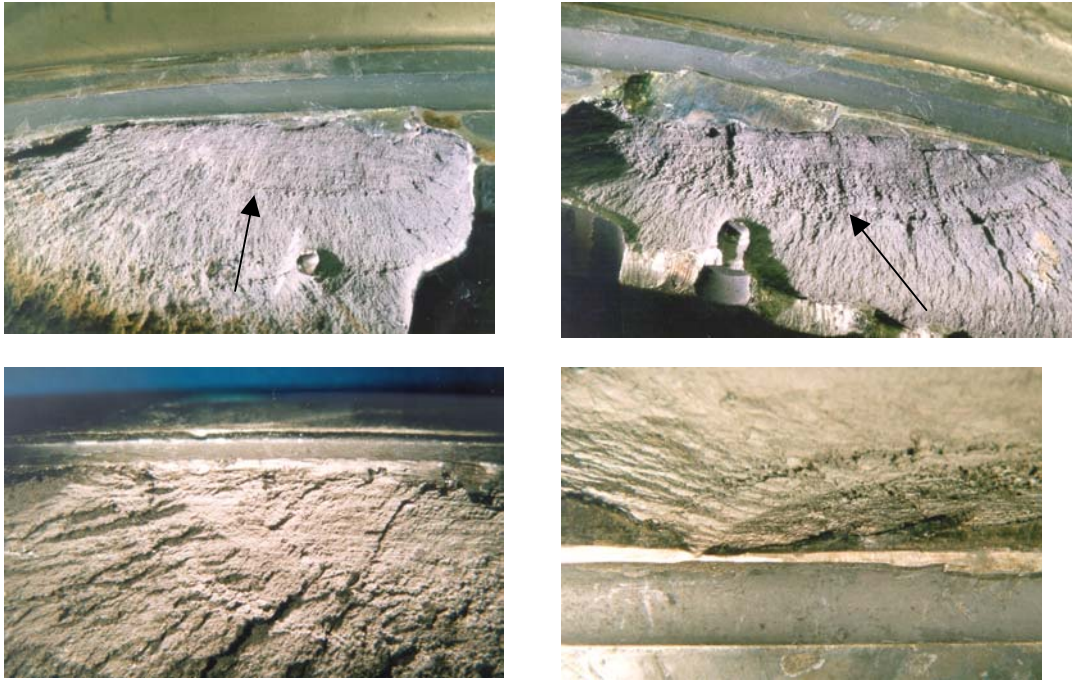
Figures 32 & 33 (Top) The pattern of fatigue crack progression is clearly highlighted in both areas. The point of change in crack propagation mode is arrowed.

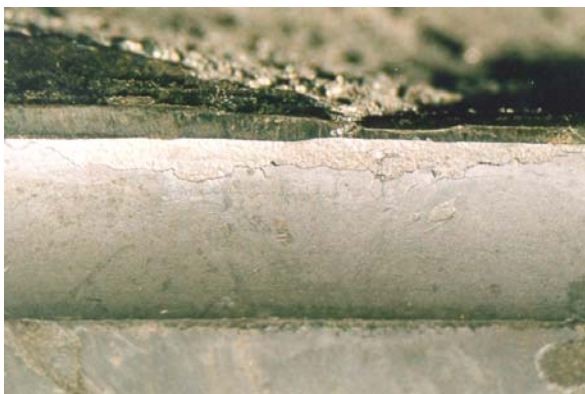
Figure 36 Undercut radius region at the region of crack initiation. Note the dry lubricant film spalling and the ‘dimpled’ metal undersurface, typical of shot peening.

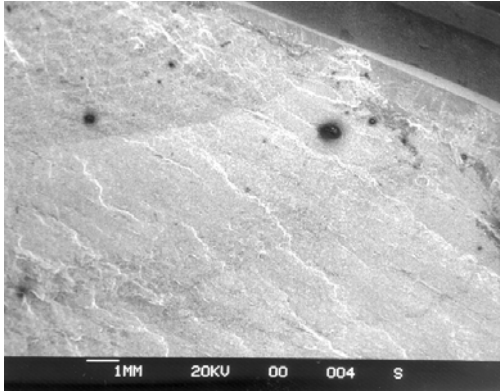
Figure 37 (L) Shows the increase in arrest mark separation at the transition between HCF and LCF crack propagation.

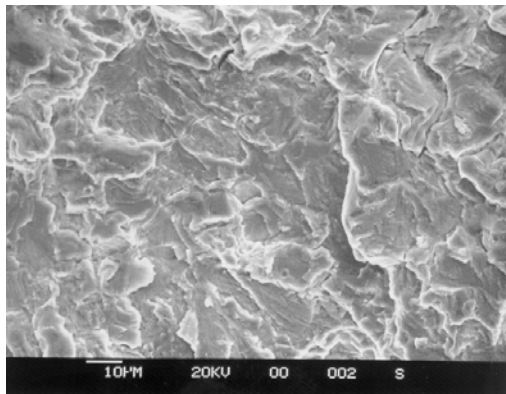
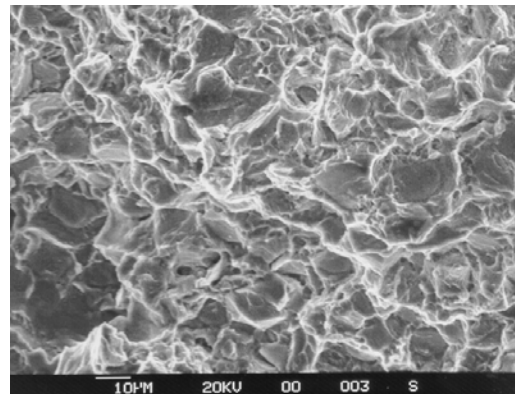
Figure 38 (L) Area of fracture near the point of origin, showing flat, faceted propagation with no defined striations (typical of HCF).

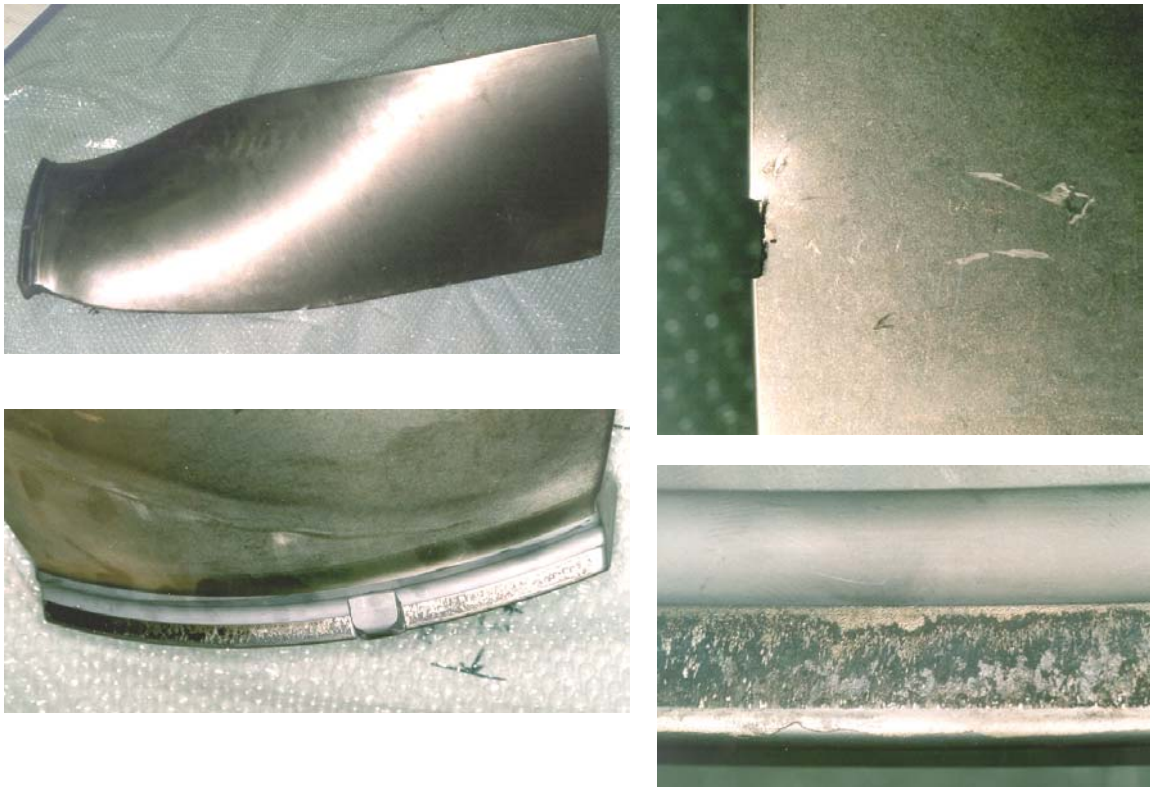
Figures 40 & 41 (Top) Damaged blade from the right engine, showing only the single leading edge nick.

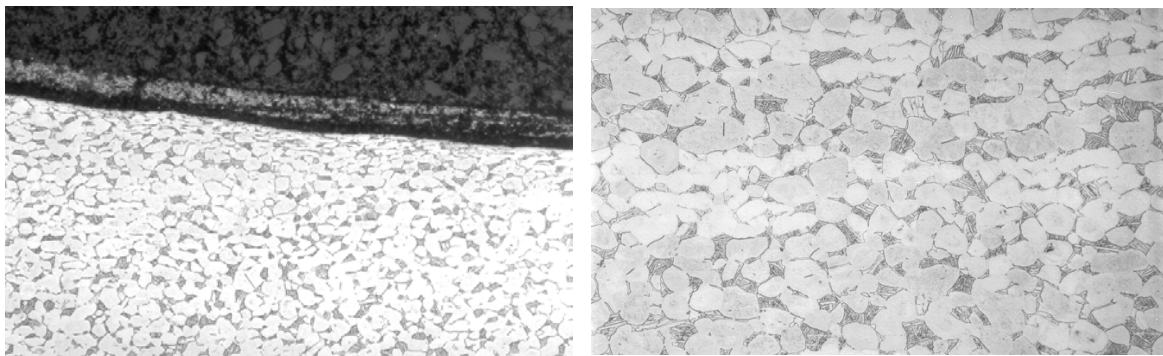
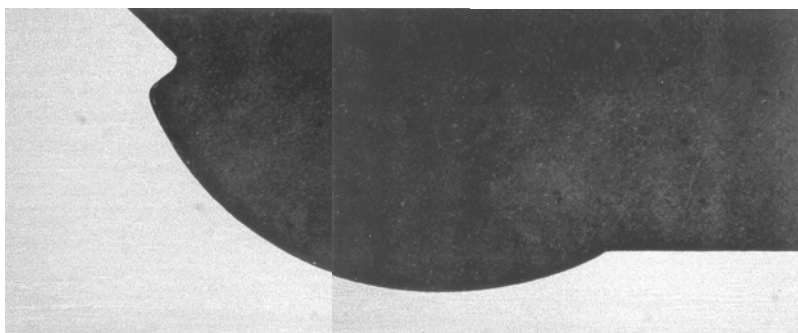
Figure 44 (Top L) Microstructure of a section taken through the undercut radius (X200).

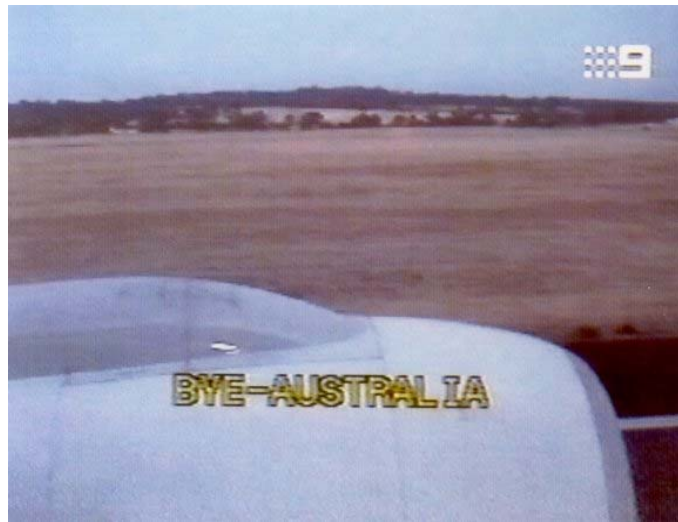
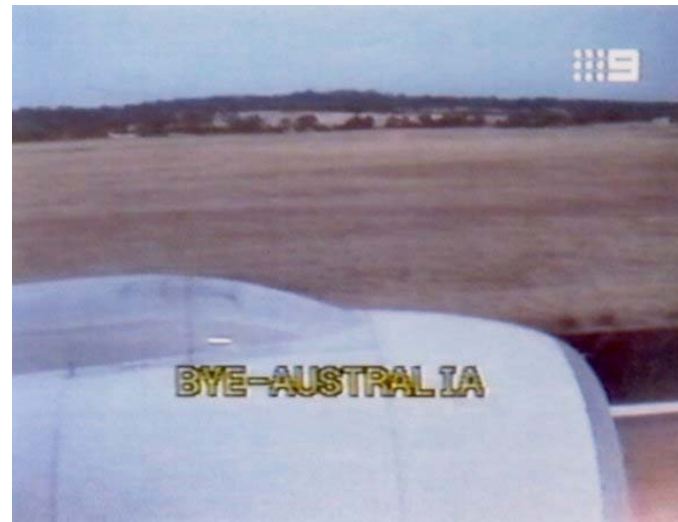
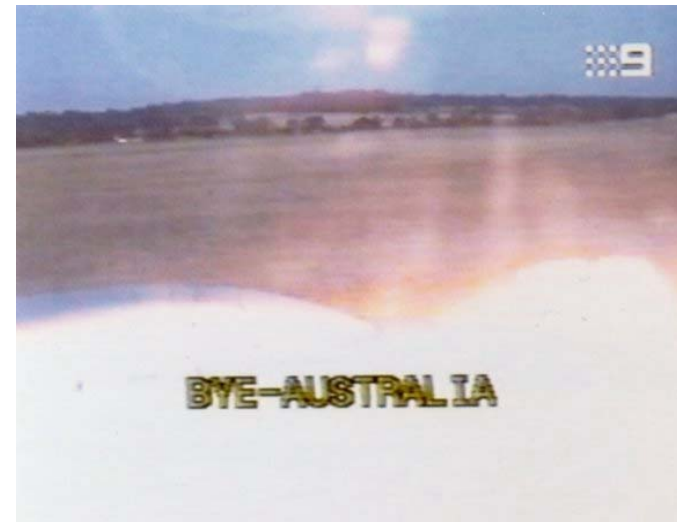
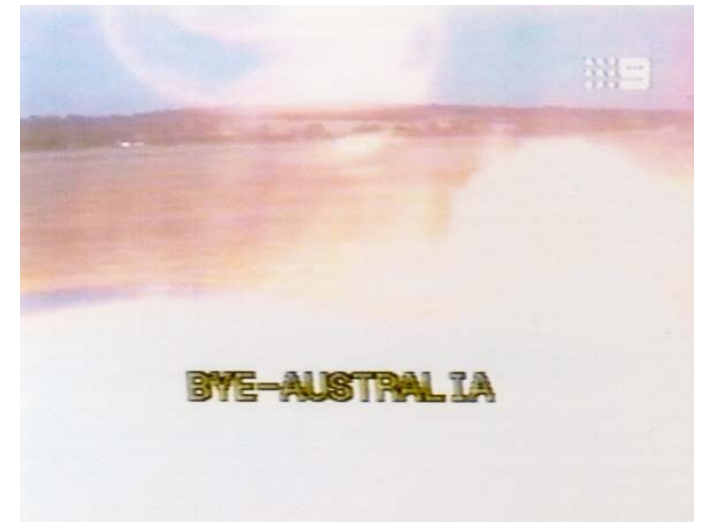
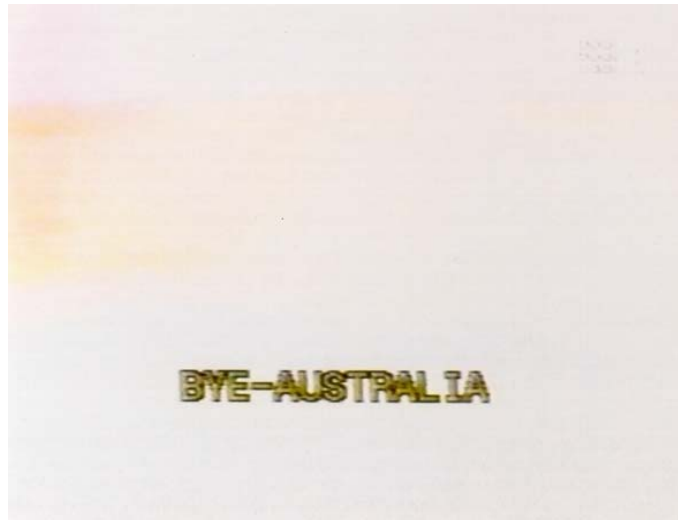
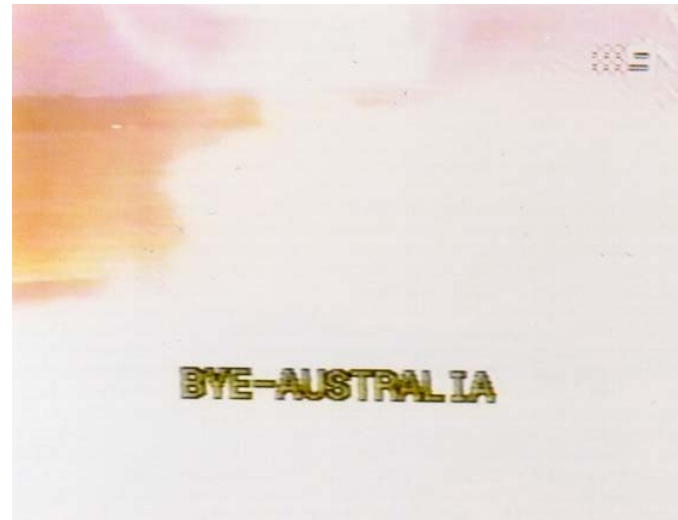
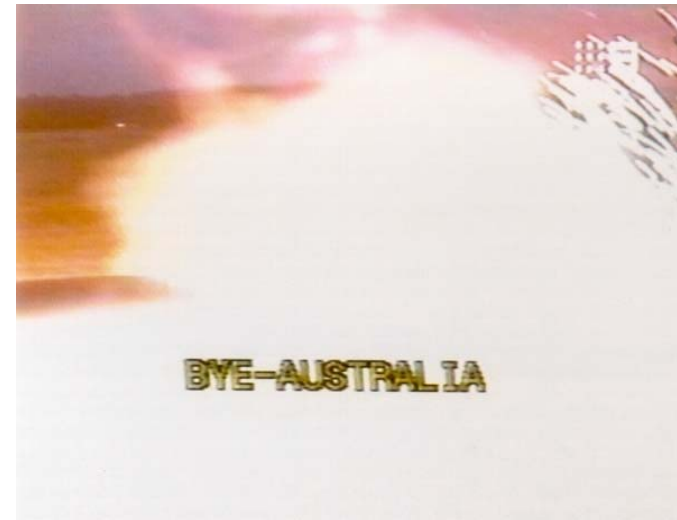
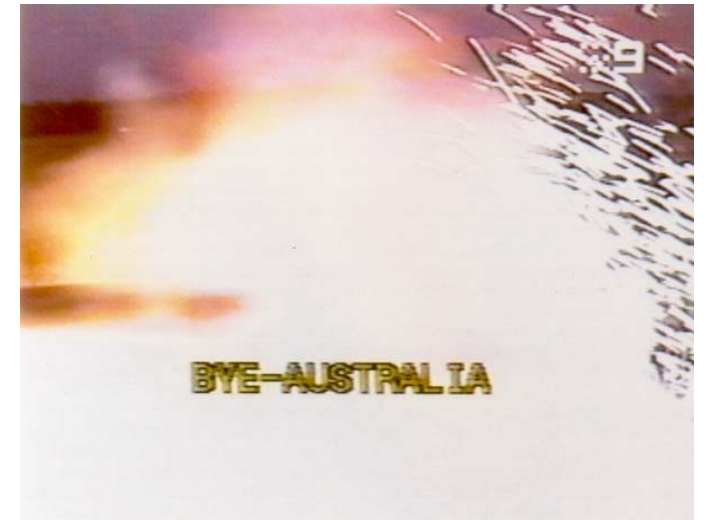
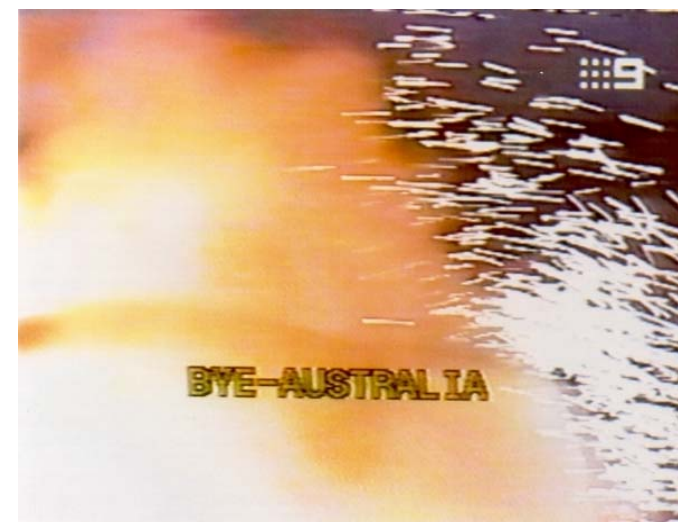
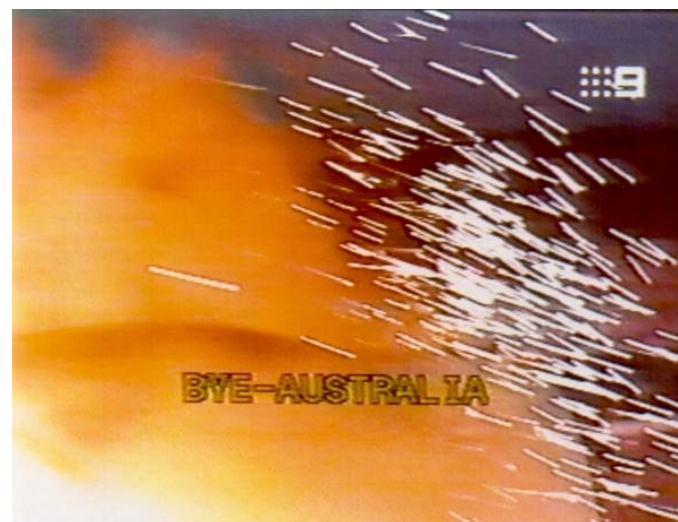
Attachment B. Image map illustrating the significant fracture regions.

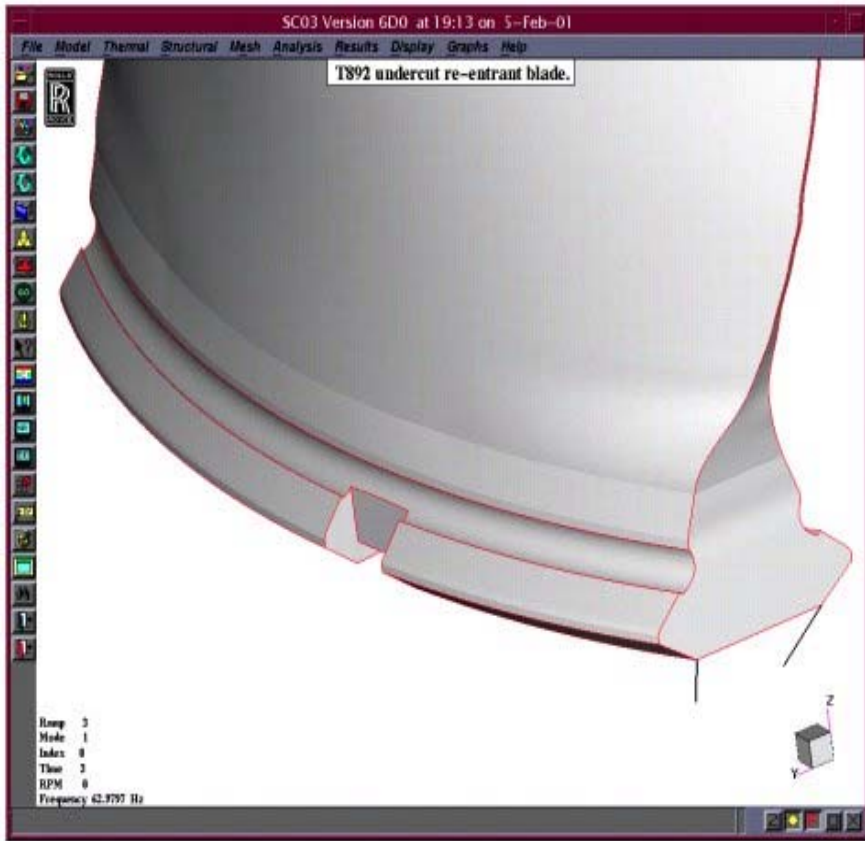
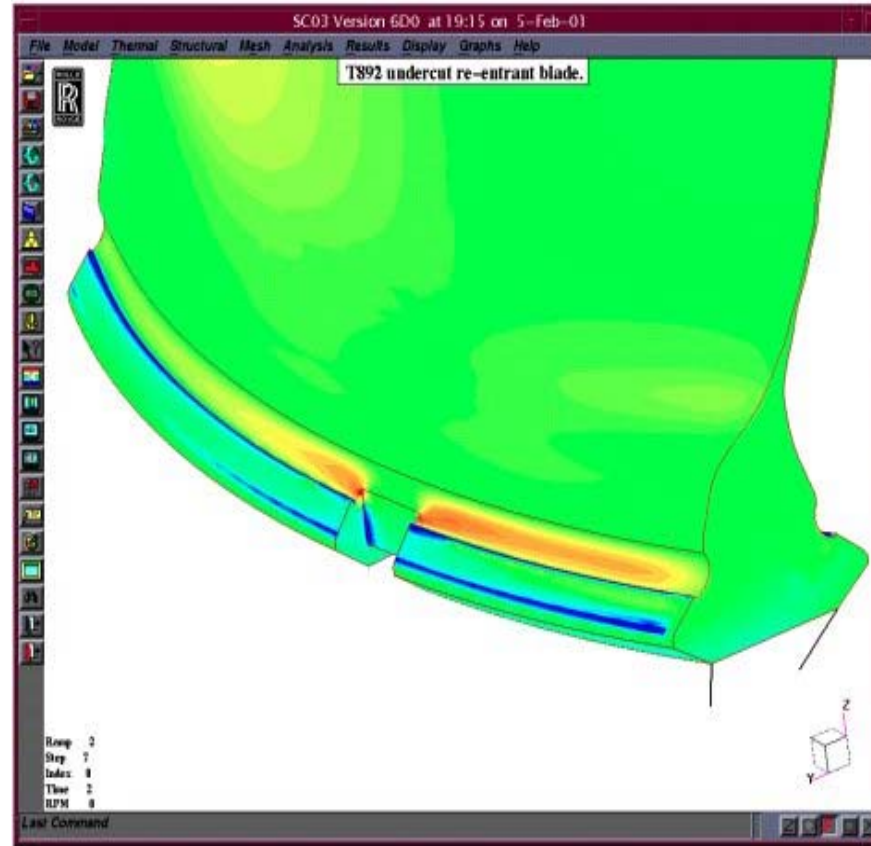
Stress distribution under static tensile loads ↓↑
