TECHNICAL ANALYSIS REPORT No: 03/02

Examination of Variable Stator Vane Control Levers

**Rolls Royce Ltd. RB.211-Trent 800
Turbofan Engine**

Boeing 777-212ER, 9V-SRE

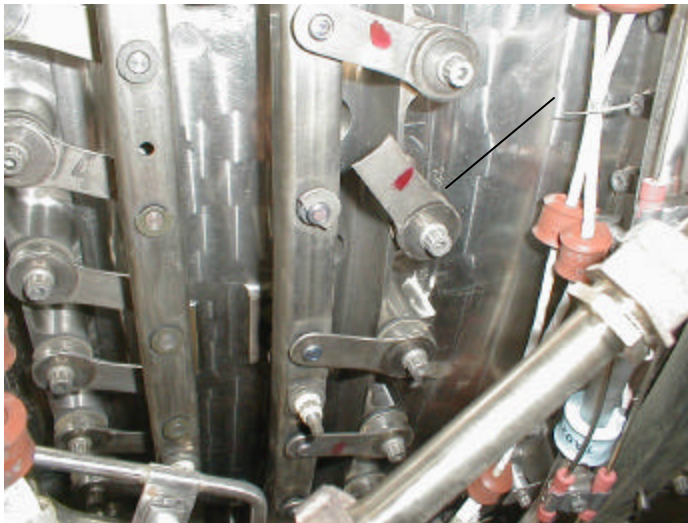
On initial inspection, maintenance personnel found a single fractured first-stage variable stator vane (VSV) control lever (figure 1). Later internal boroscopic inspection of the engine found significant levels of mechanical damage within the intermediate and high-pressure compressor stages.

Fig. 1 External view of the stage-one variable stator vane actuator ring and the single fractured lever (arrowed).

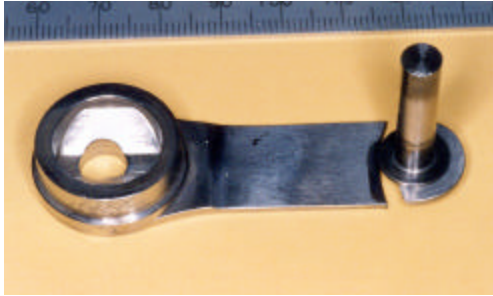
Initial inspection in the ATSB laboratory found the VSV lever had fractured transversely through the end of the arm section (figure 2), at a location coincident with the riveted connection to the actuator pin. The fracture path followed a uniform arc, extending from one side of the arm to the opposite and intersecting the pin connection at the centre (figure 3).

Fig. 2 Underside of the VSV lever removed from the engine.

Marks and wear at the VSV control lever fracture indicated an extended period of independent movement between the two halves of the component before the final engine shutdown. The bias in the wear marks to one side of the arm (figure 2) suggests that during operation, the vane remained at the limit of its travel, while the actuator ring and pin continued to move laterally in response to throttle movements.

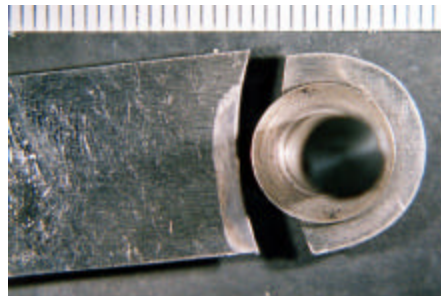
Fig. 3 Underside of the VSV lever showing the curved fracture path and the wear mark produced by in-service movement after failure.

A prominent track mark had developed on the underside of the arm where the relative movement between the separated arm and the pin flange had produced appreciable wear. The effects of wear extended to the fracture surfaces themselves, which were heavily eroded and all fracture surface detail obliterated (figures 4 & 5). Apart from the fracture, the arm had sustained little other mechanical damage and showed no evidence of deformation or distortion associated with the failure.

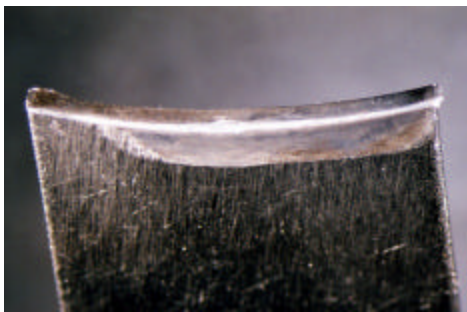
Fig. 4 Arm section fracture surface showing degree of wear and loss of detail.

While the repeated post-failure movement of the fracture surfaces against one another had destroyed any fracture surface detail, the absence of any associated physical deformation suggested the failure was probably a product of a progressive fatigue cracking mechanism. The observed fracture features suggested that the crack initiation occurred from the pin hole.

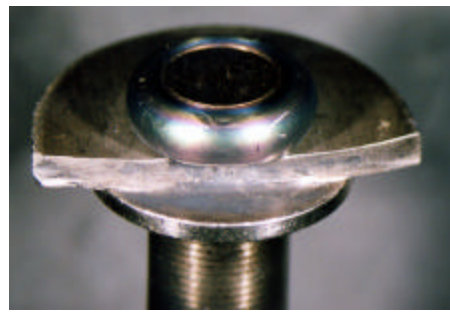
Fig. 5 Pin section fracture – adjoins the surface shown in figure 4.

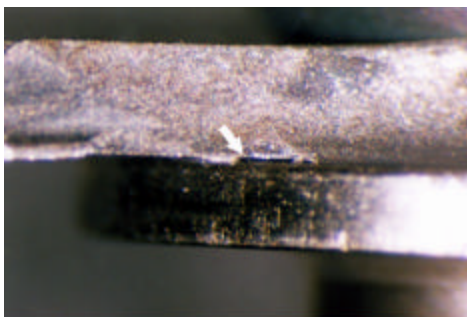
On close inspection, the fracture path appeared to intersect the bore of the rivet hole, with slight upward ‘dishing’ of the arm section beneath the rivet head (figure 6). A clearance or gap was not evident between the pin shaft and the bore of the arm hole through which the pin shaft was riveted.

Fig. 6 Gap between the pin flange and the control arm produced by upward ‘dishing’ of the arm beneath the rivet head.

The examination found evidence of distortion of the arm section by the forces used to rivet the control pin to the arm body. During riveting, the expansion of the rivet shaft could induce tensile stresses within the bore of the rivet hole if the diameter was insufficient to allow for the expansion. Tensile stresses of this nature would be expected to predispose the lever arm to the initiation and propagation of fatigue cracking.

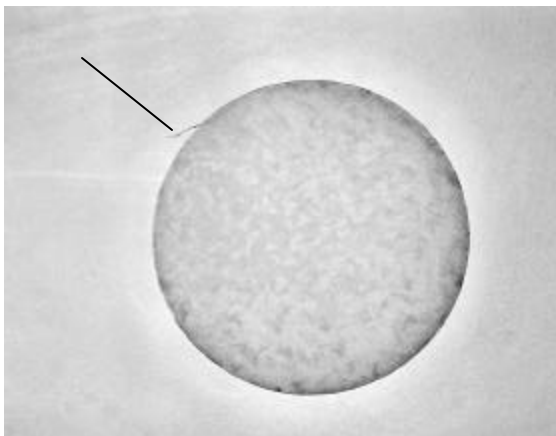
The riveted joint from lever number 31 presented a single, shallow transgranular crack extending from the joint interface into the arm section (figure 7). The crack measured 0.6mm total length and extended away from the pin by around 0.3mm. Close examination showed the crack to have initiated from the end of an area of fusion or 'welding' between the lever arm and pin materials (figure 8). The fused region extended for approximately twenty percent of the joint interface length. Indications of the initiation of a similar crack-like defect were also found at the opposing end of the fused region.

Fig. 7 (Left) Planar section through the rivet shank of lever 31, showing a crack extending into the arm material (arrowed). Magnification X 7.5

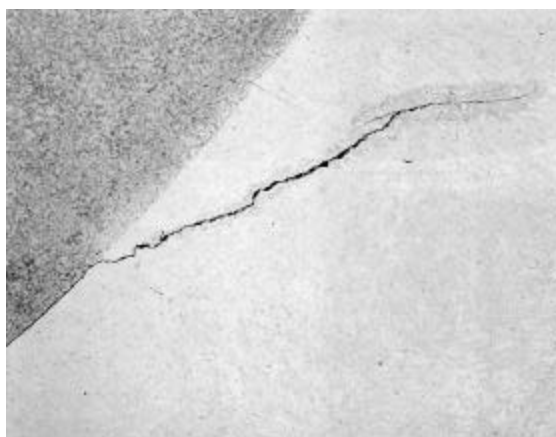
Fig. 8 (Left below) Closer view of the cracking shown in figure 7. Note the initiation from the end of a fused area around the pin circumference. Magnification X 115

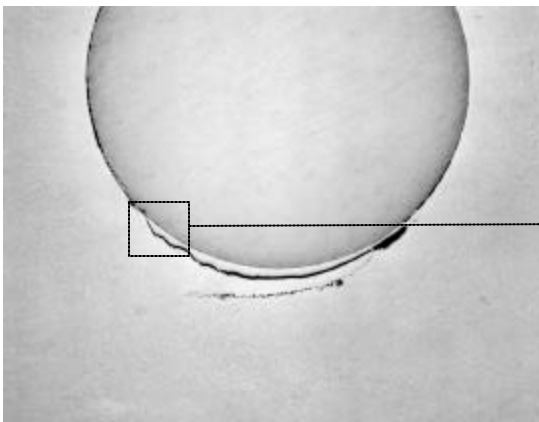
Of the three VSV levers subsequently examined after the findings from lever 31, one item (number 46) showed extensive cracking in the arm material adjacent to the arm-pin interface (figure 9). This cracking was also associated with an area of fusion between the pin and arm alloys (figure 10). Many of the cracks showed a preferential orientation, extending tangentially away from the pin. Several smaller cracks were noted within the pin material; also adjacent to the fused interface (figure 11). The metallographic study did not show any evidence of cracking or related damage in the areas that were not fused between the pin and arm sections.

Fig. 9 Cracking and separation alongside the fused interface of lever 46. Magnification X 9

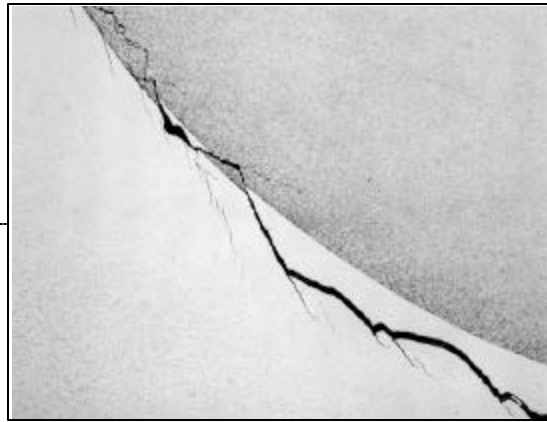
Fig. 10 Closer view of the cracking shown in the boxed area of figure 9. Note the many fine cracks extending tangentially into the arm section. Magnification X 46

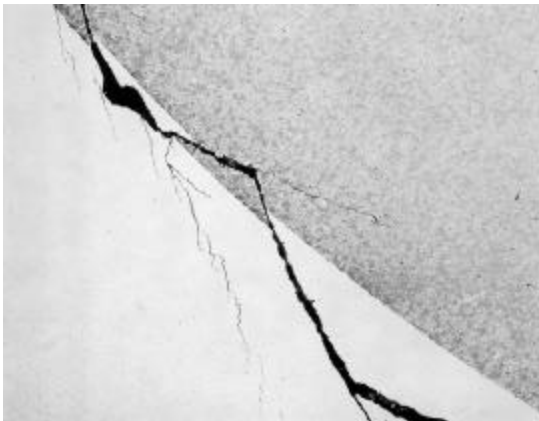
Fig. 11 Closer view again of the cracking within lever 46, showing cracks developing within both the pin and arm materials. Magnification X 92

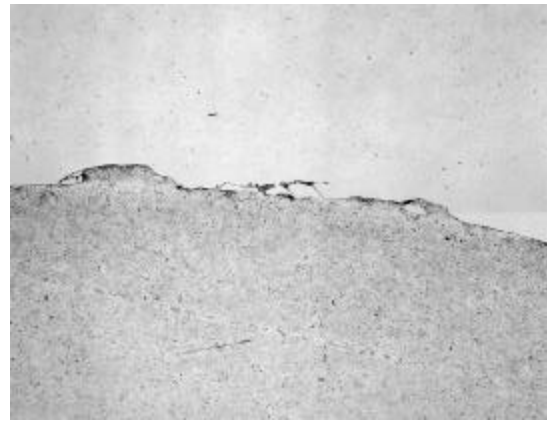
Lever number 26, while not exhibiting cracking of the extent shown by lever 46, did show an extended area of fusion around the pin circumference (figure 12), in much the same way as the other items. Interfacial flow and crack-like lap features were noted in several areas within the fused regions.

Fig. 12 Irregular interface observed within lever 26 containing many lap-like defects. Magnification X 92
