ATSB TRANSPORT SAFETY REPORT
Marine Occurrence Investigation No. 277
MO-2010-006
Final

Independent investigation into the collision between the
Singaporean registered offshore supply vessel

Far Swan

Miclyn 131

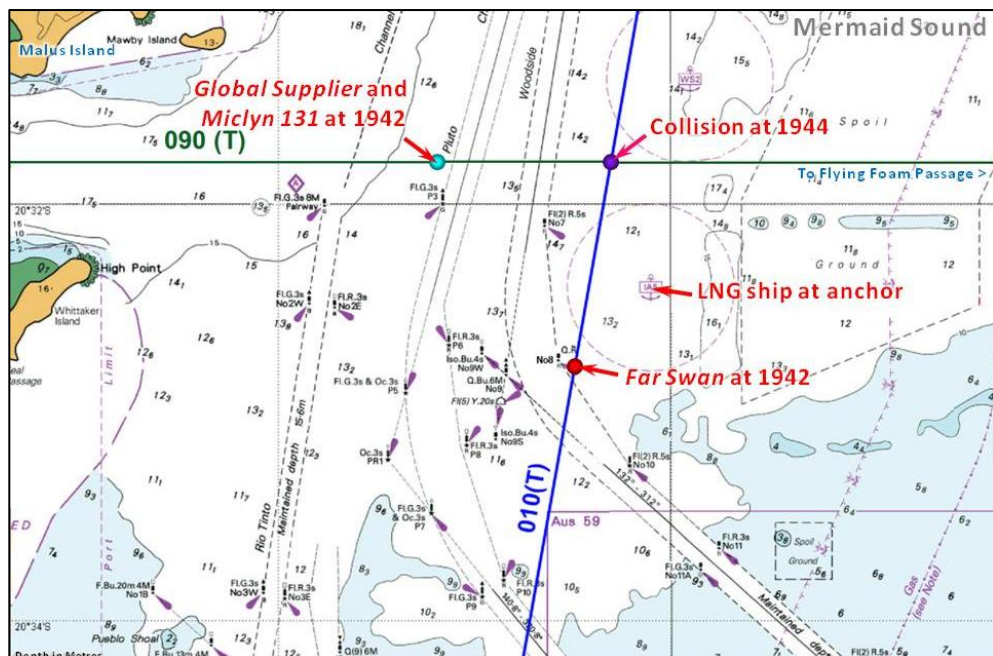
Figure 5: Section of navigational chart Aus 58 showing *Global Supplier's* track in green and *Far Swan's* track in blue

The chief mate and the lookout continued to observe the light and it soon became apparent to them that the small boat was trying to cross ahead. Although the small boat would probably pass ahead, it would be a very close crossing. The chief mate was expecting the boat to 'give way'¹³. However, there was no indication that the small boat was going to give way so the chief mate shone a search light on the boat to alert its crew to *Far Swan*'s presence. The search light lit up the small boat, which looked like an aluminium fishing boat. However, the small boat still maintained its easterly course and speed.

Having received no acknowledgment of, or response to, the search light, *Far Swan*'s chief mate concluded that the small boat was still endeavouring to cross ahead. In an effort to avoid a close quarters situation, he altered the ship's heading a few degrees to port.

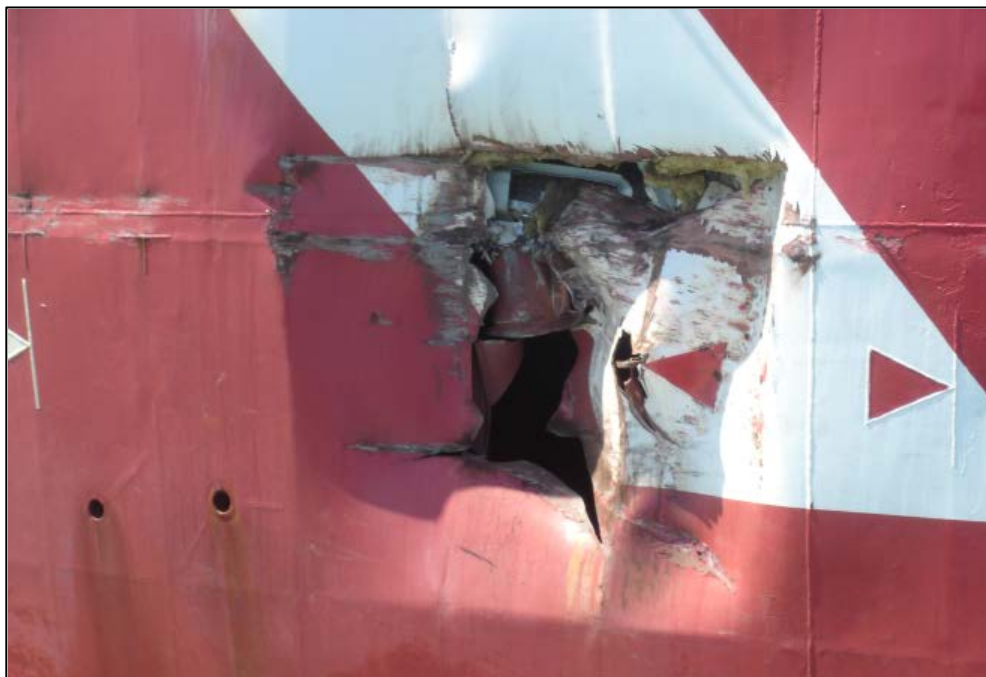
Figure 6: Damage to *Far Swan*'s hull

Shortly after 2030, *Far Swan's* crew found a large hole in the port side shell plating in the vicinity of the emergency generator room and above the ship's water line (Figure 6).

Early in the morning of 7 October, *Far Swan* berthed at King Bay. A thorough inspection of the ship revealed that the only major damage was the hole in the shell plating in way of the emergency generator room. The ship remained in Dampier while repairs were carried out.

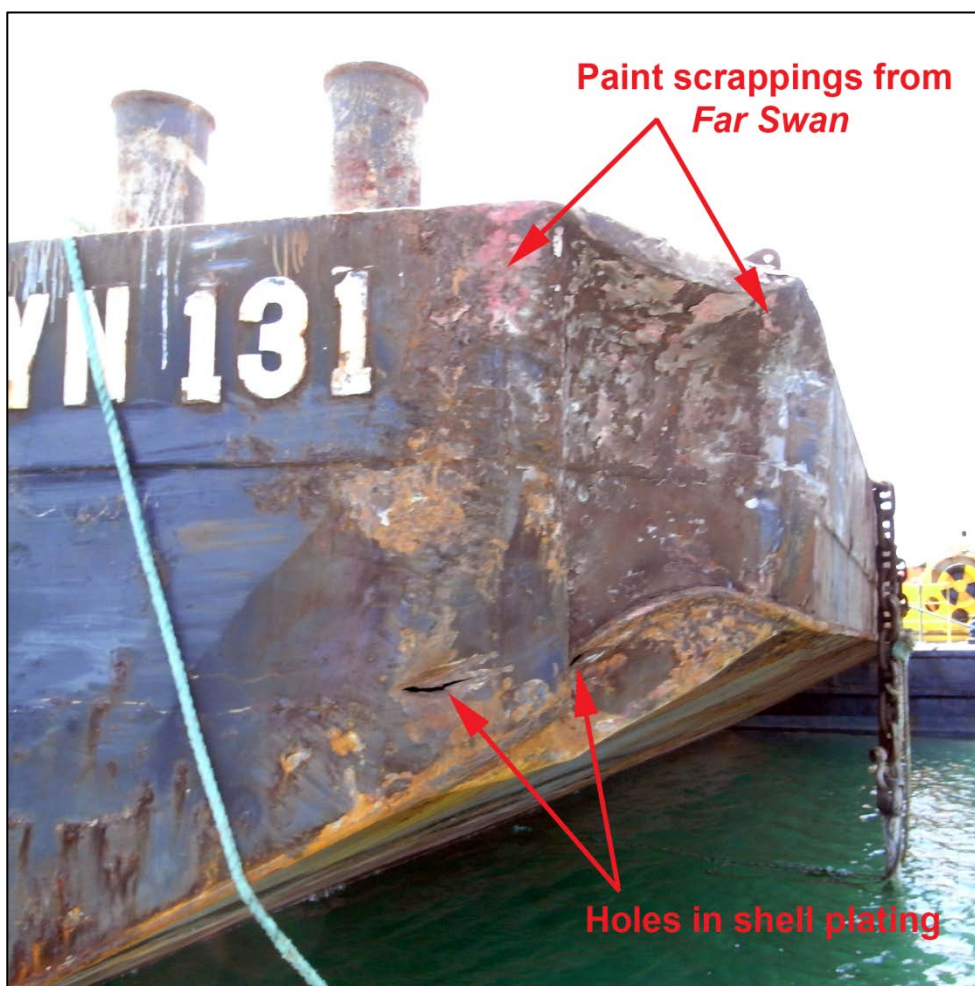
Figure 7: Damage to *Miclyn 131*

Global Supplier's skipper inspected *Miclyn 131* on the morning of 7 October and found that the starboard shoulder had been pushed in (Figure 7). He also found several small holes in the shell plating around the starboard shoulder area. *Miclyn 131* remained at Point Samson while repairs were carried out to the American Bureau of Shipping's satisfaction.

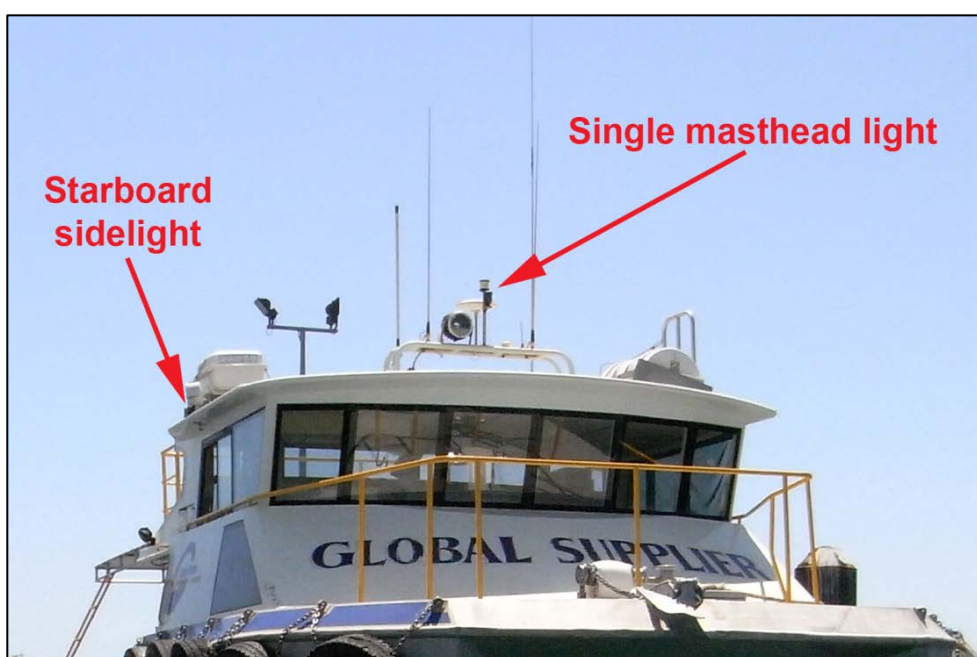
Figure 8: *Global Supplier's* navigational lights

When Global Marine purchased *Global Supplier* in 2006, several modifications were made to the vessel. This included the addition of single 8 tonne towing bollard which was mounted on its main deck. By adding the bollard, the company was enabling the vessel to be used as a 'tug'. Consequently, the appropriate navigation lights required for towing operations should have been fitted to the vessel at that time.

Despite the correct navigation lights not being on board *Global Supplier* when it departed Point Samson, the skipper undertook the tow that evening. Consequently, with the lights not fitted to the boat, *Global Supplier* was not in compliance with the COLREGs and as a result the crew on board *Far Swan* did not know the small vessel was towing a barge.

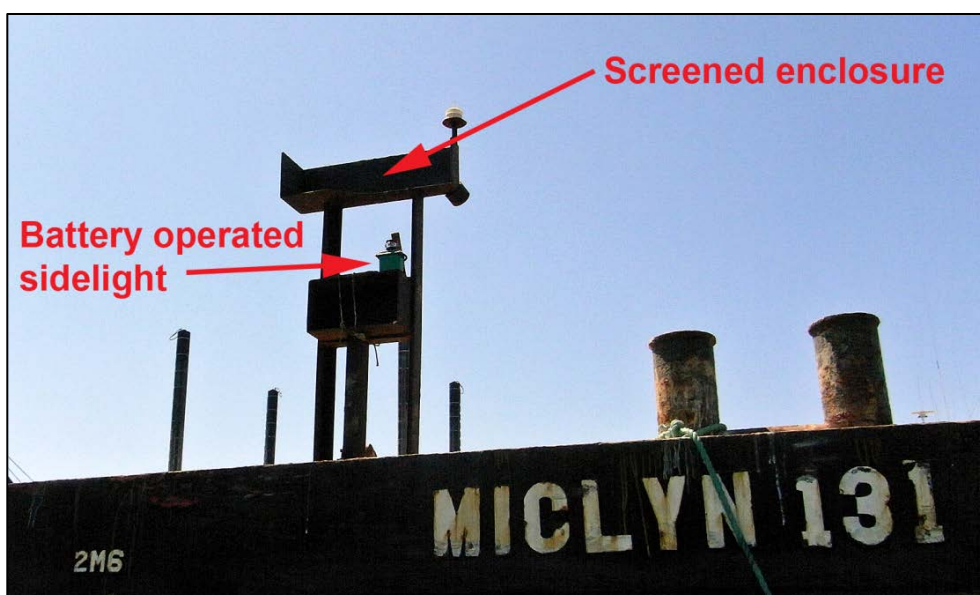
Figure 9: *Miclyn 131* sidelight

Miclyn 131 was fitted with permanent sidelight enclosures (Figure 9). The COLREGs designate the correct dimensions of such enclosures¹⁷ and stipulate that they should be painted matt black. This ensures that scattered light is appropriately restricted and the colour contrast between the light and its surroundings is maximised, thus ensuring the visibility of the light is enhanced.

However, when the ATSB investigators inspected *Miclyn 131*, they found that the portable battery powered all-round navigation lights used on board the barge on 6
