Investigation Report 510/08

Very serious marine casualty

Fatal accident on board the CMV CHICAGO EXPRESS during Typhoon "HAGUPIT" on 24 September 2008 off the coast of Hong Kong

1 November 2009

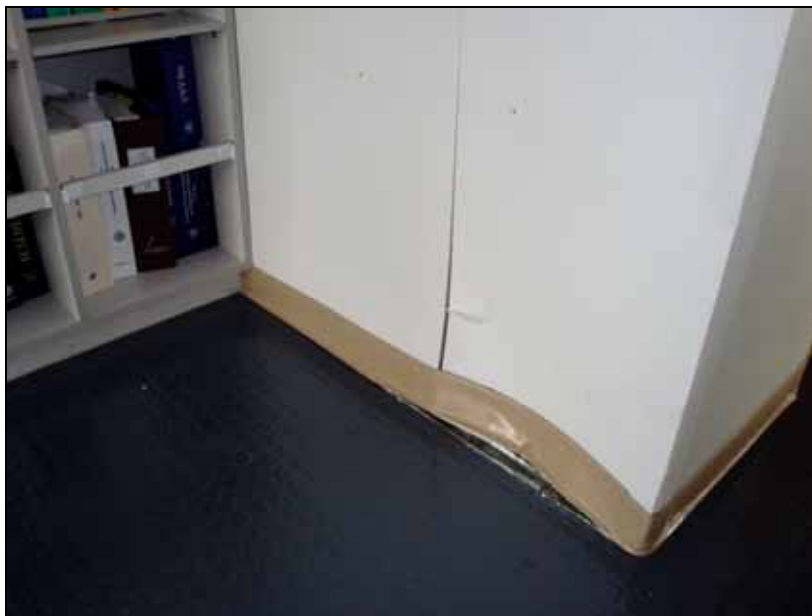
Figure 7: Deformed interior panelling at floor level¹⁷

¹⁷ Note: Such or similar deformations can be found in various places at floor level. The dents shown here are situated in a corner behind the area of the chart table (where the Master was found).

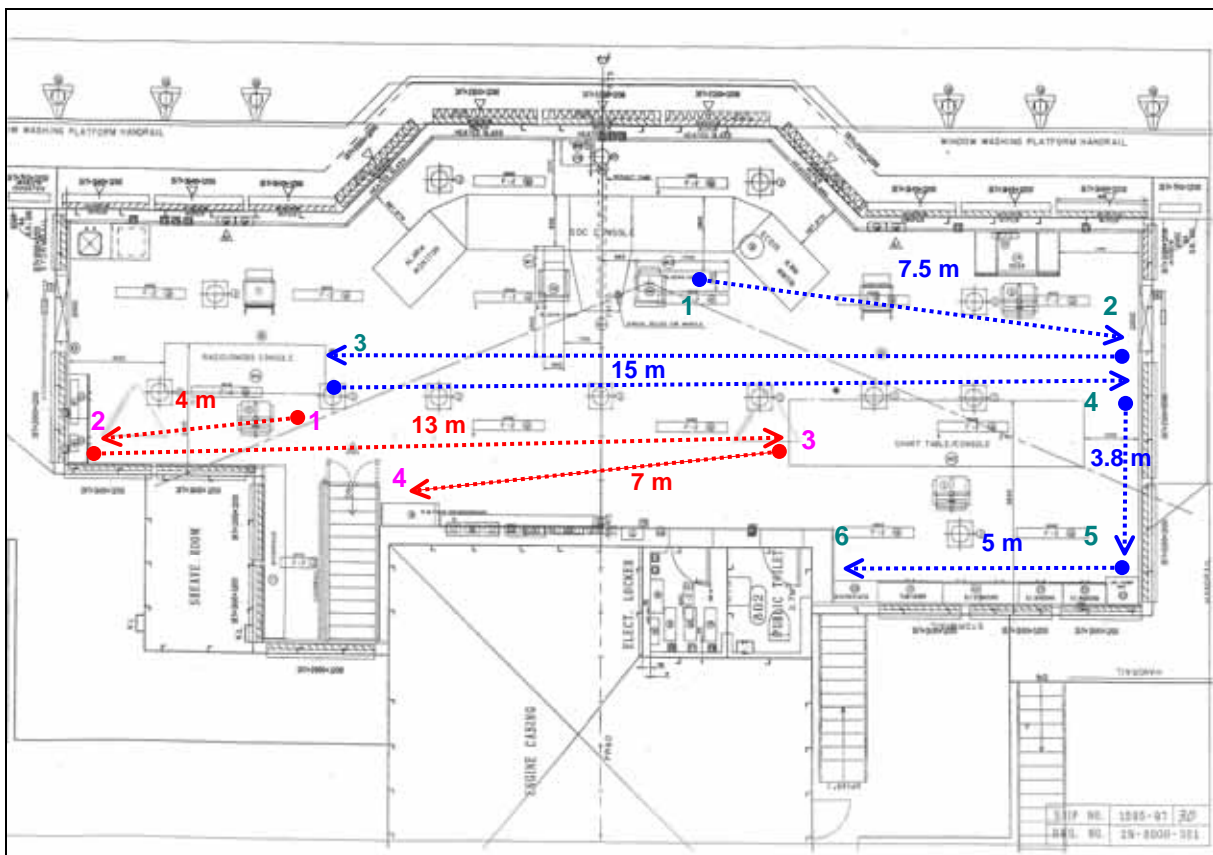
Figure 15: Path of the fall of the AB and the Master

Since it was dark on the bridge at the time of the accident and the two uninjured witnesses of the course of the accident were, during the extreme rolling of the vessel which led to the accident, primarily concerned with not losing their own footing or, as regards the OS (Helmsman), regaining it as quickly as possible, the drawing depicting the paths each fall took in **Fig. 15** is based on assumption. However, the respective start and finish positions are regarded as definite. The intermediate impact positions are confirmed at least to the extent that there are more or less distinct dents or scuff marks on the bridge panelling or panelling on the bridge furniture, which were caused on impact by the AB or the Master.

The distance between the impact positions, the serious injuries of the casualties and the in part significant deformations on the console and bridge panelling illustrate just how severely the accident victims were affected by the acceleration and forces during their fall.

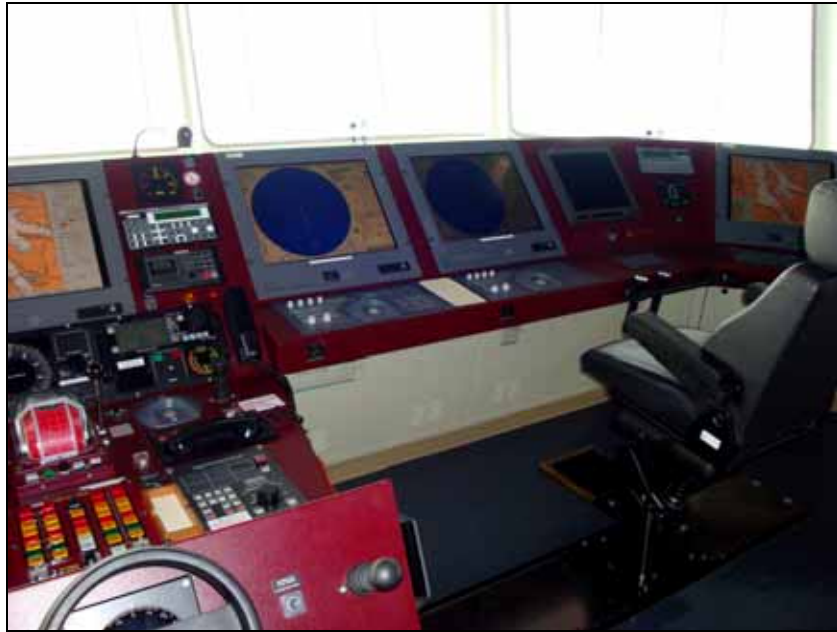
Figure 16: Radar position on the starboard side

As regards the starting position of the Master (in front of the radar screen on the starboard side of the vessel command console), it transpires that there was no handhold where he was situated (see **Fig. 16**). Despite there being handrails across the entire width of the vessel command console at various points, rather than being continuous, these are interrupted by large areas without any handhold whatsoever. **Figure 17** shows the console is only partially equipped with handrails – in the example on the port side.

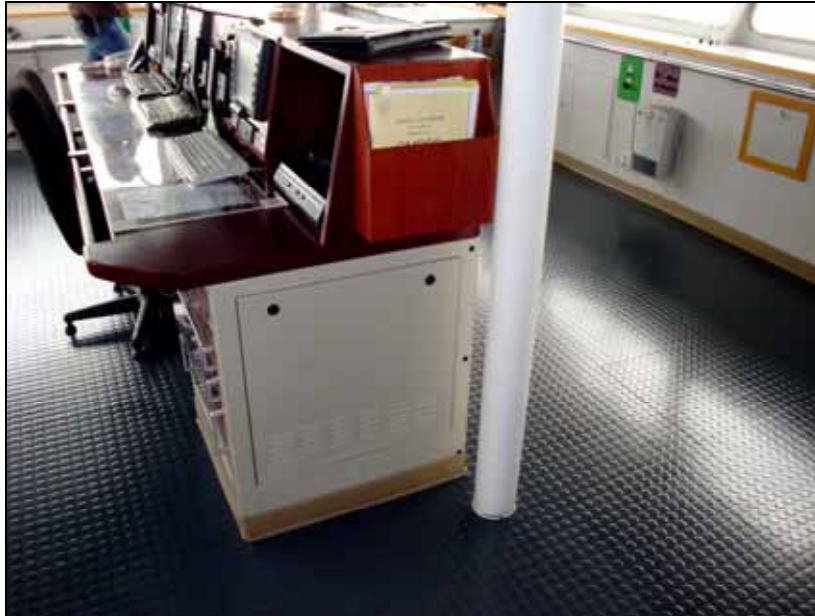
Figure 18: Handrail on the GMDSS console

The preceding information applies to a similar extent for the GMDSS console, i.e. the starting position of the AB. This is indeed equipped with a relatively wide handrail, but the side of the console is not included (see **Fig. 18**).

Figure 44: Handrail on the forward edge of the GMDSS console

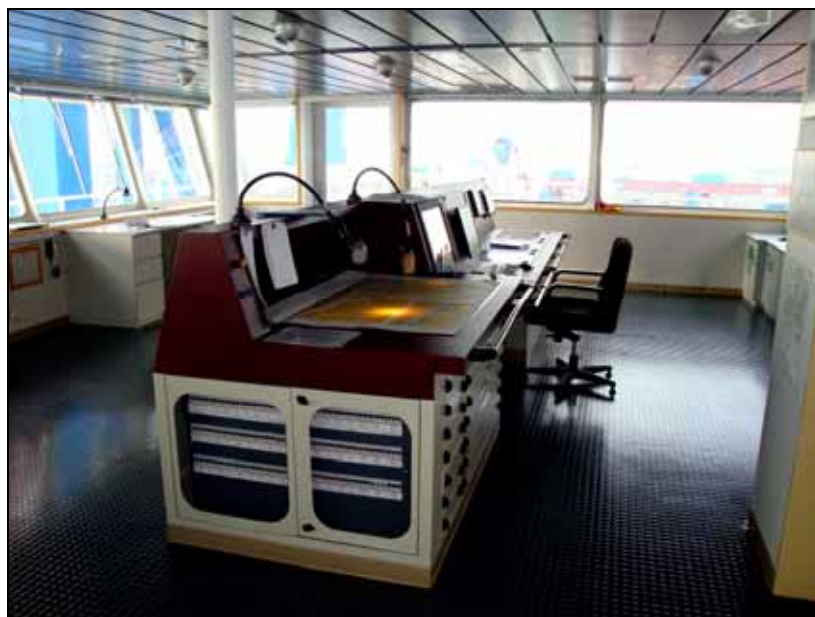
Figure 19: Handrail of the chart table

The front side of the chart table (position of the Officer on Watch, **Fig. 19**) is also not fitted with a handrail; however, a handrail is present at the usual operating positions of the GMDSS console and the table. The Officer on Watch was successful in holding on to the latter.

Figure 43: Handrail on the forward edge of the chart table

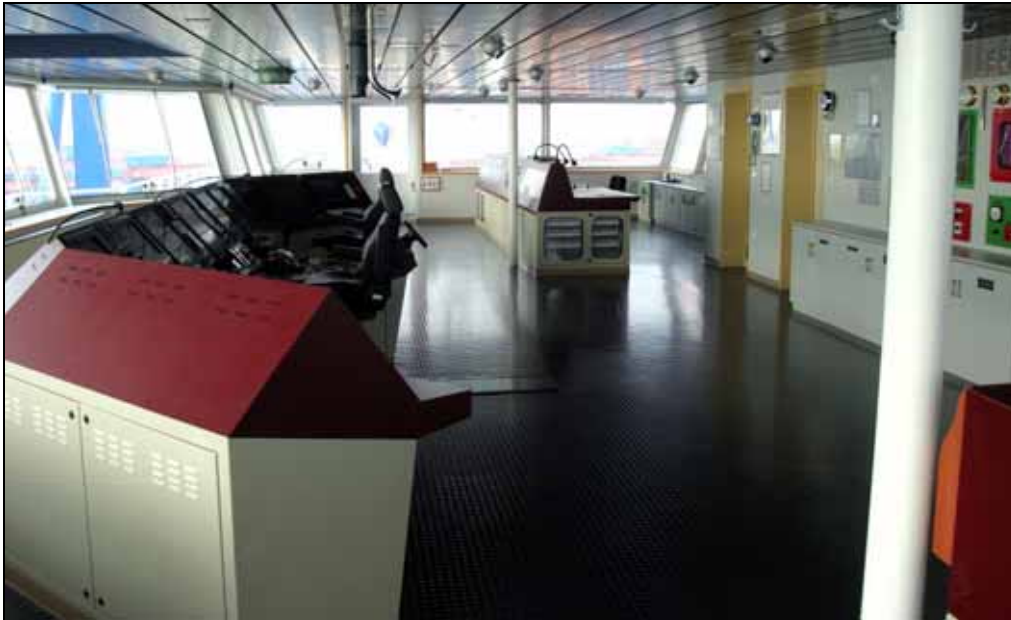
The inadequate fitting out of the bridge with handholds is finally shown by the examples in **Figures 20** and **21** below. Large sections at the side and aft of the bridge, the forward edges of the chart table and the GMDSS console as well as the front sides of the vessel command console have no handrail.

Figure 20: No handrails at the aft end and starboard side of the bridge

Figure 21: No handrails at the port side of the bridge

As a consequence of the accident, the vessel operator has organised for various additional handrails to be fitted on all vessels of the 8749 TEU class⁴⁴ and beyond that to enclose the position of the Helmsman with railing (see examples at **Figs 43 to 48**). Moreover, the accident has been discussed within the fleet and in this context possible additional safeguards on the bridge such as the clamping of lifelines or the securing of personnel with belt systems are being considered. However, such measures have not been passed on to the vessels as universally binding recommendations for reasons of practicability. Rather, it has been left to the discretion of the ship's command to carry out any steps that appear necessary and useful to minimise the risk of falls on the bridge due to heavy seas in consideration of the specific risk situation.

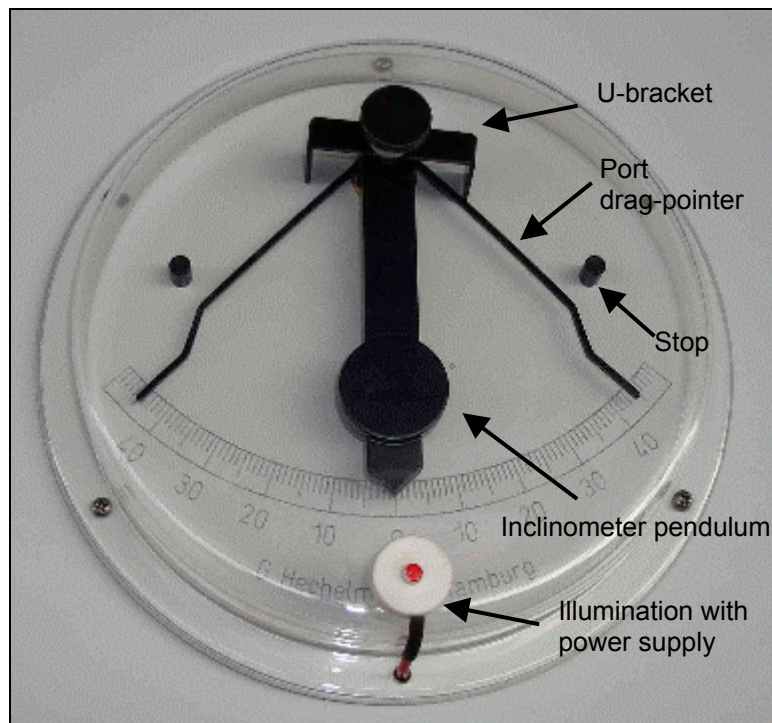
Figure 29: Photo of the inclinometer on the bridge of the CMV Chicago Express

side to side. The indicator on the inclinometer on the bridge remained at about 44 degrees on each side (see **Fig. 29**)³¹.

It was thus concluded that the roll angle on board actually amounted to 44 degrees. However, at the beginning of the investigation the expert informed the BSU of his doubts that the roll angle could be accurately recorded by such a device in a situation of this nature. Following that, the BSU acquired an identical device and provided this to the expert. Closer examination of the structural properties of the inclinometer confirmed the above hypothesis and resulted in the following.

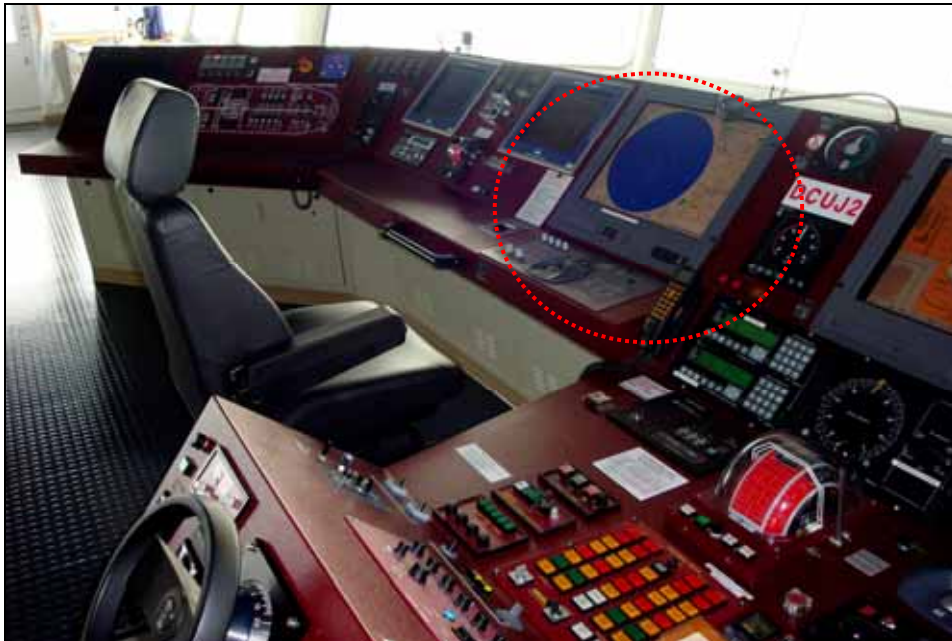
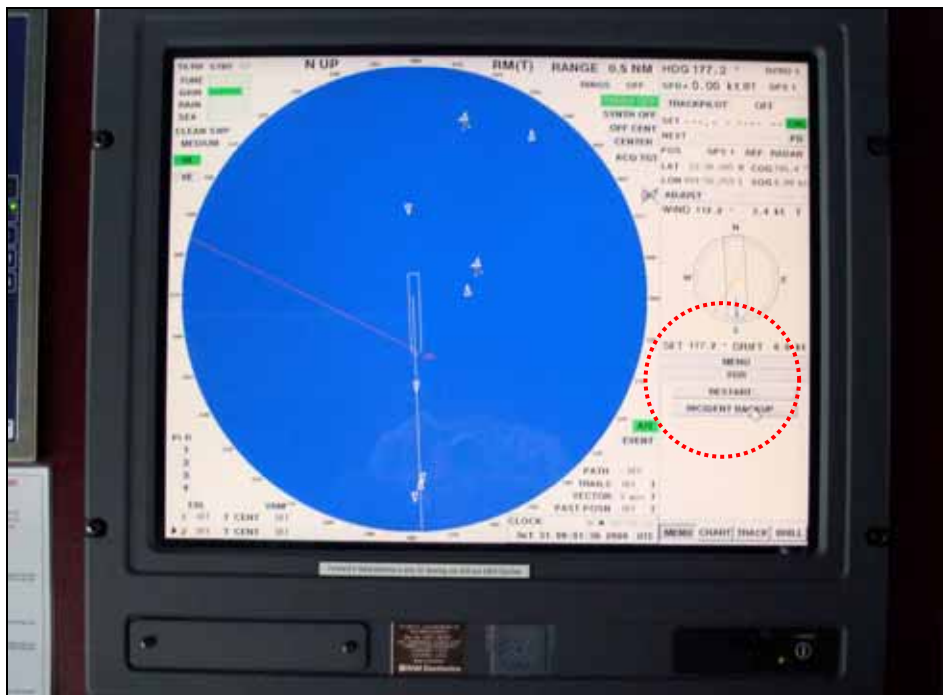
there is a possibility that crew members, who are not familiar with operating the radar equipment, must or should activate the incident backup system.

Figure 38: Extract – bridge console with port radar unit

Figure 39: Button for incident backup on the port radar unit
