Investigation Report 391/09

**Very Serious Marine Casualty**

**Fatal accident on board  
the CMV CCNI GUAYAS  
during Typhoon 'KOPPU'  
on 15 September 2009 in the  
sea area off Hong Kong**

**(Including analysis of  
Serious Marine Casualty 520/09  
Pilot injured on board  
the CMV FRISIA LISSABON  
on 16 October 2009 west of  
Borkum on the Westerems)**

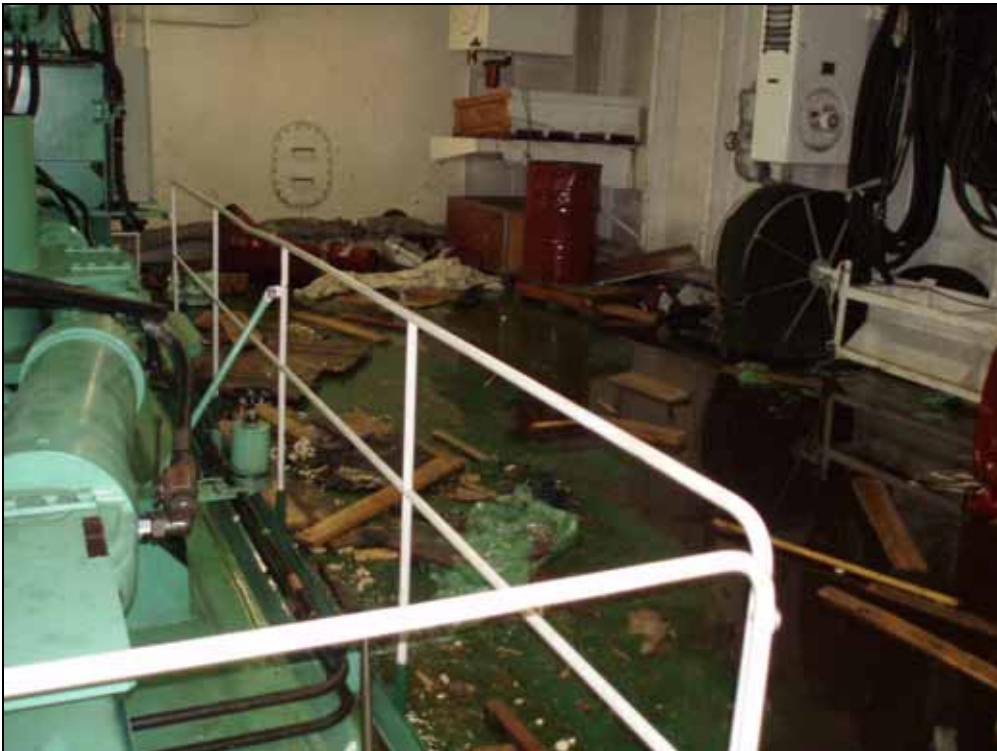
Figure 3: Steering gear compartment

The vessel sustained considerable damage. It is clear from the damage report of Germanischer Lloyd dated 22 September 2009 that, for example, the crane hooks of the cranes at Hatch 1 and Hatch 2 tore off and cannot be found and the crane jib storage brackets, the railing, the emergency exit doors in the engine room and

workshop and various navigating equipment on the bridge sustained damage. While testing the steering gear it was found that Steering Gear Pump No. 1 is faulty.

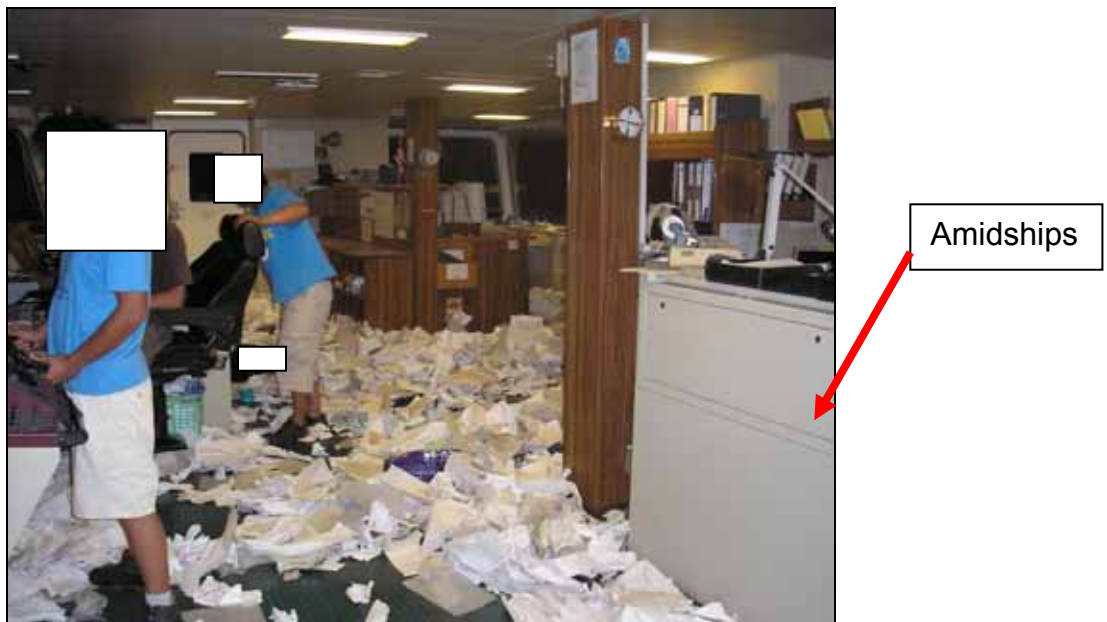
Figure 9: Bridge after the accident

According to the schedule, the watch was to be taken over by the 36-year-old third officer at midnight. A 29-year-old AB (able bodied seaman) reported to the bridge at 2350 to assist the third officer shortly before the third officer appeared on the bridge. However, the third officer ordered the AB to leave the bridge and don sturdy working shoes because he was only wearing open sandals when he appeared on the bridge. When the AB left the bridge, the third officer was standing amidships on the bridge at the radio workstation and held on firmly with both hands while the 60-year-old master sat on the starboard side in front of the radar equipment and held on to the handrail there.

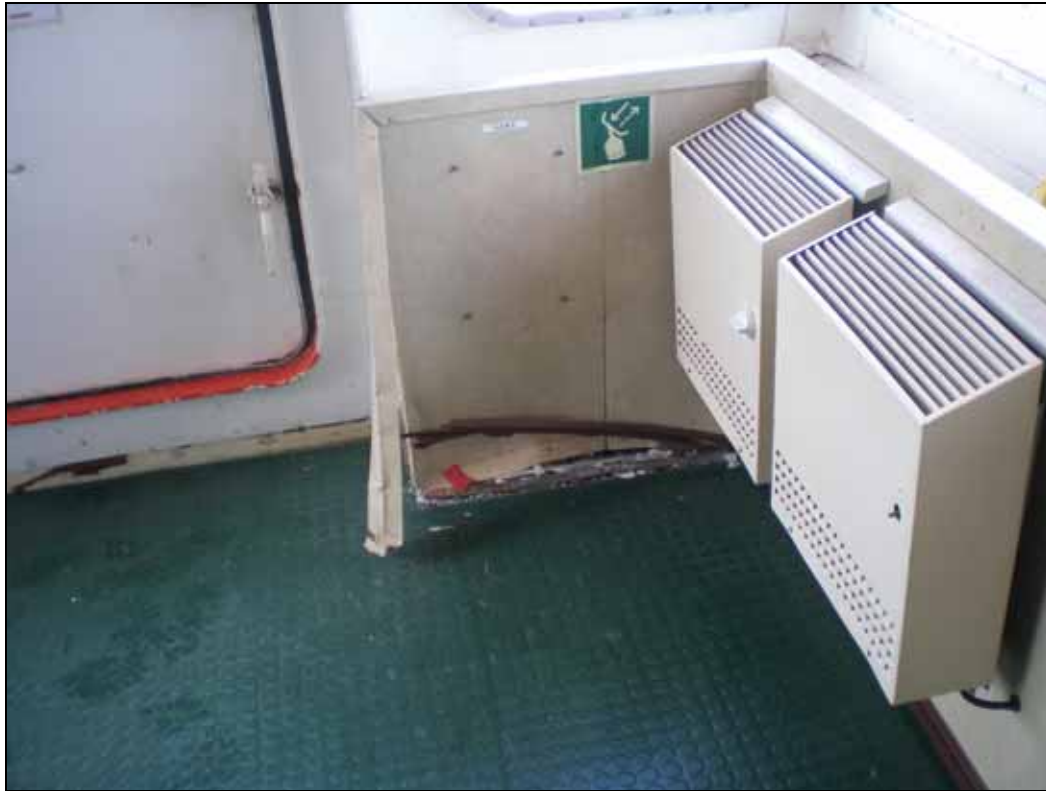
Figure 10: Damage on the port side

More and more objects fell to the floor in addition to the items already there, which slid back and forth, and the master said he noticed how the third officer bent down to collect something lying on the ground. Shortly afterwards, he heard a scream and saw the third officer sitting on the floor with his legs forward sliding to the port side, where he struck the radar transponder and a radiator.

He tried to hold on to the radiator, but did not succeed and slid across the floor to the starboard side and struck the bridge door unchecked with his face.

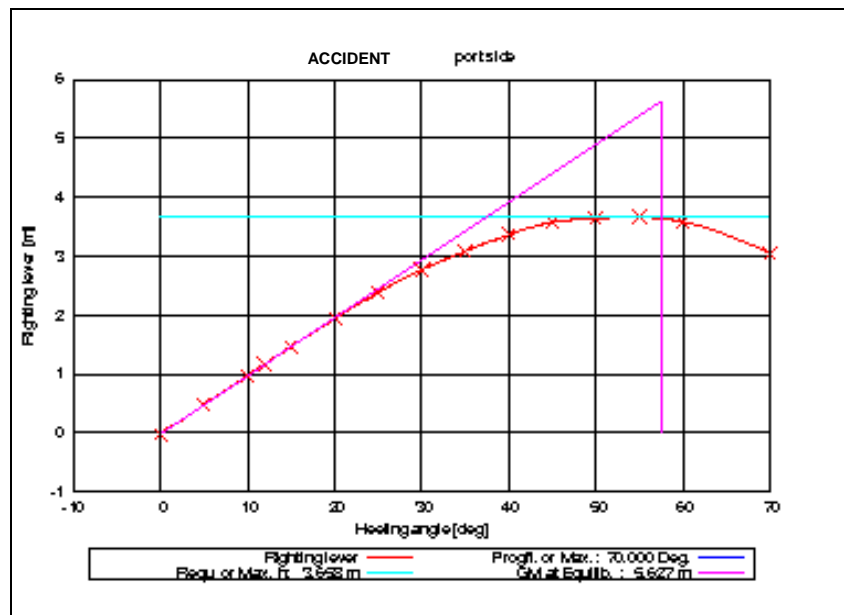
Figure 17: Righting lever curve

With a GM of more than 5.60 m, the vessel's stability in smooth water is more than adequate.

To examine the overall risk of parametrically excited roll oscillations, too, by way of example the righting levers were calculated at the midship section for the conditions 'trough' and 'crest' using an equivalent wave. For an equivalent wave which corresponded approximately to the wave on the day of the accident, a sine wave of 140 m in length (about 9.5 s) and 7 m in height was chosen. The calculations revealed that the differences between the crest and trough situation and also the comparison with the smooth water calculation were very low and the curves do not differ considerably. These slight variations are caused by the fact that the vessel was underway with a draught which was much shallower than the moulded draught. In the case of the crest, this results in a degree of additional hydrostatical stability; on the other hand, this floating condition coupled with a prominent bow flare causes the vessel to become prone to the effect of direct swell moments especially in the aft area. However, the result shows that the parametrically induced roll moments are relatively low. Therefore, the direct exciting moments from the swell in conjunction with the particular sea-going behaviour of modern container vessels at very shallow draught can be viewed as the actual cause of the accident.

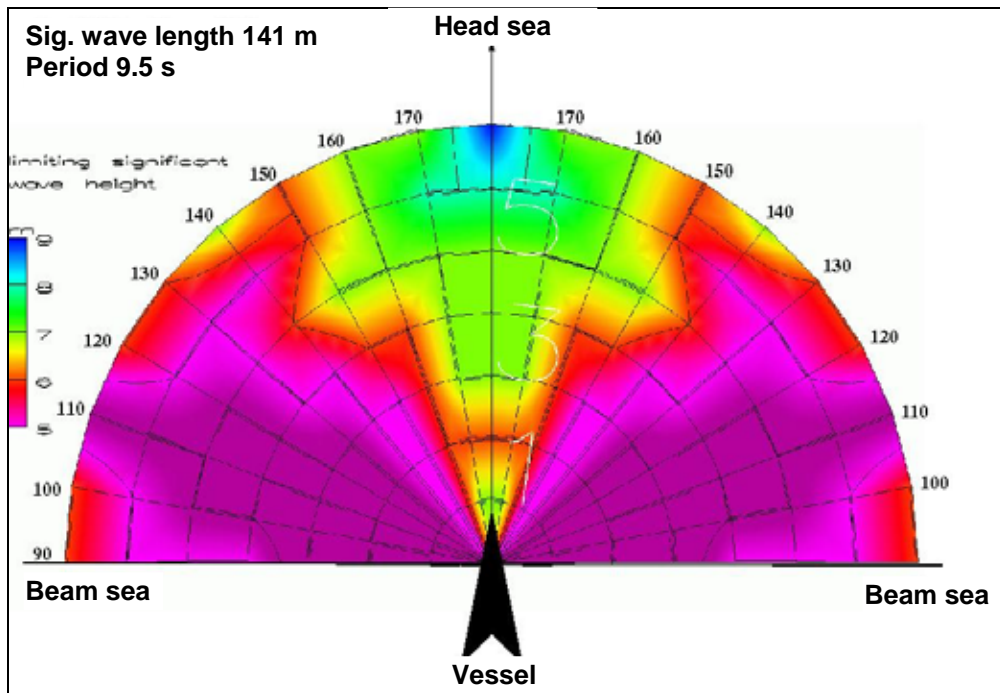
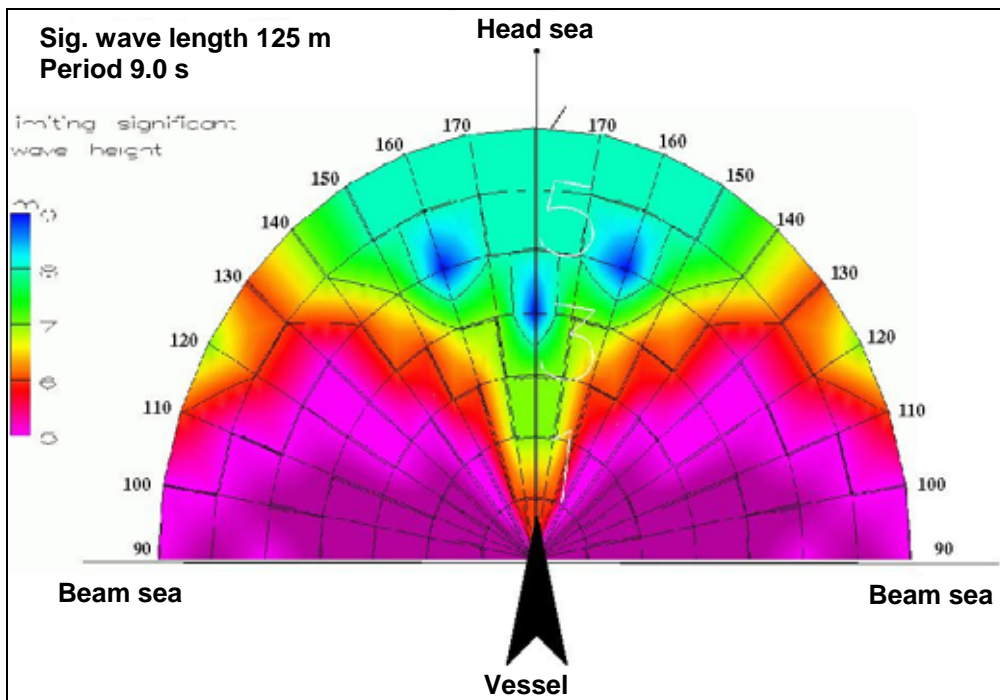
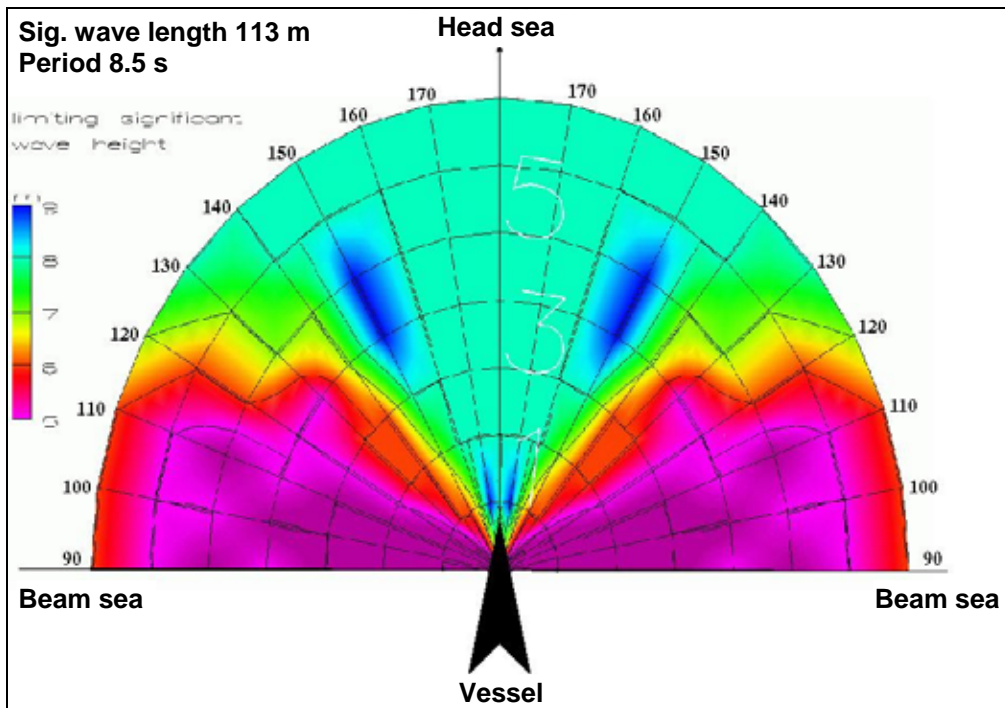
The above three polar coordinate diagrams show the calculated significant wave height [m] necessary for the occurrence of a roll angle of  $35^\circ$  with a characteristic period [s] and the significant wave length [m]. The vessel is steering to the north. The waves are approaching from the direction indicated by the radial axis. The rings indicate the speed of the vessel [kts] and the coloured legend shows the significant wave height [m].

The result of all three calculations show that as long as the crew sailed the vessel in stern seas, the wave heights required for reaching a roll angle of  $35^\circ$  are relatively high (greater than 8 m). However, if the waves come from a sufficient incident angle transverse to the longitudinal direction, larger roll angles of more than  $35^\circ$  would definitely be caused by wave heights of 5 to 6 m, as was the case on the day of the accident. The severe rolling motion is caused by the considerable roll moments applied to the vessel; here, resonances or parametric excitation have no effect. The slow speed on the day of the accident of about 2 kts also appears to play a role. To illustrate that, a higher speed of up to 15 kts is considered for the period 9.5 s.

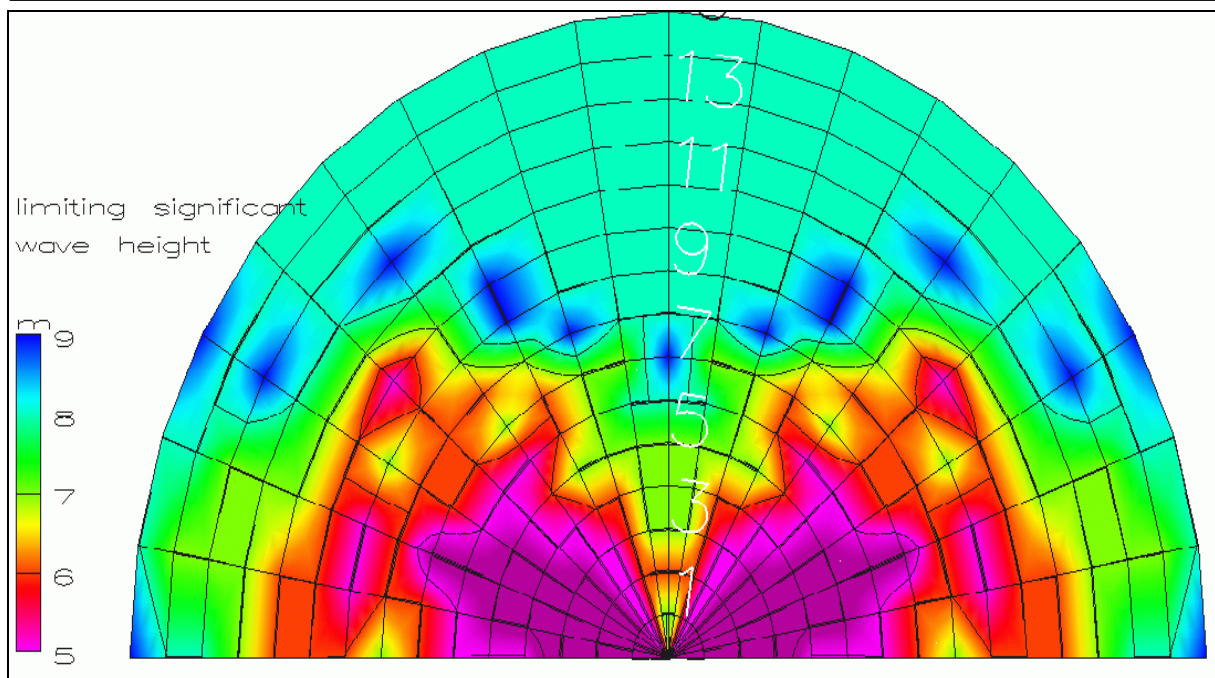
Figure 22: Polar coordinate diagram up to 15 kts

This calculation shows clearly that severe roll angles occur only below a certain speed.

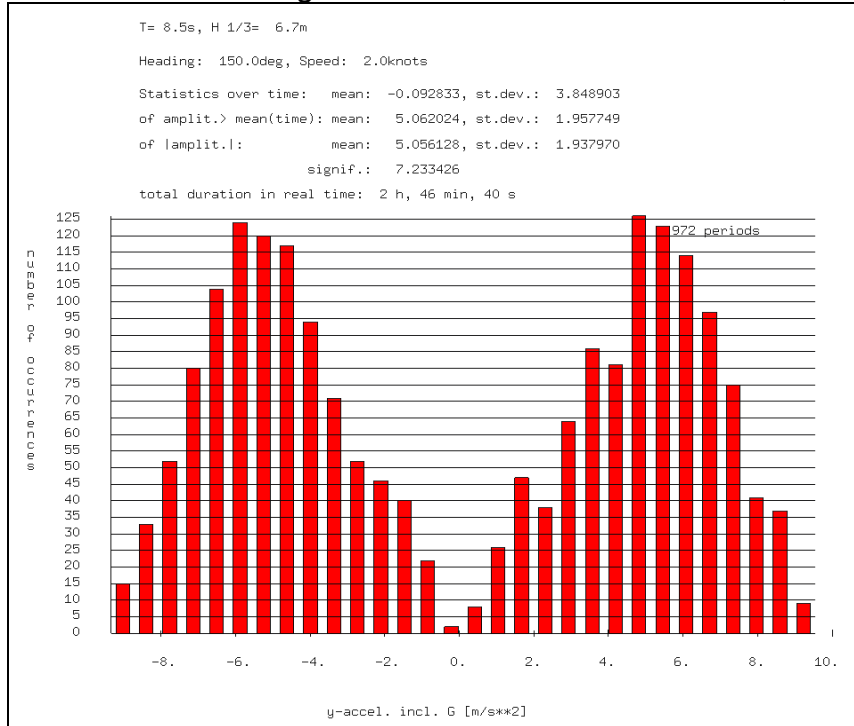
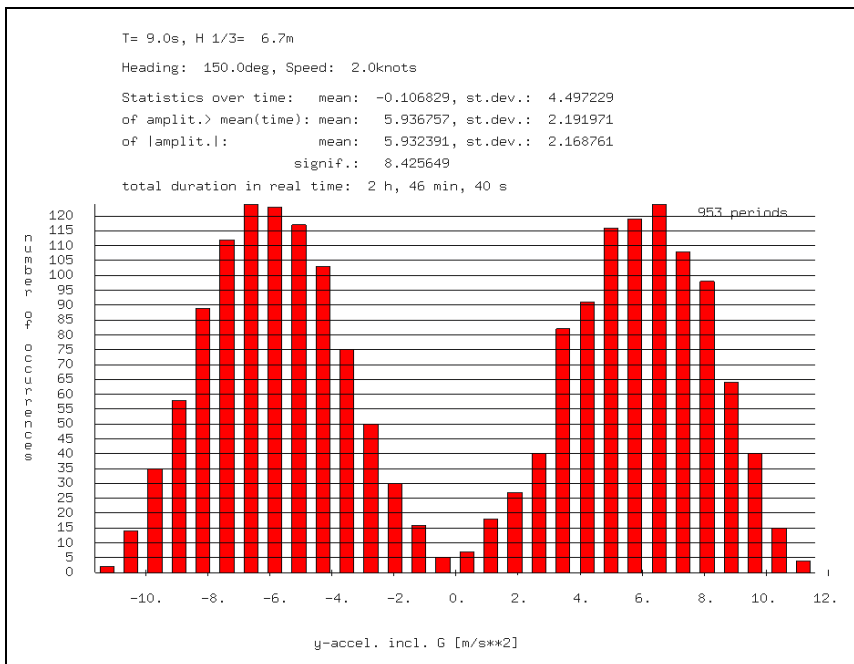
Figure 23: Frequency distribution of transverse accelerations on the bridge

The calculations show that considerable transverse accelerations must have acted on the bridge. In the case of the period of 9.5 s which probably applied on the day of the accident, transverse accelerations of more than 12 m/s<sup>2</sup> are reached, which corresponds to about 1.3 g. Even when looked at more favourably, 10 m/s<sup>2</sup>, respectively, more than 1.0 g is reached. For comparison: the load on typical lashing equipment is dimensioned with 0.5 g transverse acceleration.

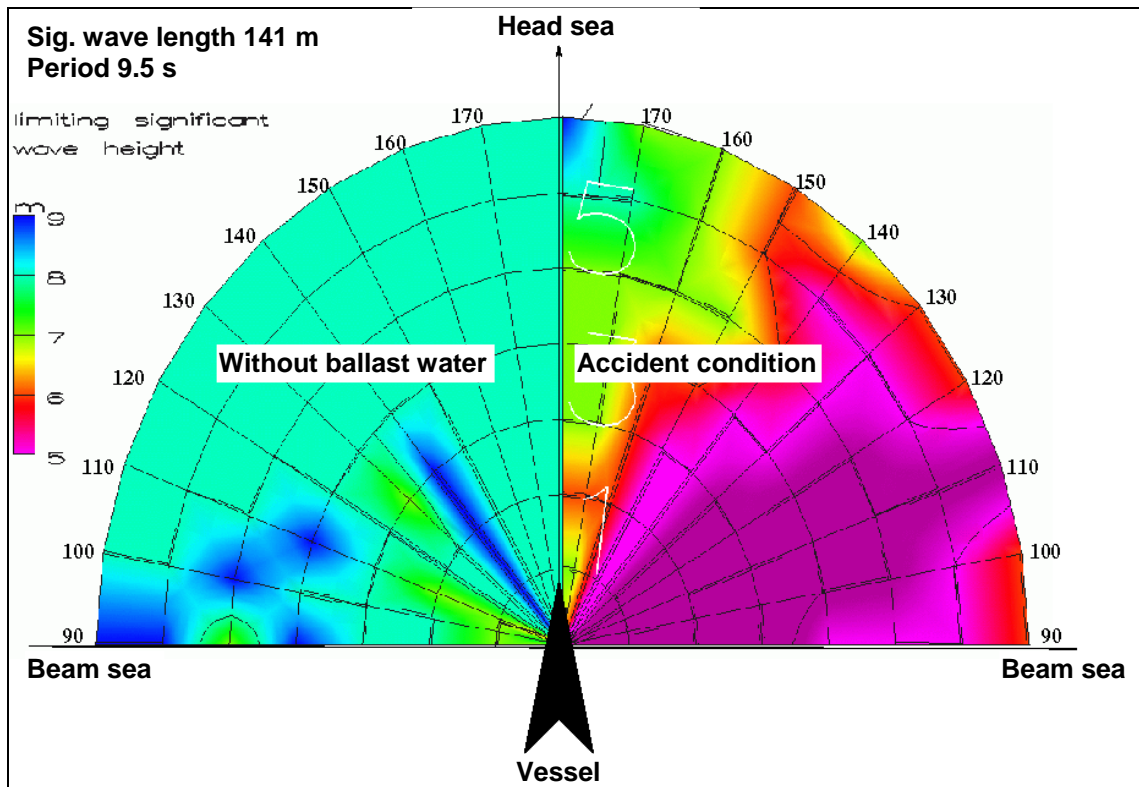
Figure 24: Polar coordinate diagram with/without ballast water

Included in the analysis were the significant wave length at 141 m, the roll angle at 35°, and the significant period at 9.5 s that prevailed on the day of the accident. On the top polar coordinate diagram the condition without ballast water is shown on the left and the condition of the vessel on the day of the accident on the right. The results of the calculations show that for the load condition 'Without ballast water', both the roll angle (Fig. 24 above, left of polar coordinate diagram) and the accelerations (Fig. 25 below) decrease very significantly.

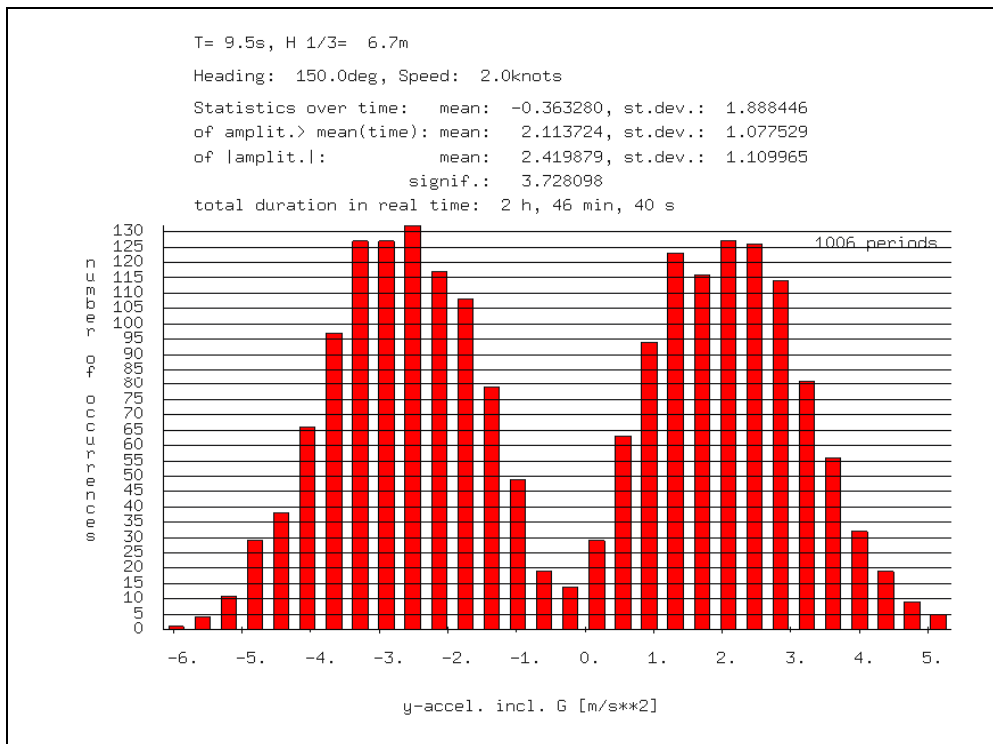
Figure 25: Vessel without ballast

For the presumed speed of 2 kts with swell approaching at a 30° angle from ahead, the maximum accelerations calculated according to the histogram are between 0.53 g and 0.66 g, with roll angles of between 18° and 23°. In the case of the vessel without ballast water, the values are significantly lower than on the day of the accident and can certainly be regarded as normal for a bad weather situation.

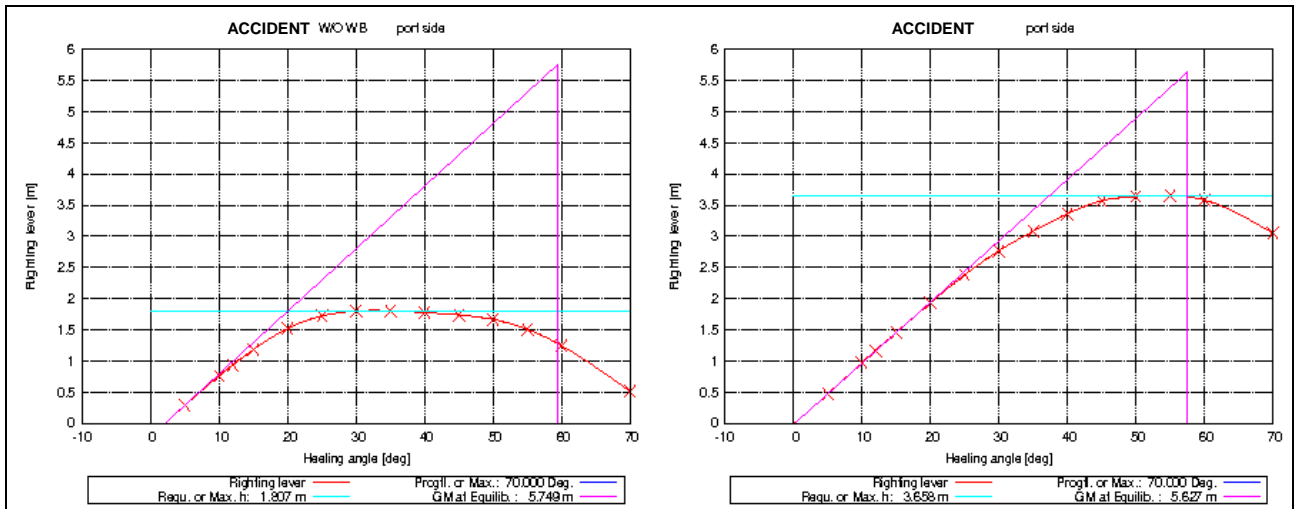
Figure 26: Stability comparison without ballast water left, accident condition right

The stability comparison shows that both cases have about the same GM. The following stability comparison of the righting lever curves shows that the initial stability is almost identical up to about 15°. The righting lever curves do not differ significantly until 20°. However, the generally enormous change in stability at larger heeling angles does not explain the obvious change of roll behaviour with regard to the condition of the vessel on the day of the accident. According to the calculation for the stability case 'Without ballast water', the roll angles are only about 20°, at which the stability difference is only marginal. The true reason for the marked change in roll behaviour, and thus also the reduction of risk to which the crew is exposed, results from the fact that the vessel now has virtually no forward draught, is no longer immersed.

The analyses show that because of the only marginal immersion at the forward perpendicular, the prominent bow flare is no longer wetted in swell, either. This means that the roll moment applied to the vessel by the swell reduces significantly, and that is the true reason for the significant improvement in the rolling behaviour.

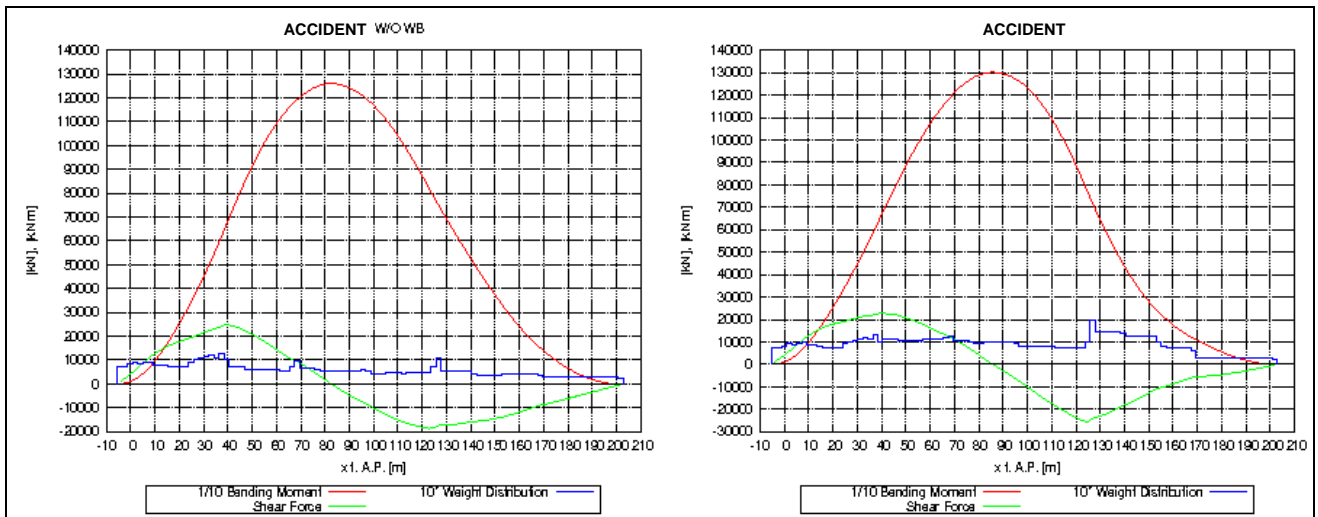
Figure 27: Longitudinal strength without ballast water left, accident condition right

The maximum longitudinal bending moment becomes slightly less in the 'Without ballast water' case, but is still markedly higher than the permissible longitudinal bending moment. In the case of 'Without ballast water', the permissible longitudinal bending moments are just exceeded by 1-2% in some places. In the calculation case 'Without ballast water', it should be noted that the minimum permissible draught was not reached at the forward perpendicular; this must be observed according to the class rule in order to avoid a slamming hazard to the bottom. Therefore, to prevent slamming damage and thus also avoid endangering the vessel's structure, she may

not sail without any ballast water at all, even if the bending moments were maintained. It is likely that the accident could have been prevented in theory through not carrying any ballast water, but precisely this condition is explicitly prohibited by the existing rules.

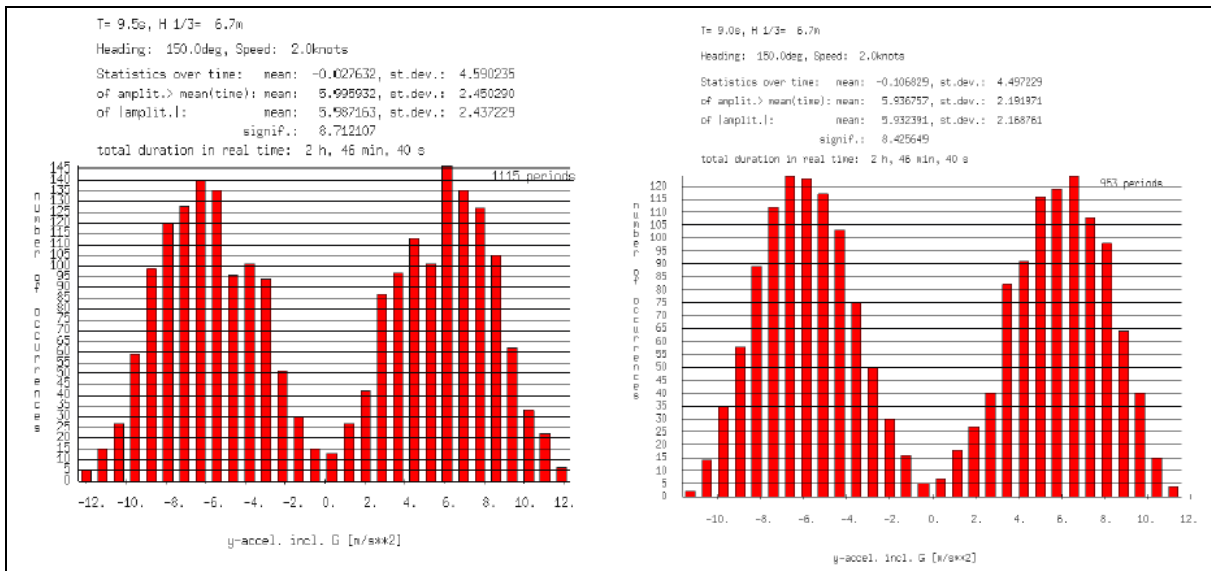
Figure 28: Transverse acceleration in Case 3 B left, accident condition right

The frequency distribution of the transverse acceleration on the bridge, simulation time 10000 s, period 9.5 s is left for Stability Case 3 B according to the stability book and right for the load condition on the day of the accident. It can be seen clearly that there is no fundamental improvement in conditions from the Stability Case 3 B and that the accelerations are comparable to those of the accident.

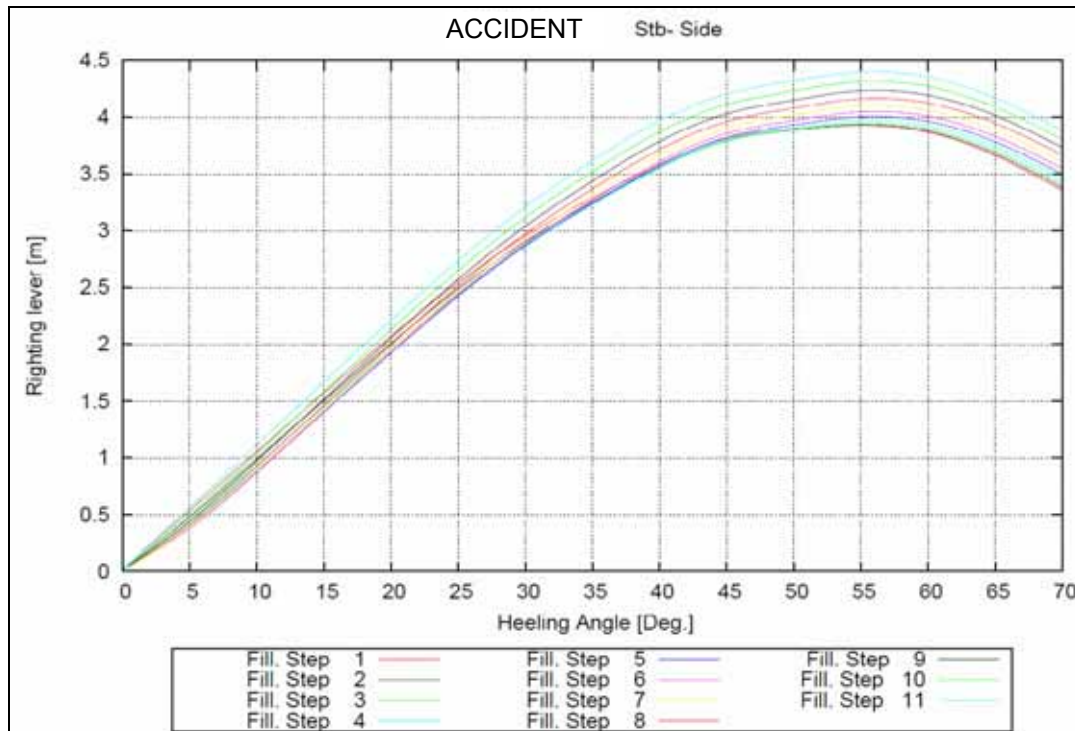
Figure 29: Righting lever partially filled tank

Although the initial GM becomes lower, the tank has hardly any hydrostatic effect even at angles of 15°. On the contrary, more ballast leads to an increase in stability because the centre of gravity shifts downward. It is also very clear that the pure effect of the reduction of stability cannot come into play because hardly any shifting moments can form due to the low tank height. The basis of the calculations is the existence of a hydrostatic equilibrium position, i.e. that water in the tank has run in the direction of the heel. However, a phase shift forms dynamically between the rolling motion of the vessel and the movement of water in the tank;

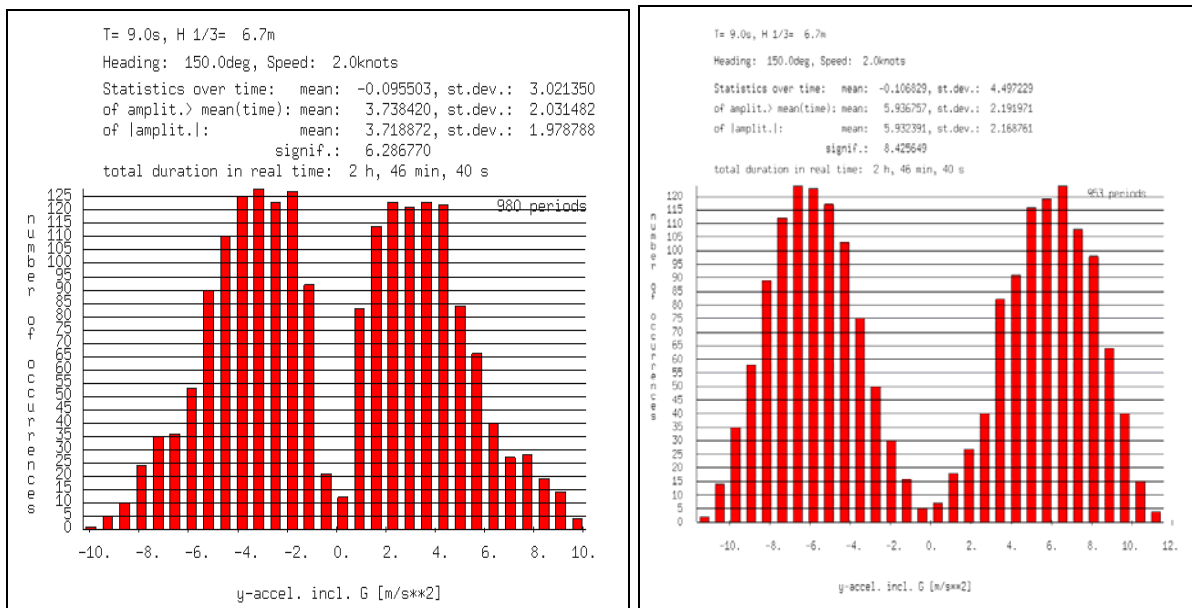
Figure 31: Transverse accelerations on the bridge influenced by the tank

The maximum effect is achieved with a filling of 600 t. This is equivalent to a reduction in roll angle of about 2-3° compared to the roll angles present on the day of the accident. Overall, with a partial tank filling the roll angle reduces up to that point and then starts to increase again. The 600 t of ballast water would cause the centre of gravity to shift downward by 28 cm, due to which the stability would increase. The acting accelerations were calculated for this maximum reduction in roll angle with ballast water of about 600 t:

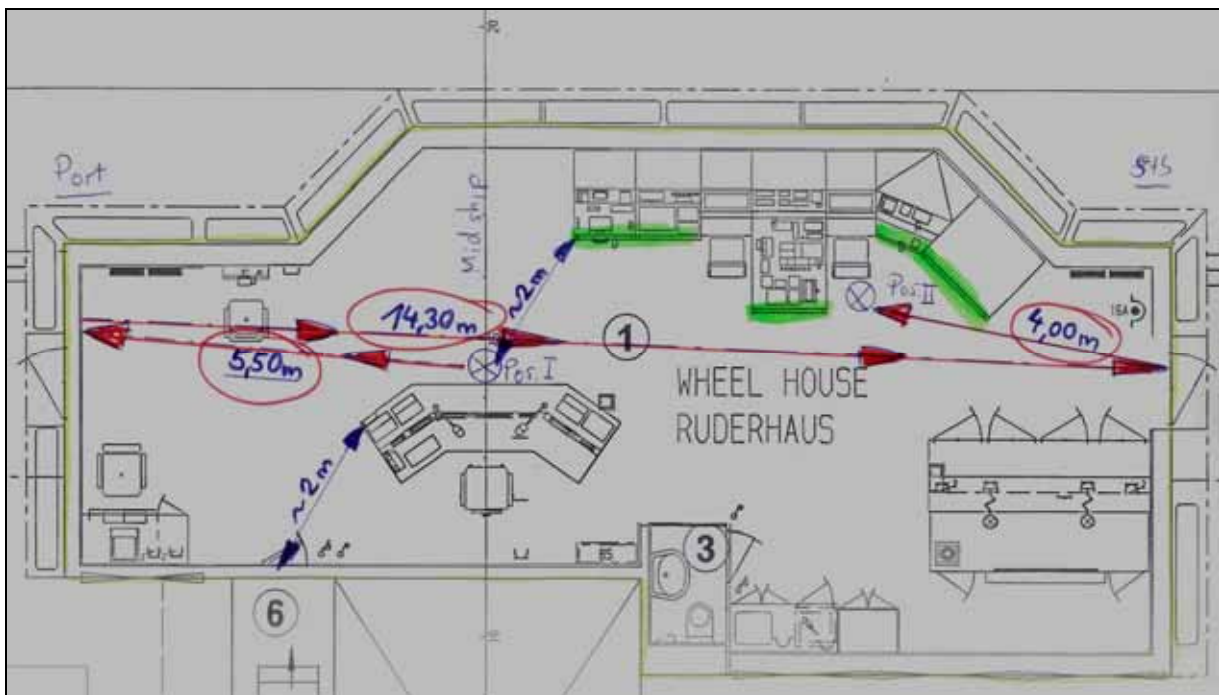
Figure 32: Top view of the bridge

Based on the testimony of the crew and photos, the whole of the bridge floor was covered with papers, folders and various material. These objects had fallen out or off of the bridge cabinets (see Fig. 9). On the one hand, this is an indication of improperly secured equipment on the bridge; on the other hand, some of the cabinet doors may not have been suited to the sea conditions from a structural perspective and did not close sufficiently. On the bridge, there were only four hand bars mounted with sufficient strength at the ship's conning position (marked in green on the following sketch). No hand bars or the like are fitted at the radio workstation or, in particular, the cabinet at Pos. I.

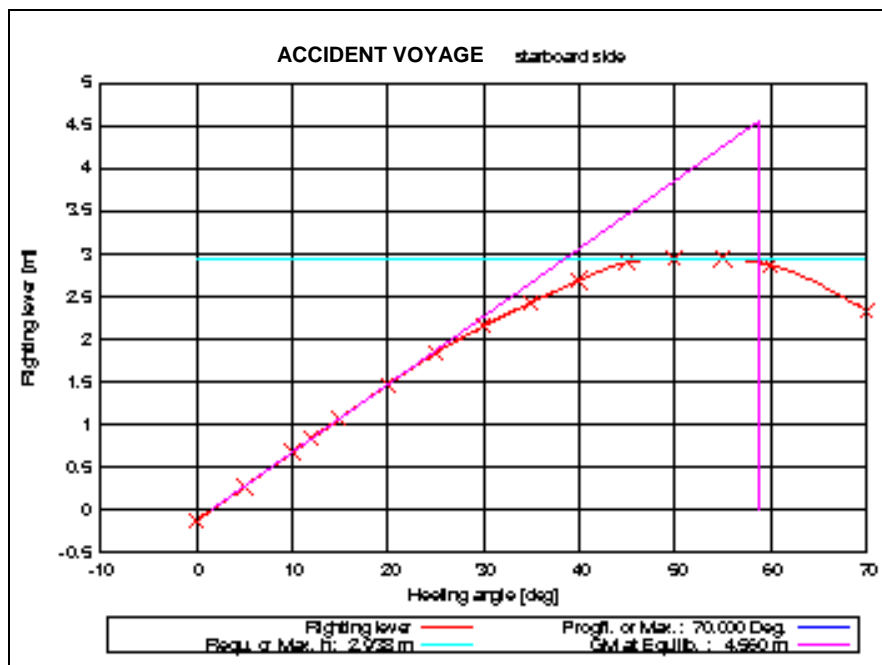
Figure 38: Righting lever curve for smooth water – FRISIA LISSABON

The righting lever curve for smooth water in the accident condition is more than sufficient.

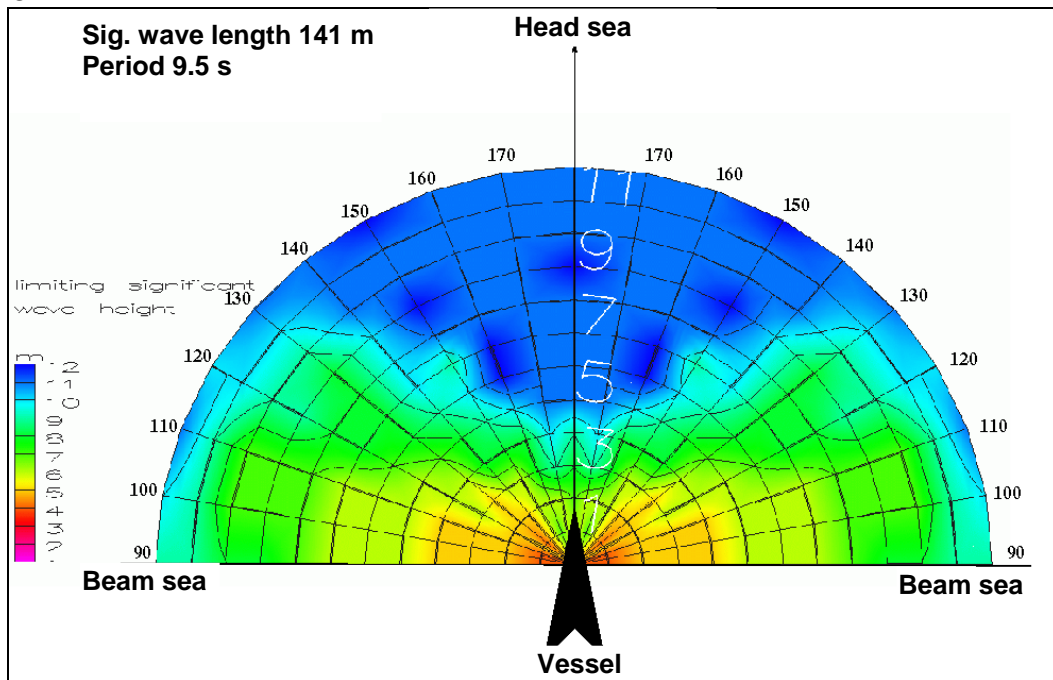
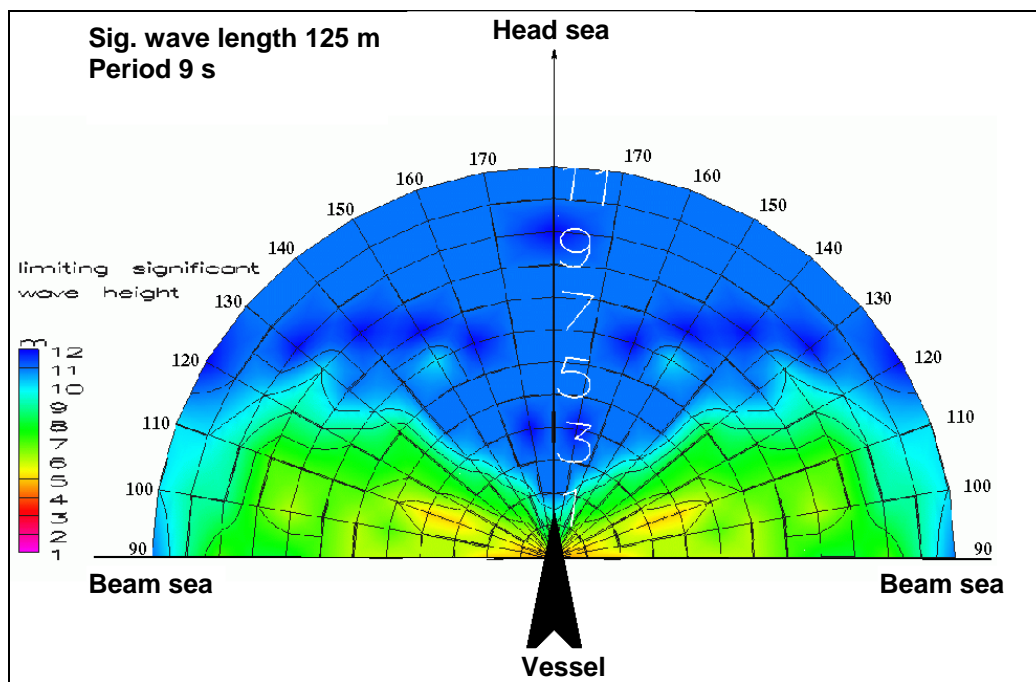
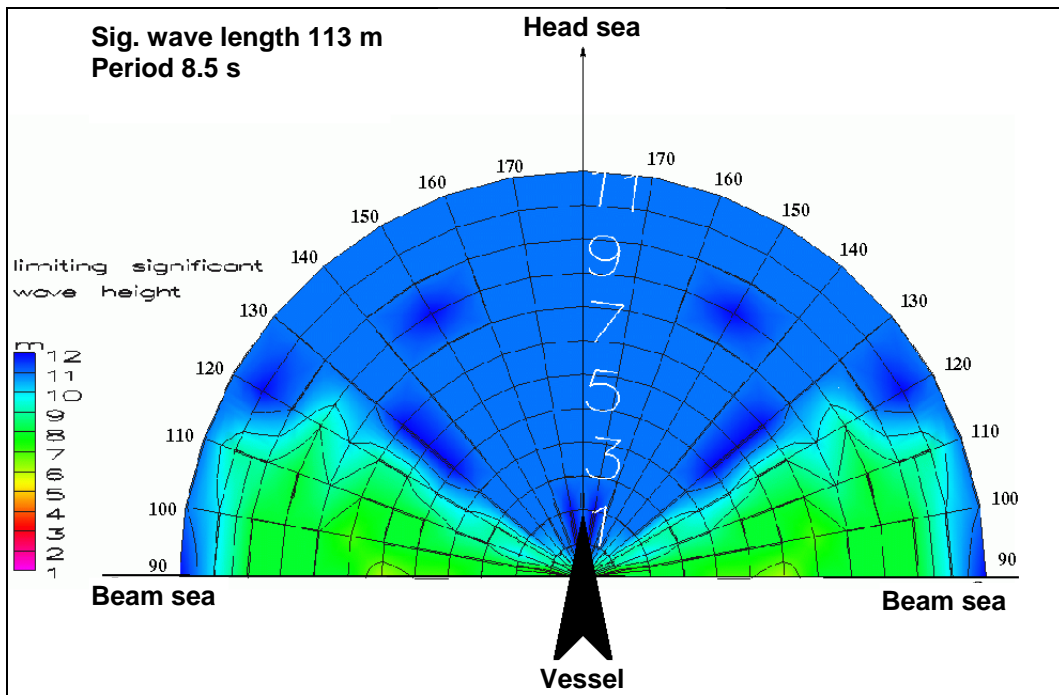
Certain parallels with the accidents involving the CCNI GUAYAS and the CHICAGO EXPRESS can be seen in the polar coordinate diagrams. Parametric rolling is not dominated and resonances are not visible, therefore, the cases are comparable. However, in the case of the FRISIA LISSABON a large angle range is present in which large roll angles do not occur with such long waves. The calculations fit very well with the statements. The accident occurred in a head sea at an encounter angle of 60°, which equates to an angle of 120° on the radial axis in the above polar coordinate diagram. However, it also reveals that the accident could have been avoided had the vessel been steered into the sea, which was not possible owing to the draught and fairway conditions leading up to the scene of the accident. Due to the high level of swell, the weather situation was worse than during the accidents off Hong Kong. The calculations relating to the FRISIA LISSABON show clearly that the rolling of the vessel could have been significantly minimised and the accident thus avoided if it had been possible to steer the vessel directly into the sea at a sufficient speed of about 5 kts. However, the data from the polar coordinate diagrams are not available in the required stability information on board since such calculations are not made in this regard. Accordingly, the crew had no knowledge of this information. The frequency distribution of the transverse acceleration on the bridge at a speed of 5 kts is shown on Figure 42 below.
