ATSB TRANSPORT SAFETY REPORT
Aviation Occurrence Investigation
AI-2009-008
Final

Reliability of Piper PA-31-350 aircraft engine turbocharger units

AI-2009-008, Reliability of Piper PA-31-350 aircraft engine turbocharger units

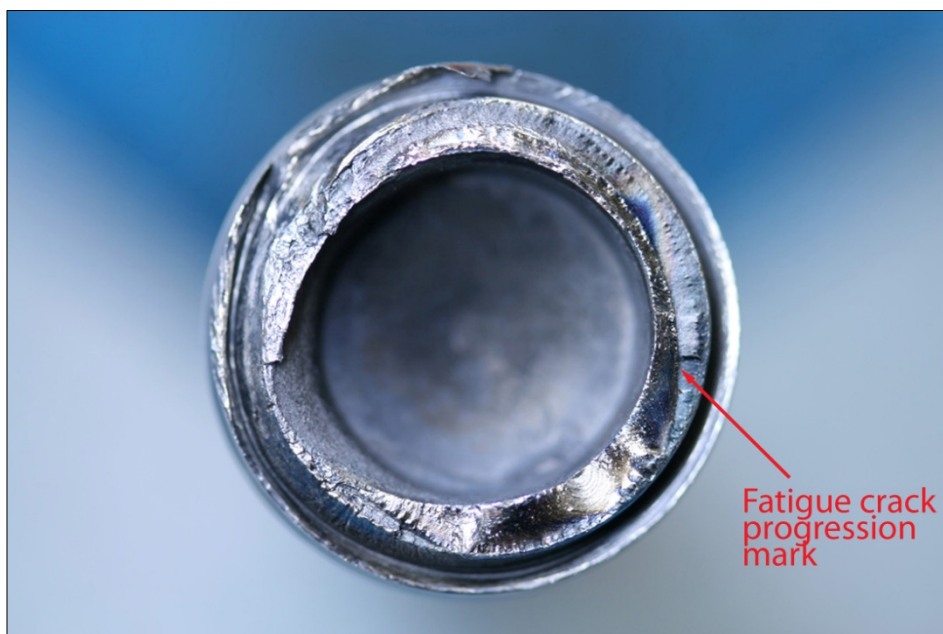
Figure 3: Fracture surface (shaft) of turbine wheel YEO30243.

The YEO30243 assembly fracture surfaces presented several chordwise, crescent-shaped features that were indicative of fatigue crack initiation and growth from an external surface origin (Figure 3).

Scanning Electron Microscopy (SEM) conducted on this region confirmed the presence of fatigue features, and the extensive damage to the surfaces in some areas.

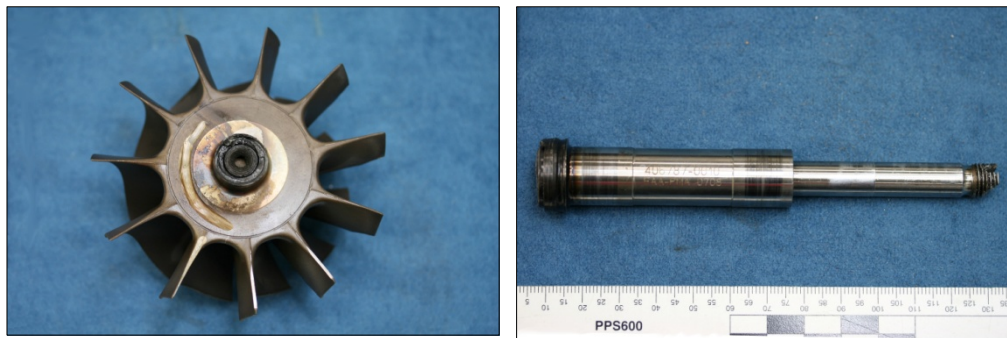
Figure 8: Failed turbine wheel/shaft ex turbocharger YEO30243

The turbine wheel had fractured from the shaft at a similar location on all three samples examined. The fracture was approximately 5 mm below the underside of the wheel (Figures 4 to 7).

In all cases, the fracture had occurred transverse to the principle axis of the shaft, at a location coincident with the bottom of the piston ring groove (Figures 2 and 3).

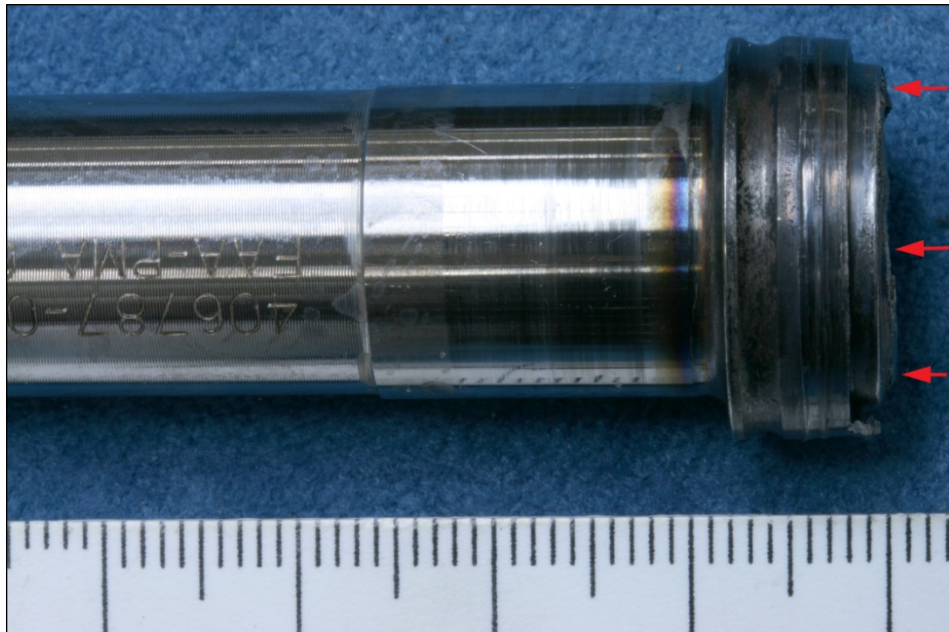
Figure 10: Magnified view of failed end of turbine shaft (YEO30243) showing location of fracture and turbine end journal bearing surface.

Some minor heat tint/discolouration was observed on the journal bearing surfaces. A dimensional evaluation of the bearing surfaces revealed them to be within the limits supplied in the overhaul manual. The CDN00747 shaft exhibited more circumferential scoring on the journal bearing surfaces, and a thick black oily residue on the central shaft. Again, this was considered to be a result of the longer time in service than the other two components.

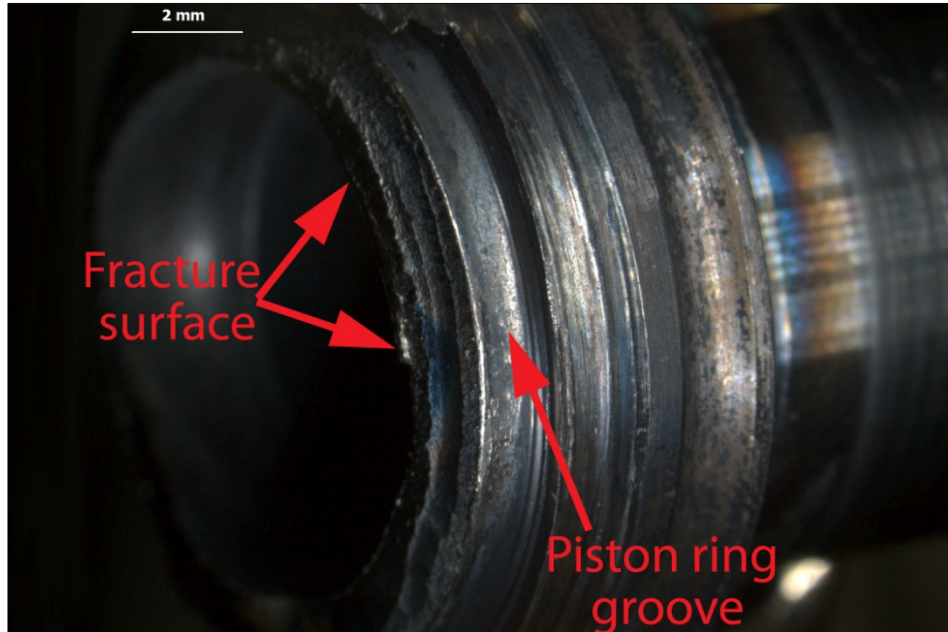
Figure 11: Side view of the turbine shaft fracture (YEO30243) showing location of failure with respect to the piston ring groove.

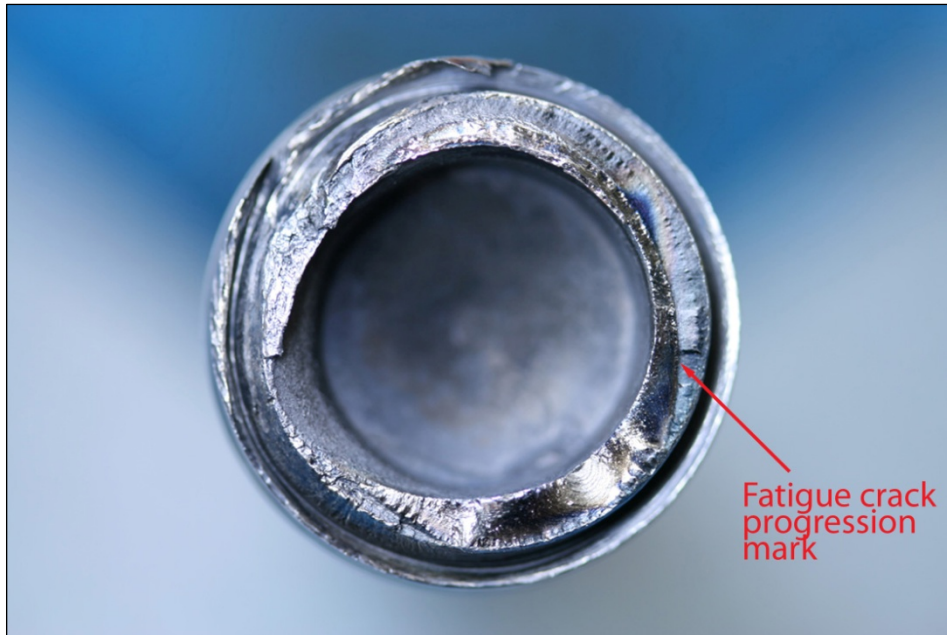
Figure 12: Turbine shaft fracture surface (YEO30243).

Following cleaning, several crescent shaped marks were observed extending radially across the fracture surface. These features were indicative of fatigue crack initiation and growth from the base of the external piston ring groove (Figures 8 and 9).

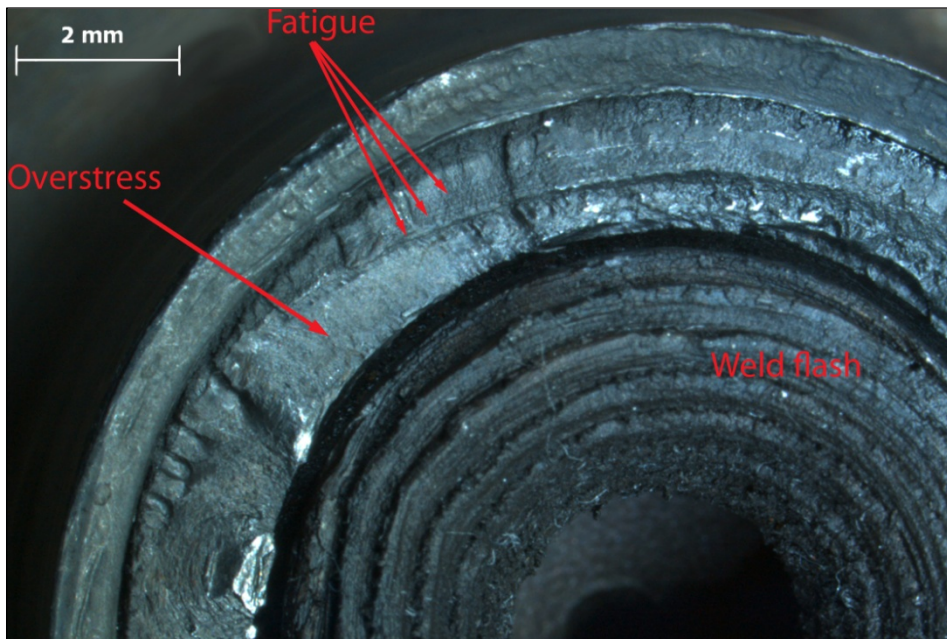
Figure 13: Magnified view of Figure 5 showing fatigue crack propagation features initiating from outer surface.

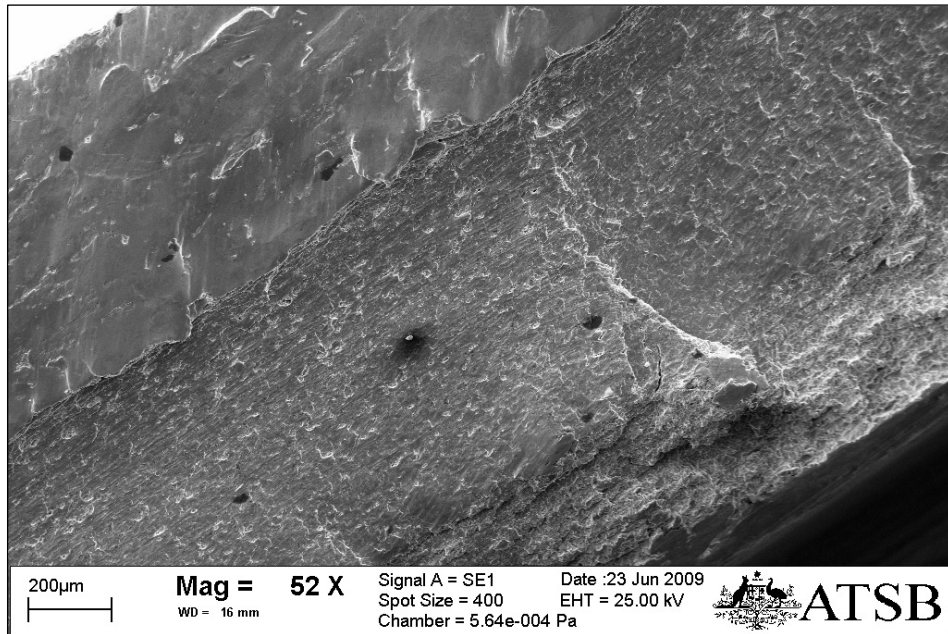
Scanning electron microscopy (SEM) confirmed the presence of a fracture surface demarcation between two distinct regions of failure mode (Figure 10). Closer examination towards the external surface revealed finer progression marks, consistent with fatigue crack growth.

Figure 14: SEM of shaft fracture (YEO30243) showing demarcation between surface areas.

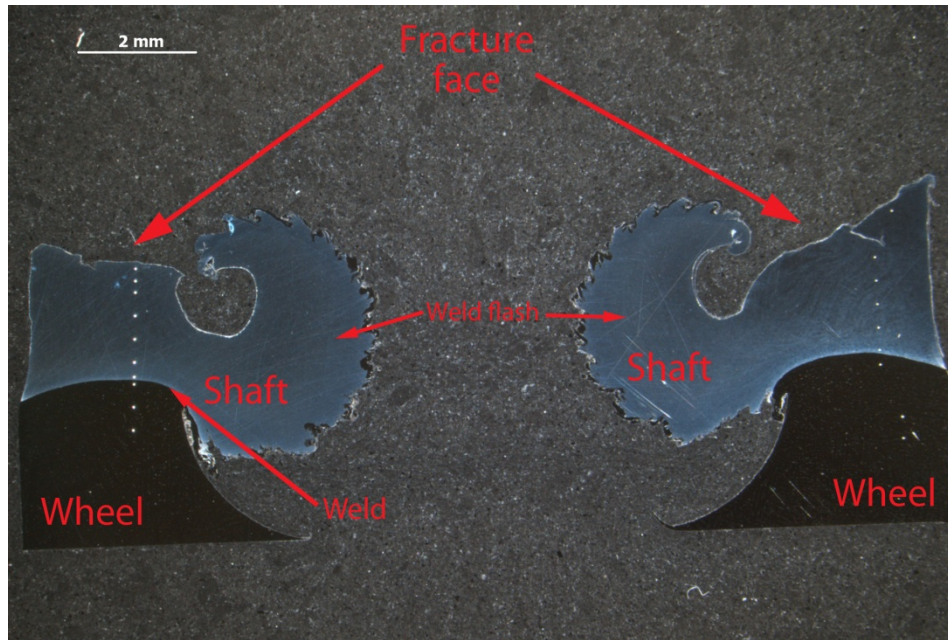
The sample was sectioned longitudinally to bisect the fracture face in the region of the fatigue origin. After metallographic preparation and etching, the fracture was observed approximately 2.5 mm axially from the weld line, on the shaft side (Figure 11). The fracture was coincident with the bottom of the piston ring groove on the side closest to the turbine wheel (Figure 12).

Figure 15: Wheel fracture face showing location of fracture with respect to the weld.

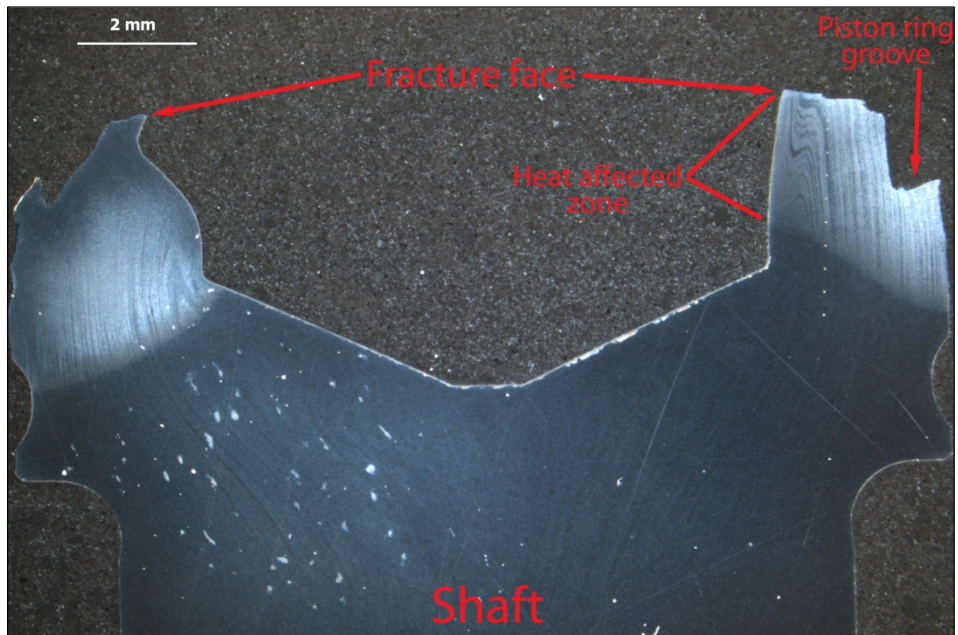
Figure 16: Shaft fracture face showing location of fracture with respect to piston ring groove.

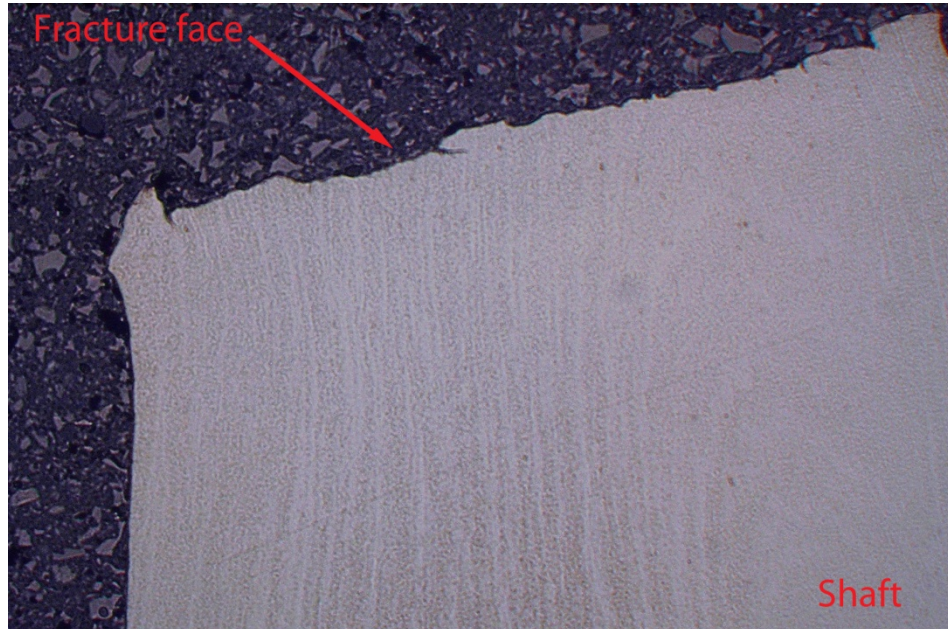
Figure 17: Shaft fracture surface micro.

The fracture face was generally smooth and flat across the sample, and presented a transgranular propagation path - consistent with a fatigue failure mechanism (Figure 13).

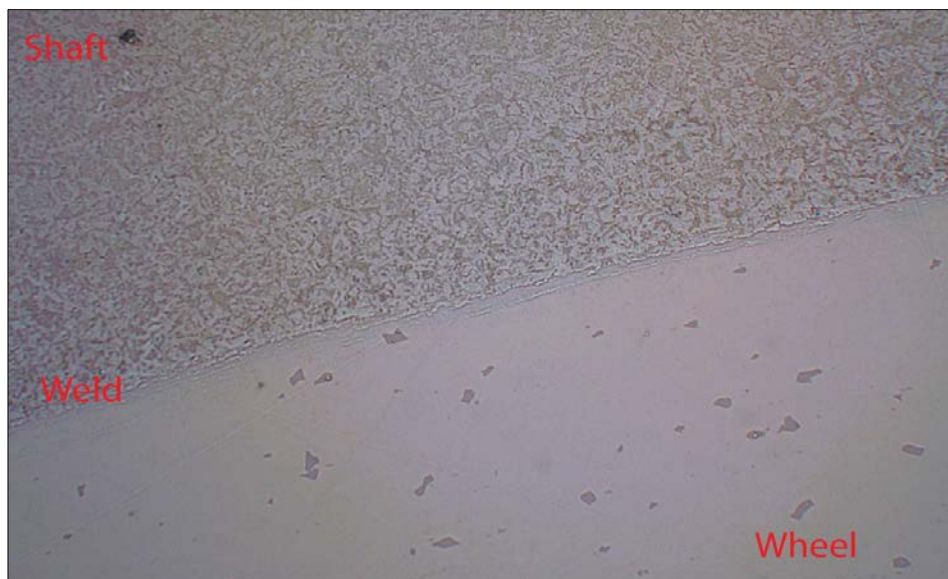
The weld fusion boundary appeared sound, with no evidence of incomplete fusion, inclusions or other deleterious features (Figure 14). The wheel bulk material exhibited finely distributed precipitates within a uniform matrix - consistent with the material type.

Figure 18: Shaft fracture face showing location of fracture with respect to piston ring groove.

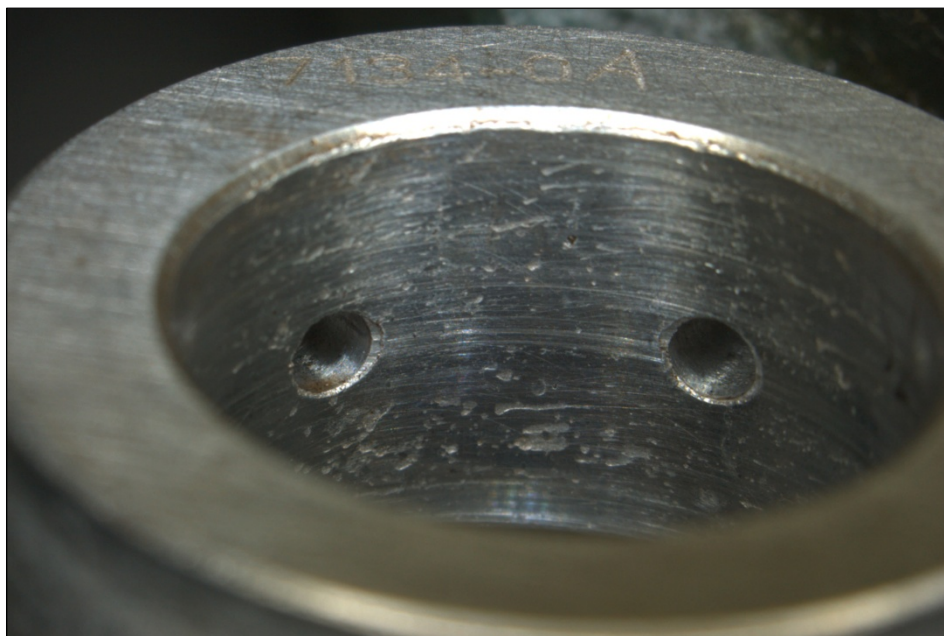
The bearings removed from YEO30243 appeared to be in relatively good condition. Evidence of circumferential scoring was noted on the external and internal surfaces, which appeared to be more severe on the compressor end bearing (Figure 16). The oil holes appeared free and clear, with evidence of the chamfered corners visible, suggesting the bearings had suffered little wear.

Figure 20: Internal surface of bearing showing scoring damage (YEO30243).

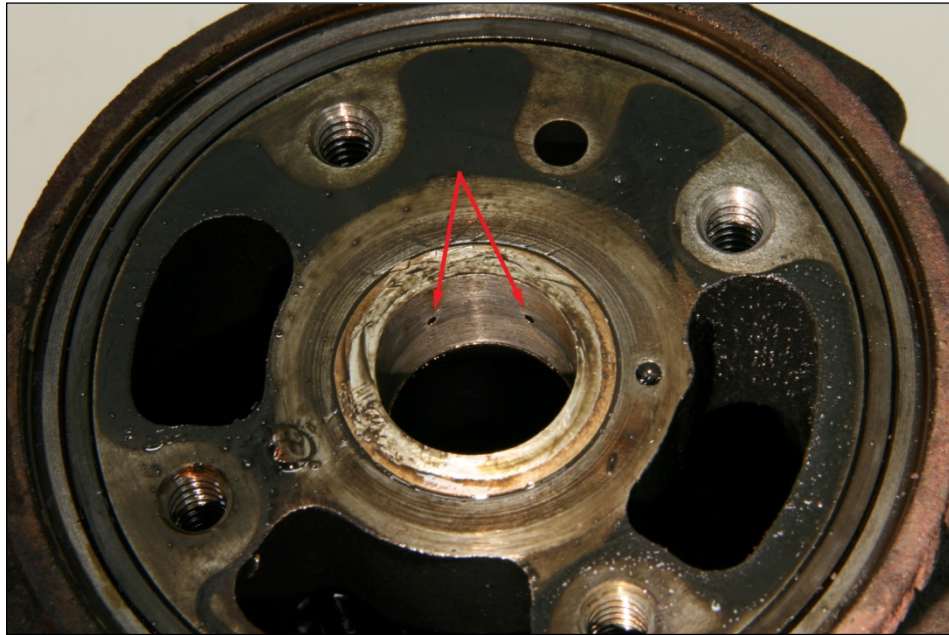
The compressor end bearing from CDN00747 exhibited significant wear and distortion of the internal diameter (Figure 17). The oil holes were significantly reduced in size on the internal surfaces – consistent with the effects of plastic deformation, metal flow and wear.

Figure 21: Compressor end bearing in-situ showing damage to the oil feed holes.
