Collision between freight trains 1901S and 5132S at Dry Creek, South Australia

11 October 2011

Publication Date: December 2011

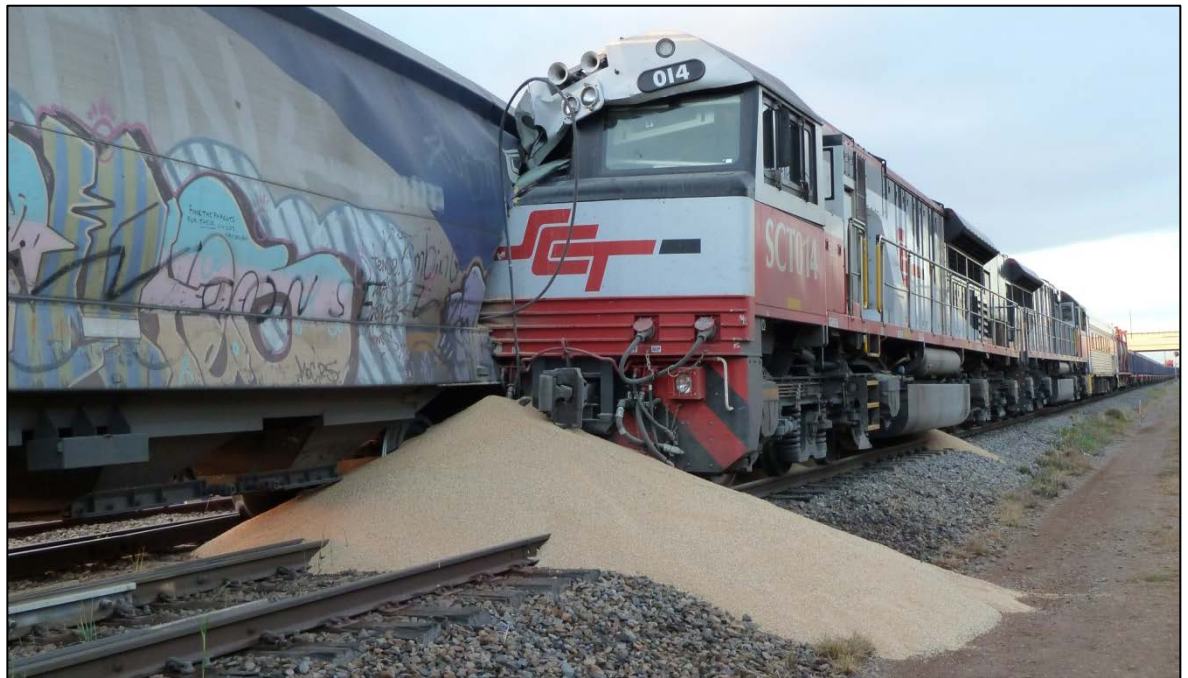
Figure 1: Leading locomotive of train 1910S post-collision with train 5132S

There was no injury to the train crews as a result of the collision. There was significant damage to the crew cab of the lead locomotive of train 1901S and to the grain wagons of train 5132S that were struck during the collision.

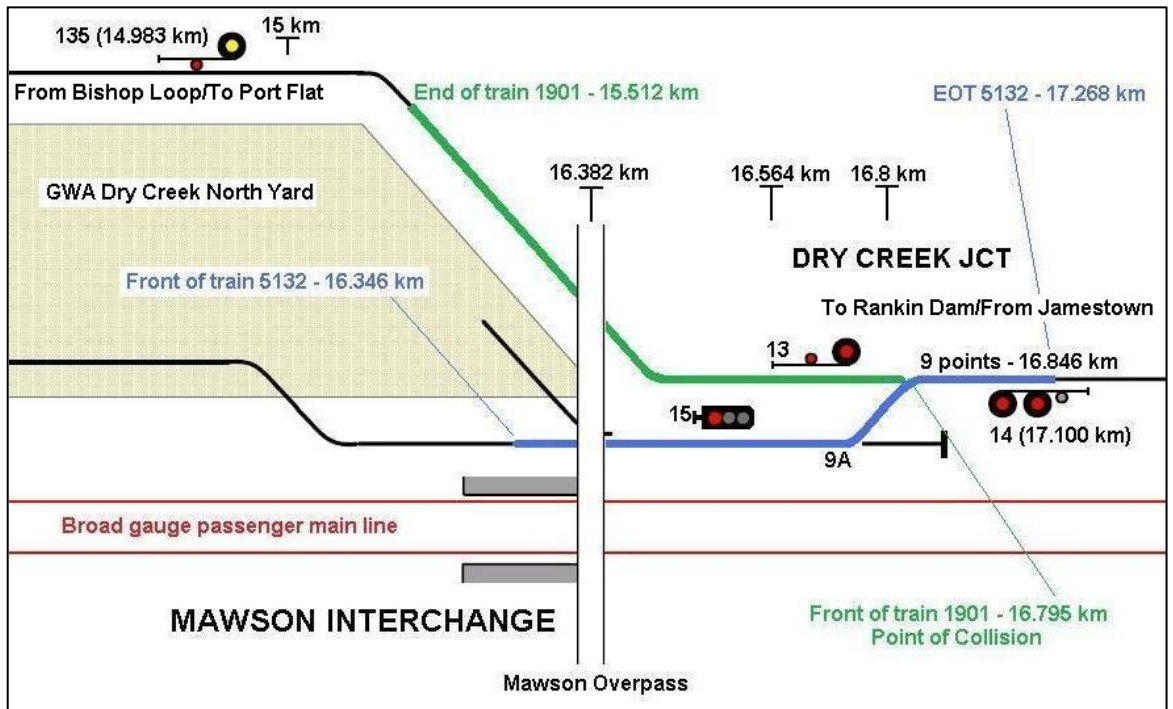
Figure 3: Incident site Dry Creek Junction

After entering the main line the train was accelerated to 60 km/h approaching signal 13 at Dry Creek Junction, the incident site (Figure 3). Signal 13 was displaying a red indication.

At approximately the same time, train 5132S, coming from Jamestown, was traversing the turnout at Dry Creek Junction at low speed, approximately 13 km/h, to enter the shunt main track that runs parallel to the main line. Approximately 22 wagons had cleared the fouling point with the remainder of the train occupying the main line.

Information obtained from the data logger of train 1901S shows that an emergency application of the train brake was made approximately 86 m prior to signal 13, however train 1901S proceeded past the stop signal at 59 km/h travelling a further 231 m before colliding at approximately 22 km/h with train 5132S. As a consequence of the collision, train 1901S separated in two locations.
