Foundering of the general cargo ship *Tycoon* at Christmas Island 8 January 2012

Abstract

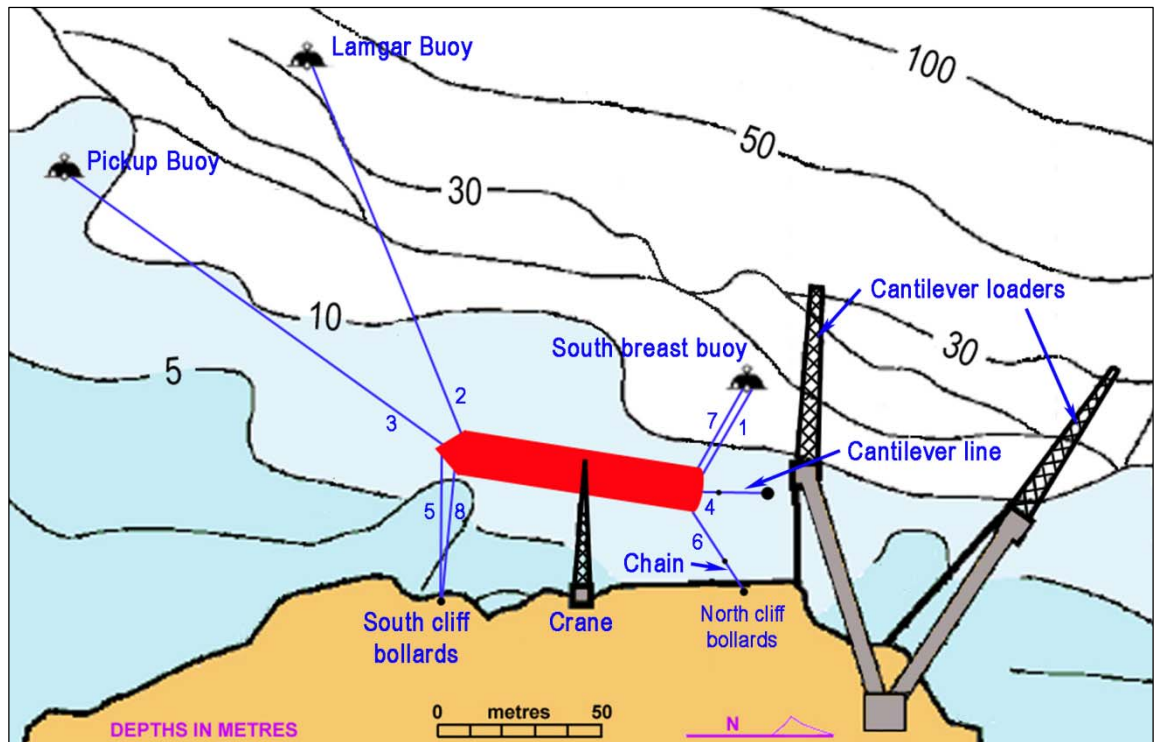
Figure 3: *Tycoon's* mooring arrangement at the inner moorings

At 0645³, the Christmas Island pilot boarded *Tycoon* and at 0715, the first of the ship's stern lines was run to the south breast buoy (Line 1 in figure 3). Ship's lines were then connected to the lamgar buoy⁴ (2), the pickup buoy (3) and the cantilever line (4). A forward ship's line was run to the south cliff bollards (5). A ship's line was then connected to the north cliff chain (6), followed by another stern line to the south breast buoy (7).

At about 0420, the cantilever line (4) came free at its anchor chain connection. The master was advised and the crew on the after deck recovered the ship's line and the cantilever line using the aft centre-line mooring winch.

At about 0615, one of *Tycoon's* aft starboard breast lines to the south breast buoy parted. As a result, the one remaining aft starboard breast line began to take the increased strain and the ship started to move ahead and towards the rock-face and crane pylon. The wind was now west-south-westerly at 13 knots and the sea was 4 m on a 1.9 m west-north-westerly swell.

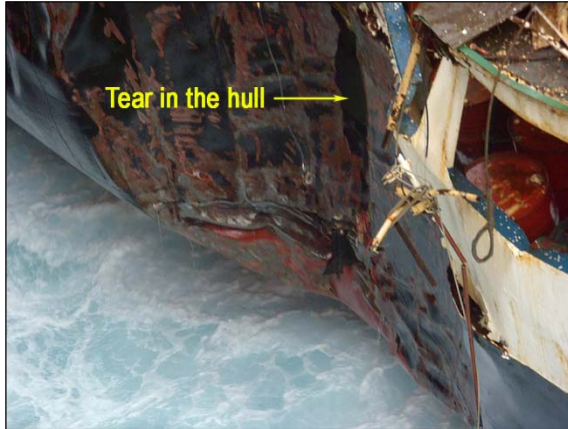
Figure 4: Tear in hull

While the line was being run, the ship was continually pounded against the rock-face and crane pylon and, at about 0820, a 1 m vertical tear could be seen in the port side of the ship's hull in way of the engine room (Figure 4).

At about 0843, the tear in the ship's hull in way of the engine room had grown to about 2 m in length and had opened up to about 0.5 m in width. The engine room was now taking on water.

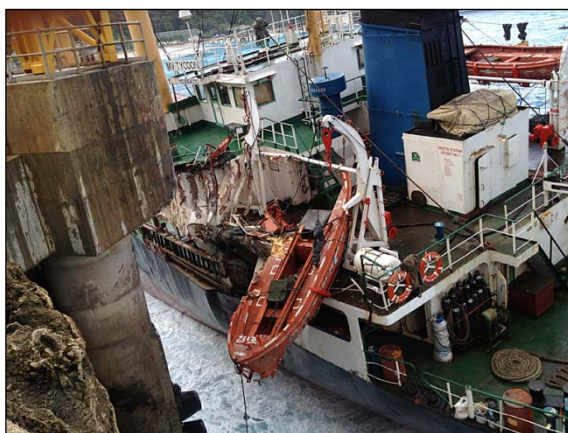
Figure 5: Damage to port side of ship

By this time, the ship had suffered severe damage to the port side of the accommodation. The port lifeboat had been smashed and was hanging from its davits (Figure 5).

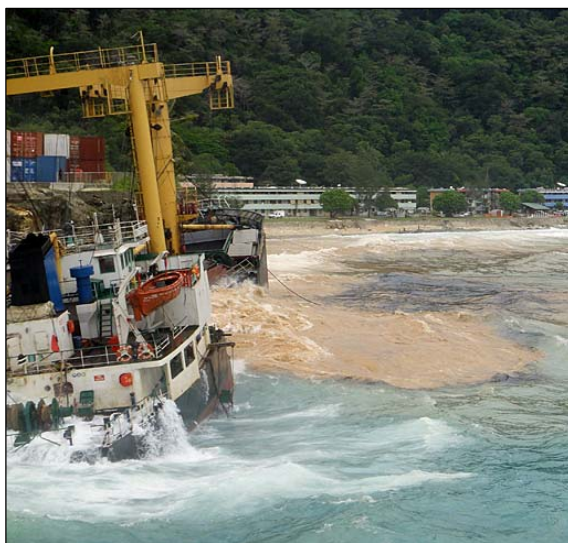
Figure 7: Failure of ship's hull at number 2 hold

At about 1100 on 9 January, the ship suffered a catastrophic failure of its hull in way of number two hold. The starboard side of the hold collapsed inward exposing the contents of the hold to the sea (Figure 7). Damage to the hull in way of the engine room had also allowed oil and other pollutants to be washed into the sea.

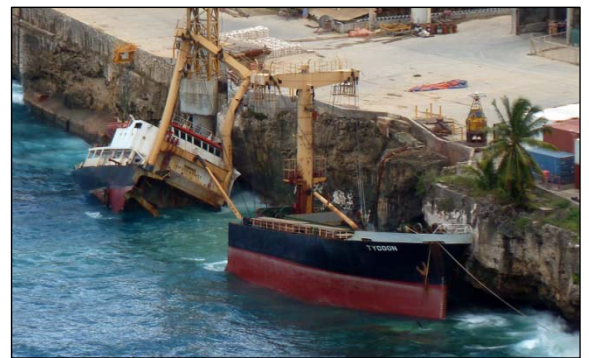
Figure 8: Tycoon awaiting salvage

At the time this preliminary report was released, the ship remained lying against the rock-face and crane pylon awaiting salvage/removal (Figure 8).
