Australian Transport Safety Bureau

Rare software glitch causes sudden pitch down

Aviation Safety Investigator

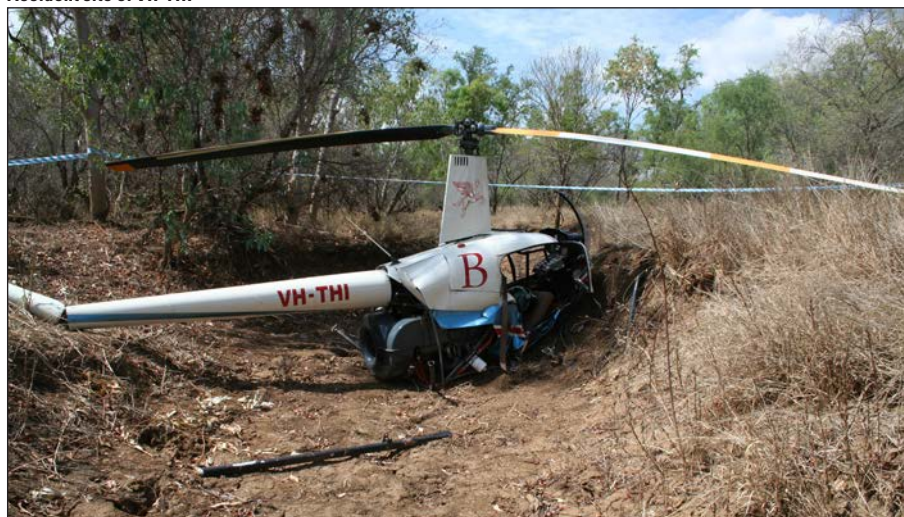
Accident site of VH-THI

The ATSB's investigation found that the helicopter's engine had stopped while operating at low altitude. The cause of the engine stoppage was most likely due to fuel exhaustion, which happens when there is insufficient useable fuel to supply the engine.

To maximise the performance of the R22 during mustering, the station's pilots generally minimised the helicopter's weight by only uplifting enough fuel for the expected duration of the flight. If the pilot took off with less than a full tank of fuel he may have thought that there was more fuel on board the helicopter than was actually the case.

On the day of the accident, neither the fuel uplifted and consumed, nor the flight time was formally recorded by the station pilots.

The ATSB urges all pilots and operators to review their fuel management practices and procedures to ensure they are effective, consistent and reliable.

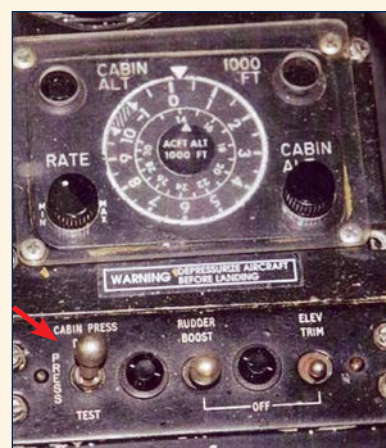
Unrecognised hypoxia in an unpressurised cabin continues to pose a serious safety threat. In many cases, pilots have either not noticed existing visual warning systems, or those systems failed to operate correctly.

Typical King Air C90 cabin pressurisation controller with adjacent three-position cabin pressure control switch indicated by arrow

The Australian Transport Safety Bureau has reinforced its call for operators of single-pilot, turbine-powered, pressurised aircraft to consider installing an aural cabin altitude pressure warning system that operates separately from their aircraft's visual warning system.

Audible warning systems provide a voice prompt warning through the aircraft's cockpit speakers and the pilot's headset. Considering the potential outcome if an aircraft's existing visual depressurisation warning is missed, or fails to operate, an additional and independent warning system could prove invaluable.

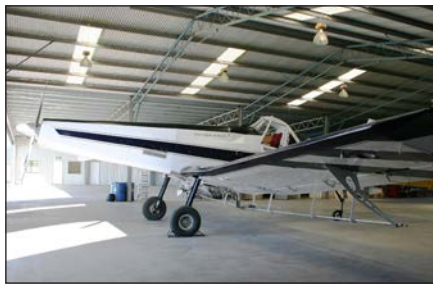
Investigation AO-2008-084

On 29 December 2008 the pilot of a PZL-M18A Dromader aircraft was conducting agricultural spraying near Nyngan NSW. Witnesses reported seeing something detach from the aircraft before it rolled and crashed into the ground. The pilot was killed in the accident. The ATSB's investigation found that during the flight a 1.8 metre section of the aircraft's right wing had detached from the aircraft.

While not directly related to the in-flight breakup the ATSB also identified that a number of operators of PZL-M18 Dromader aircraft were not calculating the correct flying hours when the take-off weight was over 4,700 kilograms.

That resulted in the overestimation of those aircrafts' remaining service life and meant that it could not be assured that they were being operated within their safe service life.

- the operator examined its fleet and retrospectively applied the correct service life factors and adjusted their processes to apply correct service life factors to all future flights
- CASA contacted operators of M18 Dromader aircraft to ensure that procedures are in place to record aircraft time-in-service for overweight operations and that overweight flight time is factored into the calculation of Dromader airframe service life.
