Australian Transport Safety Bureau

# The Australian

# Aviation Safety Investigator

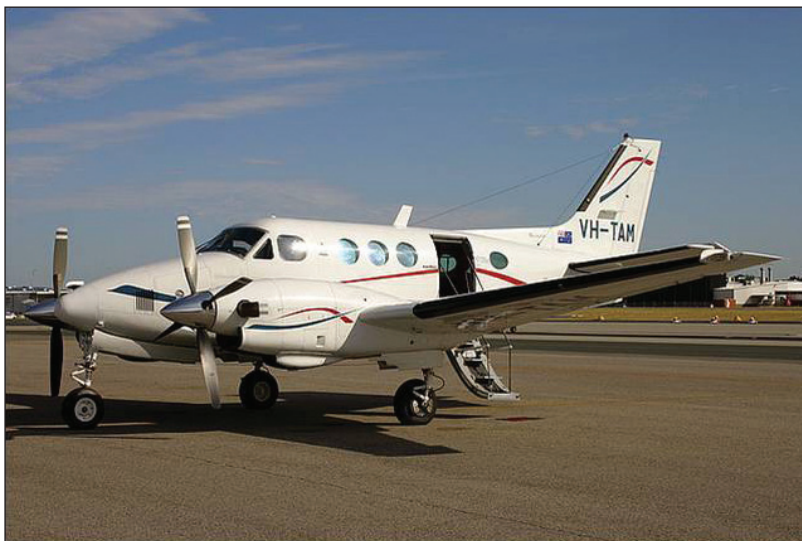
The incident occurred on 16 July, 2009, when the pilot of a Beechcraft King Air C90, registered VH-TAM, departed Perth Airport on a flight to Wiluna, Western Australia, carrying one passenger. Unbeknownst to the pilot, however, the left landing gear squat switch was operating only intermittently. As a result, the aircraft was prevented from pressurising in flight. To

make matters worse, the cabin altitude warning system was not operating, thanks to the incorrect connection of the switch wiring during previous maintenance.

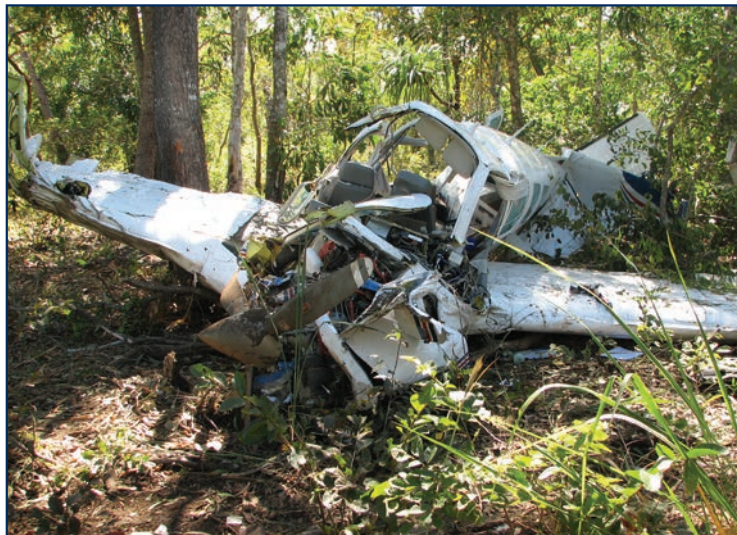
The ATSB investigation assessed the aircraft as being intact prior to the impact with terrain. The investigators did not identify any anomaly that could have affected its normal operation. However, data recovered from an onboard engine data recording system was consistent with

an interruption of the fuel flow, and the loss of engine power about 42 seconds before impact.

The aircraft had been equipped with four fuel tanks, two main tanks (one in each wing), and one tip tank in each wing, with the use of the tip tanks restricted to level flight only. There was evidence from the wreckage that there had been sufficient fuel in each of the main tanks. The pilot had a written fuel log indicating the left tip tank had been selected on reaching cruise altitude, and the right tip tank selected when the left tip tank was nearly empty. It is likely that the pilot omitted to select a main tank before descending from cruise altitude, and the right tip tank ran dry at a low altitude with insufficient time available to restore fuel supply to the engine.

Accident site and surrounds of the Beechcraft A36 Bonanza

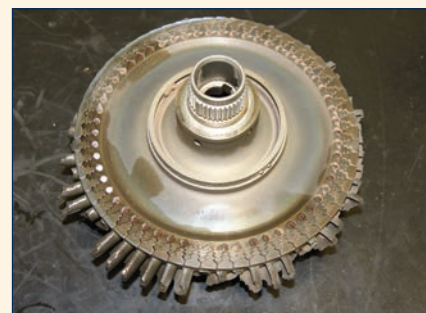
The ATSB investigation found that the failure of the Pratt & Whitney PT6A-114 engine had probably been precipitated by fracture of the compressor turbine blades. Separation of the hot section revealed significant damage to the compressor turbine rotor assemble. All of the blades were fractured through the airfoil section; the majority of them close to the blade platform. Many of the blade sections exhibited the

Compressor turbine rotor assembly

deformation, cracks and nicks associated with impacting circulating blade debris. The compressor turbine shroud and vane ring had also sustained extensive impact damage and gouging.

The FAA parts manufacturing approval information indicated that part number T-102401-01 compressor turbine blades that had been installed in the engine during the most recent overhaul were not approved for the PT6A-114 model. A review of the operating parameters indicated that PT6A engine variants not approved for installation of the T-102401-01 blades typically exhibit maximum operating temperatures higher than the other engine variants that were approved from the PMA blades.

CASA recommended that operators and maintainers of PT6A check their engine maintenance logs to ensure that the compressor turbine blade part number(s) installed are correct for the engine variant according to FAA PMA approval information. ■
