Final Report of the Investigation into
the anomaly of the HyShot Rocket at
Woomera,
South Australia on 30 October 2001.

Neville McMartin
Senior Transport Safety Investigator
Australian Transport Safety Bureau
18 June 2002

TECHNICAL ANALYSIS REPORT No: 08/02

*Examination of launch vehicle debris
from the HyShot ‘Scramjet’ Flight
Program*

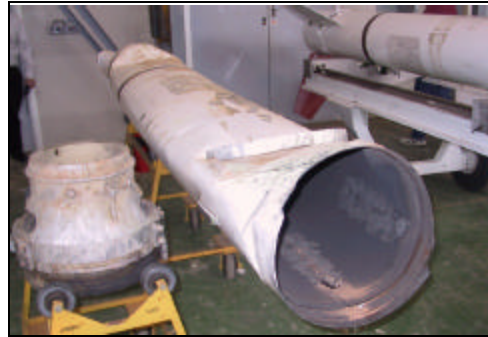
The first stage booster was recovered from within its designated impact area.

FIGURE 2.
Recovered first stage alongside the adaptor and the assembled unused first stage.

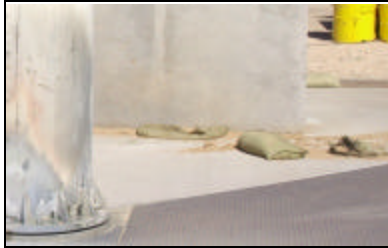
FIGURE 4.
A number of sandbags adjacent to the launch rail pedestal and blast wall, after the launch. Source: ARDU

That would have required a sandbag or rock to have been deflected off the infrastructure and impact a fin.

- d) suitability of the use of sandbags at the base of the launcher pedestal, in lieu of the specified grouting.
- 2) That SLASO require all Australian launch operators to submit a comprehensive risk hazard analysis for independent verification prior to the issuing of a licence, permit or exemption certificate.

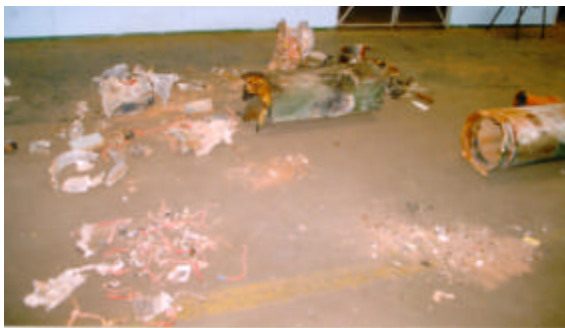
As a result of the extreme forces associated with the high velocity ground impact, the scramjet payload was extensively fragmented (figure 8). Reports from the recovery personnel indicated that a small grass fire had started following the impact and evidence of this was found amongst the payload debris. There was no evidence to suggest that this fire had originated during the flight. Fragments of the vehicle nosecone were recovered with the payload – indicating that nosecone ejection did not occur in-flight (figure 9). Both scramjet exhaust port covers (‘muffs’) were also found with the nosecone debris (figure 10). The level of fragmentation and damage to the payload and support structures prevented any meaningful examination of the scramjet mounting security or other features of relevance.

Fig. 8 (top L). Debris and remnants of the HyShot scramjet payload and Orion motor casing.

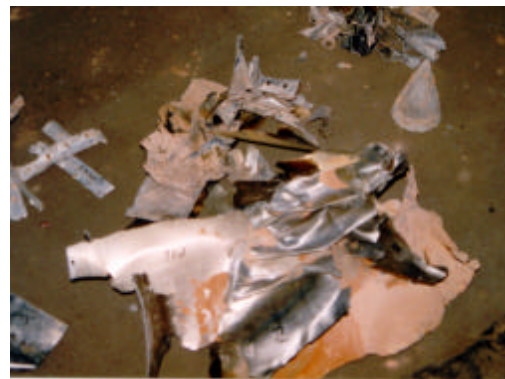
Fig. 9 (top R). Remnants of the vehicle nosecone structure.

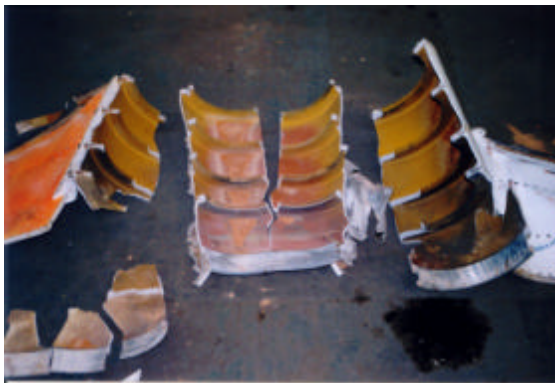
Fig. 13. Multiple longitudinal fractures within the tail can – typical of sideways impact.

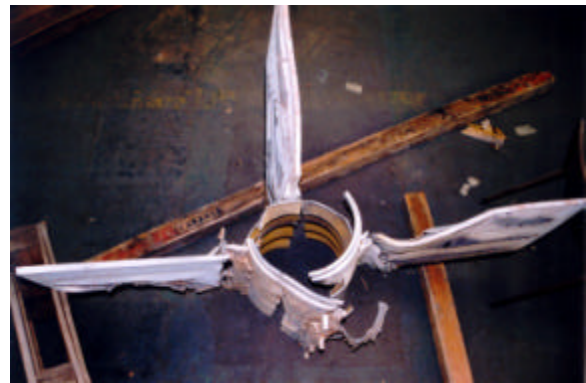
Fig. 14. Re-assembled sections of the tail can, showing the orientation and positions of the recovered fins.

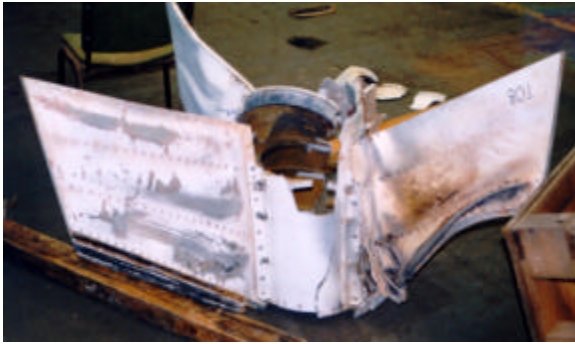
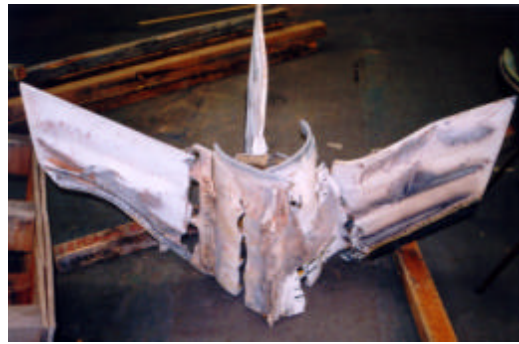
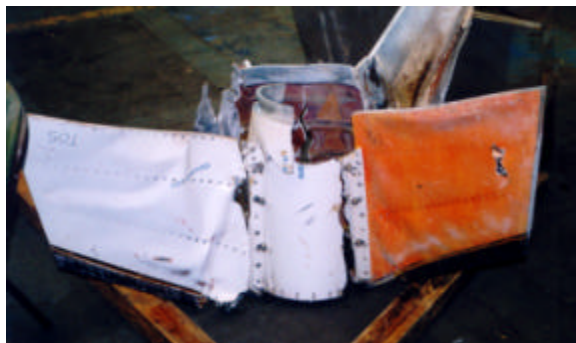
Figs. 15, 16 & 17 (below left).

Reconstruction of the Orion tail can and fins as recovered, showing the aerodynamic heating effects and the variation in these effects around the vehicle.

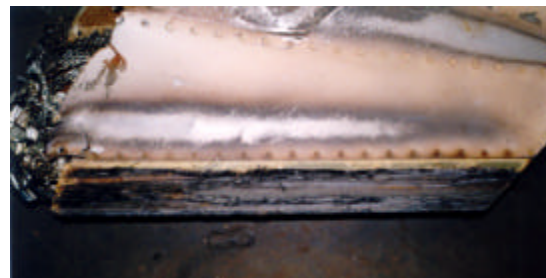
Fig. 18. Bands of heating behind the leading edge of an Orion fin.

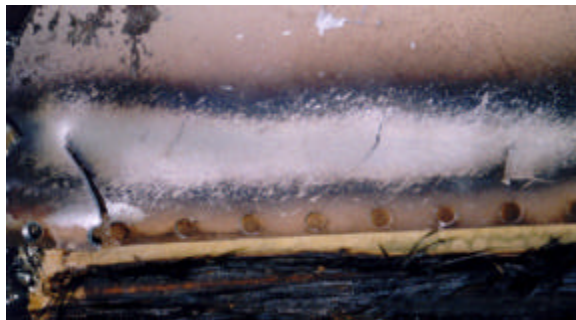
Fig. 19. Closer view of the heated area, showing the development of transverse cracking.

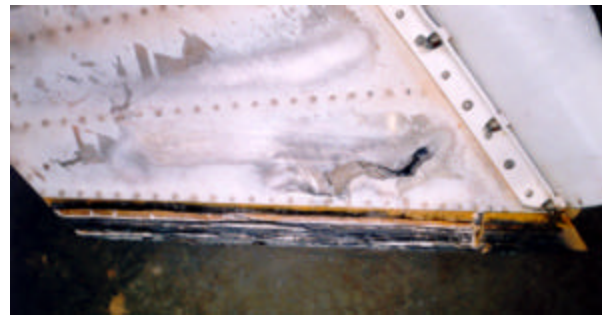
Fig. 20. Area of skin burn-through, with associated thermal damage to the internal honeycomb structure.

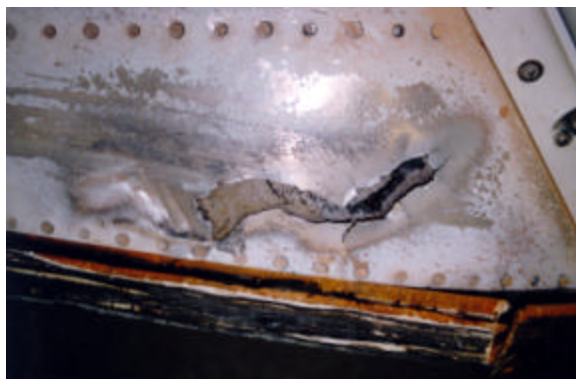
Fig. 21. Closer view of the burn-through area shown in figure 16.

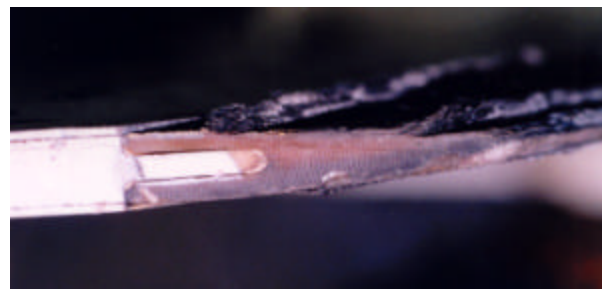
The composite leading edge shroud was found intact on the two fins facing the cooler side of the Orion tail section and showed further evidence of the differential heating between the surfaces of the fins. Both shrouds examined showed marked differences in the appearance of the ablated material from side to side. The cooler faces of the shrouds tended to show a smoother, less disrupted surface, whereas the warmer faces had sustained a greater level of charring and delamination (figure 22).

Fig. 22. Edge of the phenolic leading edge shroud, showing differences in the surface appearance from side to side.

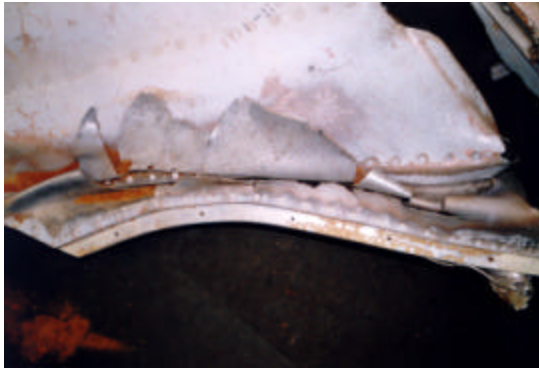
Despite the loss of the leading edge shroud from the third remaining fin, the underlying strip had not sustained any notable thermal damage, even though the material back from the leading edge showed the effects of severe heating (figure 23). The immediate tip of the leading edge strip was well preserved, despite appreciable melting and metal-loss from the skin and structure behind (figure 24). In comparison, the tip of the leading edge strip from the adjacent (missing) fin showed extensive melting and ablation of the tip and the structure immediately behind the tip (figure 25). Separation and partial exfoliation of the wrought section was evident, with the edges deflecting away from the ‘hot’ side of the vehicle (figure 26). Deposits on the tail can surface immediately behind the melted edges clearly depicted the molten, oxidised material streaming backward (figure 27).

Fig. 23. Fin leading edge strip. Showing no thermal damage, despite the obvious damage to the skin behind.

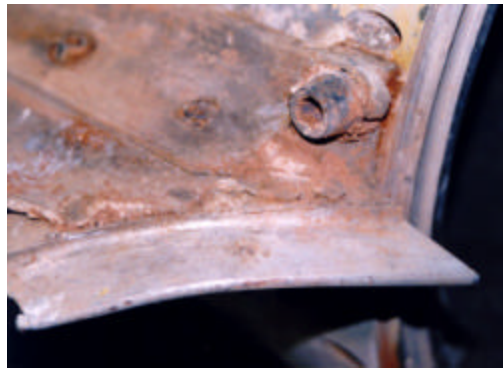
Fig. 24. Tip of the leading edge strip shown in figure 23. No evidence of thermal damage, although the skin behind is partially melted and eroded.

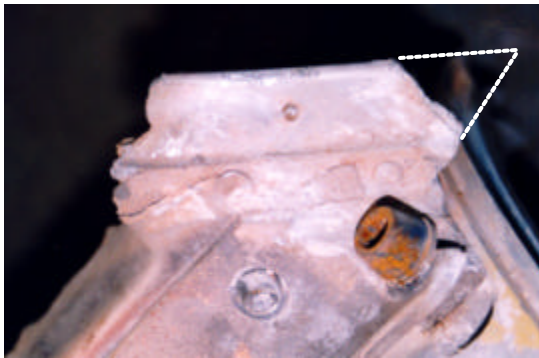
Fig. 25 (above left). Melting and metal loss from the leading edge tip on the missing fin. The skin and surfaces immediately behind also show metal loss.

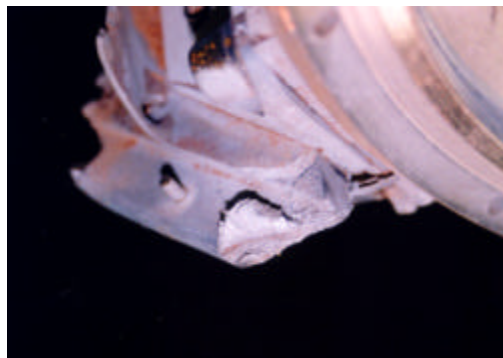
Fig. 26 (above right). View from the opposite side, showing the exfoliation effects and backward distortion of the tip material.

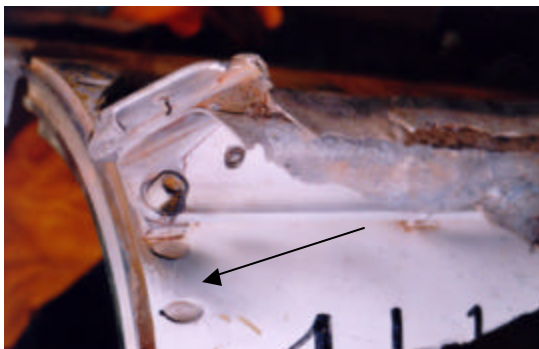
Fig. 27 (left). Flow patterns on the tail can surfaces from the molten, oxidised material streaming backwards.

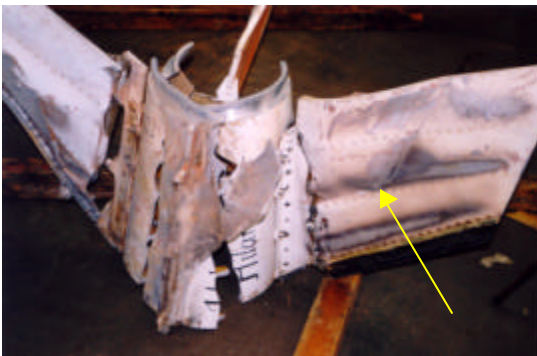
One of the Orion fin surfaces appeared to show witness marks to the impact with another component. The affected fin (facing the location of the missing fin) bore an angular impact mark that could be clearly attributed to forceful contact with the outer leading edge corner of the missing fin (figures 28 & 29). Contact marks at the corner showed an impression of the leading edge strip, which suggested the loss of the protective shroud (figure 30). Also evident were several impressions from rivet heads along the fin tip. The fin surfaces in the impact area showed a uniform band of aerodynamic heating, with the characteristic discoloured, flaking paint. Close examination showed that this heating had occurred before the impact, as much of the flaking paint had been removed and the exposed edges remained bright and unaffected. Had the impact occurred before the heating, thermal damage to the exposed metal edges and a less uniform heating pattern would have been expected.

Fig. 28 (top left). Re-assembled tail can and fins, showing the orientation between the missing fin and the impact mark on an adjacent fin (arrowed).

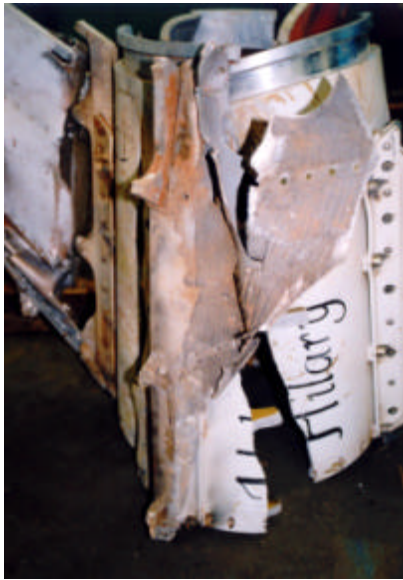
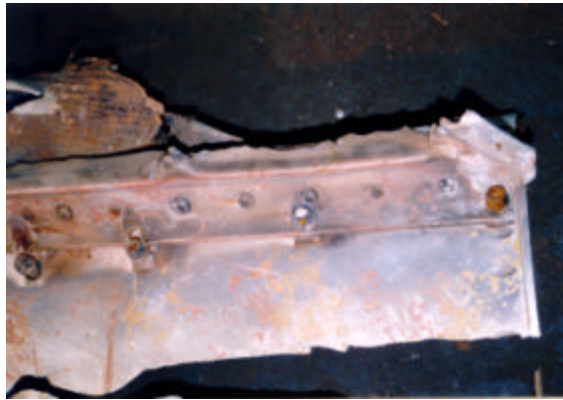
The fractures and tearing within the structure and skin at the attachment point of the missing Orion fin showed evidence of failure under bending towards the adjacent (impacted) fin. Remnants of torn skin remained attached on the surface facing the adjacent fin, whereas the skin on the opposite side had predominantly failed along the base of the mounting flange (figure 31). Further evidence of severe aerodynamic heating was found on the skin and structure surrounding the fin, with the skin fracture surfaces showing the effects of the irregular, thermally induced cracking that characterised some of the other heated areas (figure 32).

Figs. 31 (left) & 32 (above). Failure of the surface skin from the missing fin. Note the differences between the heavily heated side (above) and the opposite side (left).

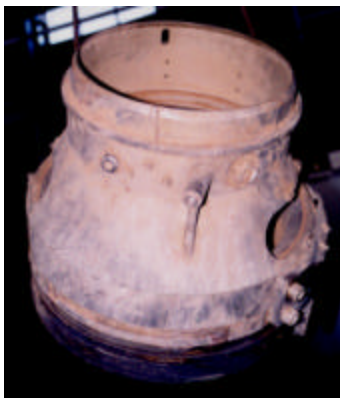
Fig. 33 (left). Terrier – Orion adaptor showing the abrasion damage over the external surfaces produced during ground impact.

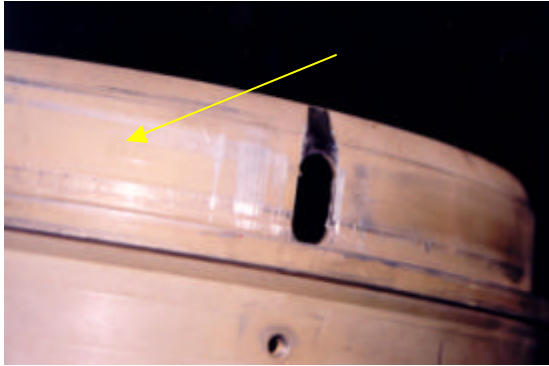
Fig. 35. Orion coupling area – note the missing key and the bands of axial scuffing. The angular band (arrowed) is indicative of misaligned vehicle separation.

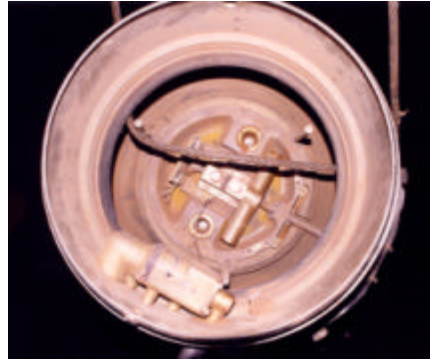
The adaptor surfaces (both inside, [figure 36] and out) showed no evidence of combustion products that may have indicated either a leakage from around the ignition assembly, or proximity to the Orion vehicle when the second-stage burn commenced.

Fig. 36. Internals of the adapter unit, showing the ignition mechanism. All surfaces were free from combustion products.

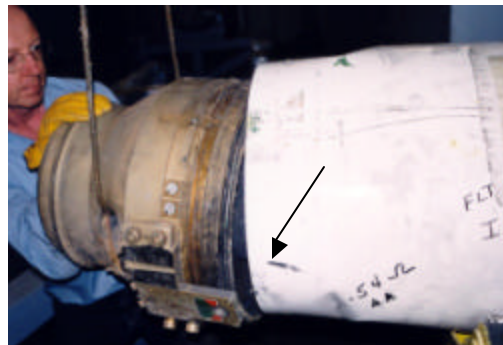
Fig. 38 (top right). Adapter unit, showing interconnection with the Terrier casing. The small bleed of combustion products (fig 39) is arrowed.

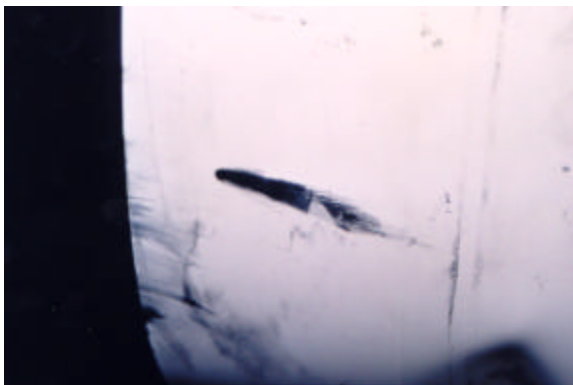
Fig. 39 (left). Small bleed of combustion products from a vent hole designed to allow the escape of o-ring bypass gasses.

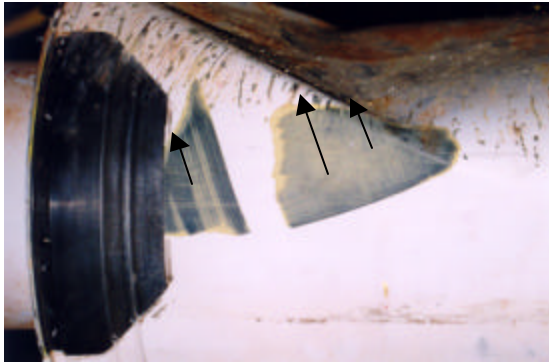
The base of the Terrier motor body displayed two angled abrasion marks that were witness to a glancing impact with one of the Nike fins (figure 40). The orientation and edge definition of the marks indicated an angled, downward movement of the fin when it struck the motor body. The undamaged area between the two marks also matched with the recessed area beneath the forward end of the fin rib (at the Nike fin incidence setting point, figure 41).

Fig. 40. Nike fin impact mark with the side of the Terrier motor casing. The direction of the impact is shown.

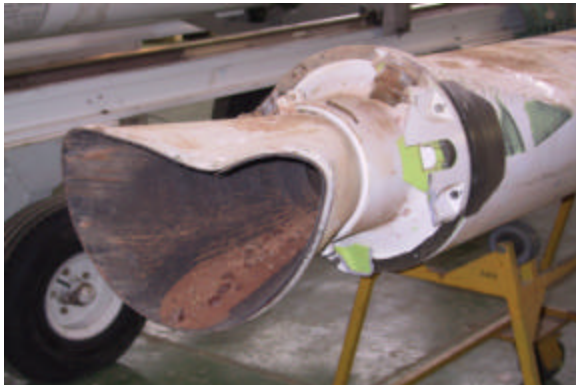
Fig. 42 (left). Terrier motor base with the remnants of the fin support structure in place.

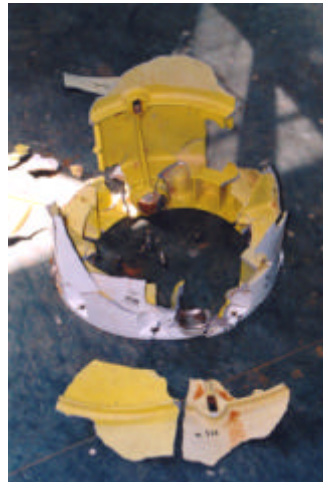
The Terrier booster vehicle fins were carried by a cast tail can structure affixed to the base of the motor body. The central spar of each fin engaged into a socket within the tail can and was secured by a single circlip around the outer socket diameter. Following the flight, fragments of the Terrier tail can were recovered over a path oriented with the approximate track of the vehicle before ground impact. The only structure remaining with the motor body was some of the mounting points where the tail can bolted to the motor base (figure 42). Re-assembly of the recovered fragments from the tail can illustrated the degree of disruption (figure 43), with all four fin sockets broken apart. All fracture surfaces presented a typically brittle appearance that were consistent with the component failing under gross overload conditions.

Fig. 43 (right). Partially reconstructed fin support structure, showing the level of breakup.

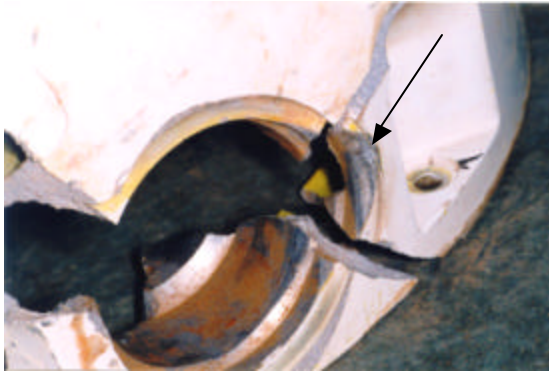
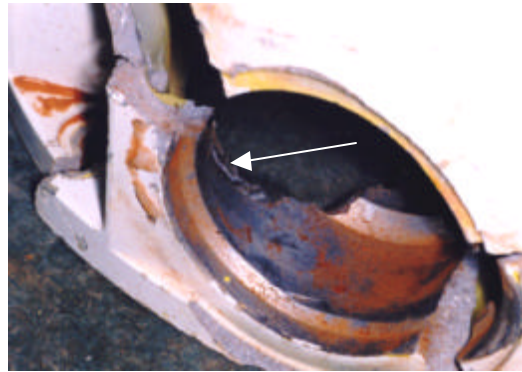
Inspection of the failed fin sockets showed evidence of breakage under angular bending loads from the fin spindles. Diagonally opposing areas of distortion and indentation within the sockets (figures 44 & 45) matched with semicircular score marks on the fin spindles (figure 46) and provided good evidence that bending loads from the Nike fins contributed to the failure of the tail can structure. The examination did not find any evidence of material or manufacturing defects within the recovered tail can sections.

Figs. 44 & 45 (above). Journal socket within the Terrier fin support structure, showing evidence of break-up under sideways bending of the fin spindle.

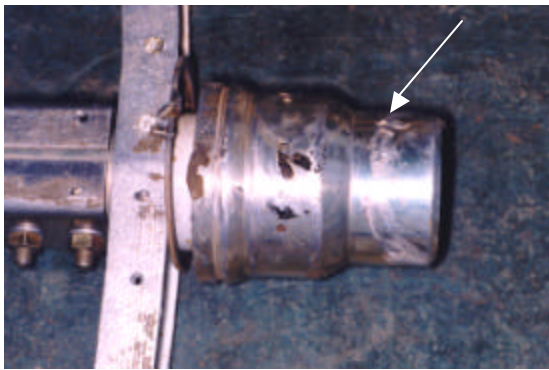
Fig. 46 (left). Fin spindle, with score marks corresponding to the socket damage shown above.

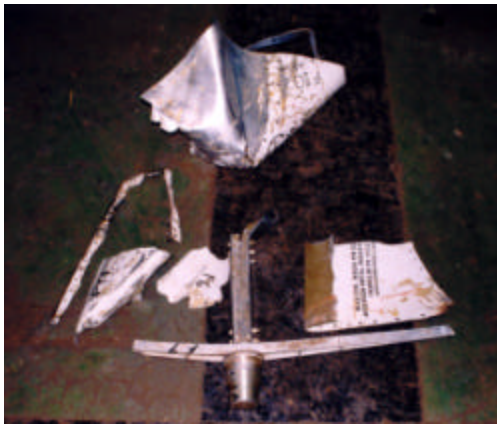
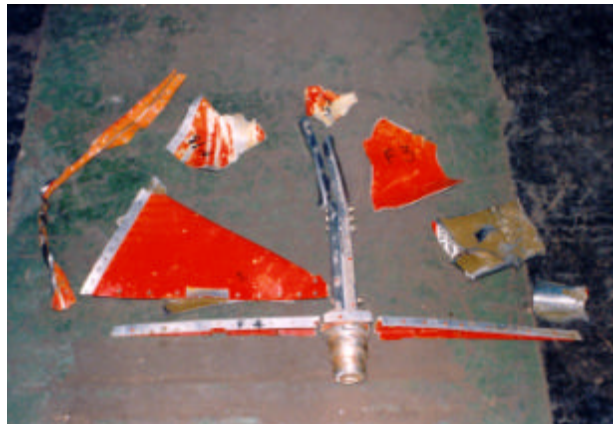
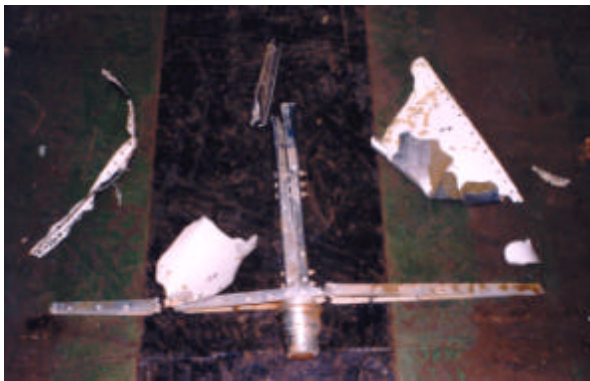
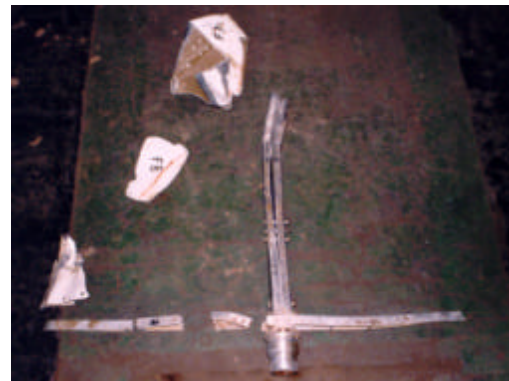
Figs. 47, 48 (top left & right), Figs 49, 50 (above left & right). the Terrier (Nike) fins. A large amount of the fin skin was not located.

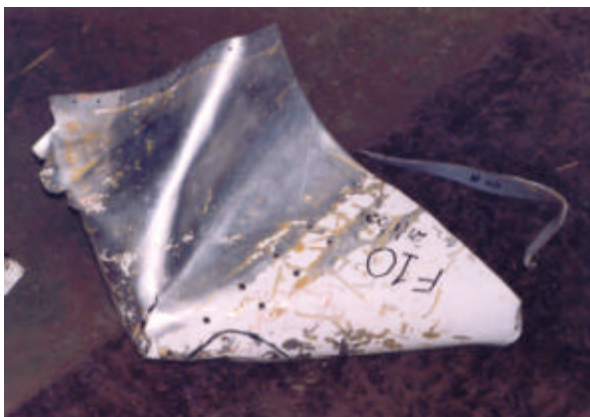
Fig. 51. Nike fin skin section, showing abrasion and removal of the paint from the leading face surface.

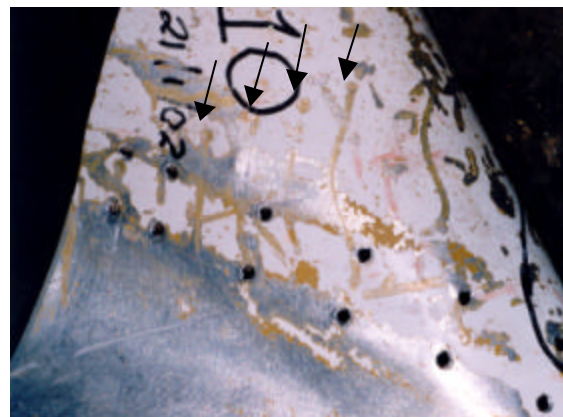
The same section of fin that showed the abrasion also showed witness marks from a glancing impact with the edge of another fin (figure 52). Regularly spaced impressions from rivet heads were identified across the surface, with the spacing of these marks matching the spacing of the row of domed head rivets along the fin leading and trailing edges. Parallel drag marks extended behind each of the rivet impressions, indicating the relative movement of the two surfaces following the impact.

Fig. 52. Nike fin skin section showing a clear impact mark from the leading or trailing edge of another Nike fin. Note the row of rivet indentations.

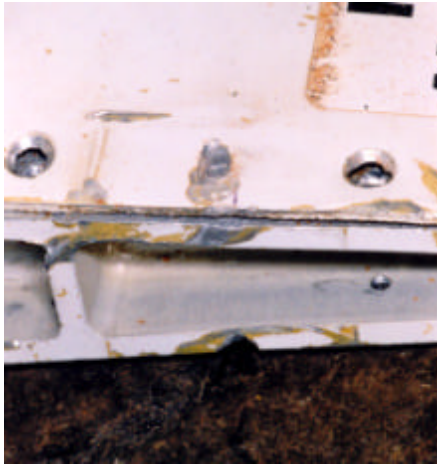
The Nike fixed fin angle of incidence was adjusted using trailing edge adjustment lugs. Marks and damage around the fixed fin adjustment lug mounting points indicated in-flight movement and possible insecurity of the fin adjustment lugs. Crushing damage of the fin rib sections beneath the lug mounting set-screws was possibly pre-flight damage which may have contributed to in-flight movement. It was also noted that the Nike fins were not designed for securing in the location used and contained no reinforcement or other strengthening features in this area. The Nike fins were designed to be secured on the leading side of the fin base, whereas the original Terrier fins were designed to be secured on the trailing side of the fin base.

As mentioned in section 1.2, the adaptation of the Nike fins for use on the Terrier booster vehicle required the use of a securing / incidence setting lug on the trailing side of the fin base – opposite to the area designed into the Nike fins for this purpose. Evidence exists on several of the trailing rib sections of the cup-point set-screws seating irregularly against the surface of the fin (figure 53). Appreciable indentation and in one case, partial crushing of the fin rib had occurred (figure 54). While it was not possible to determine at what stage of the flight the damage occurred, the indications did highlight potential deficiencies with this method of securing the fins.

Fig. 53 (left). Clamping point for the fin securing lug – note the disruption produced by in-flight movement.

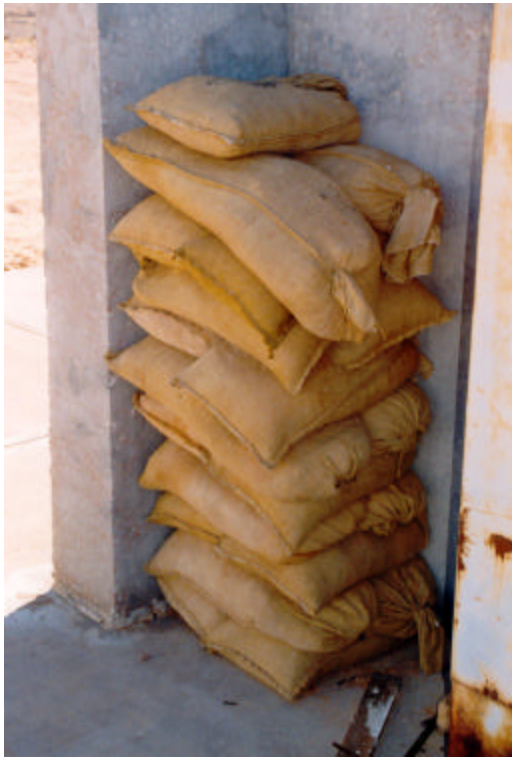
During launch preparation, sandbags were placed around the base of the launcher. The Astrotech "Operation and Inspection Log for the Assembly of the Terrier-Orion Suborbital Launch vehicle system" called for grout to be placed at the base of the launcher. However, grout was not available, thus sandbags were used to protect the base of the launcher. UQ suggested that it was possible that a sandbag or a rock in a sandbag could have damaged a fin during the initial launch phase. That would have required a sandbag or rock to have been deflected off the infrastructure and impact a fin. Video footage and still images viewed by the ATSB Specialists and Astrotech, indicated that a number of the sandbags were ejected and/or disrupted during the ignition and launch. However, it was not possible to determine if a rock had impacted a fin during the launch sequence.

Fig. 57 (above). Sand bags typical of those used around the base of the launcher pedestal, in lieu of the grouting.

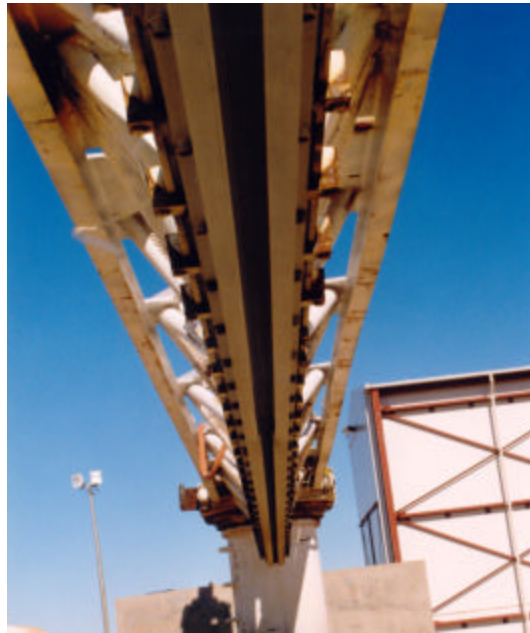
Fig. 58. (top right). Launcher rail – good condition.

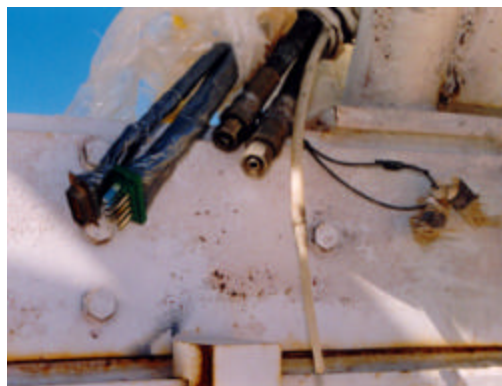
The umbilical connection between the launch vehicle and the control circuitry was inspected in-situ on the launcher (figure 59). While the various electrical connectors were present, it was found that the two gas-line connectors had been removed and were not able to be inspected. All components examined showed no evidence of striking the launch vehicle or having otherwise interfered with the launch.

Fig. 59 (right). Umbilical connections (less the gas connectors) – all undamaged.
