TECHNICAL ANALYSIS REPORT

Report No. 20/02

Examination of a Failed Rolls-Royce RB211-524 Turbofan Engine

Boeing Commercial Aircraft Group, 747-436, G-BNLD

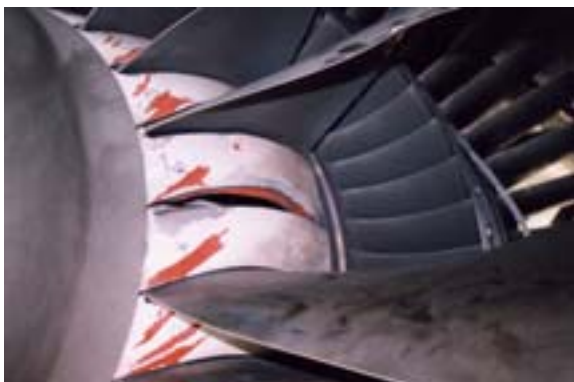
Fig. 3. View showing the fan rotor annulus filler plates around the failed blade position.

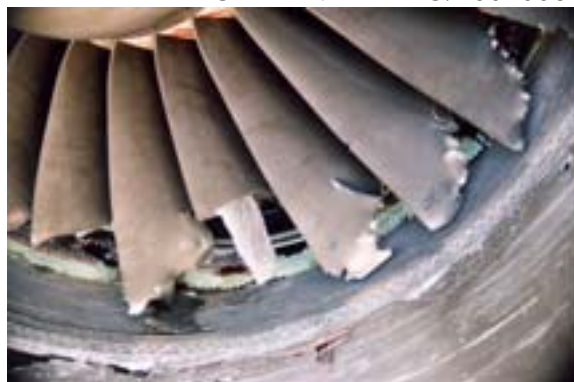
Fig. 4. Damage sustained by the fan blades – many had fractured through the internal cavity.

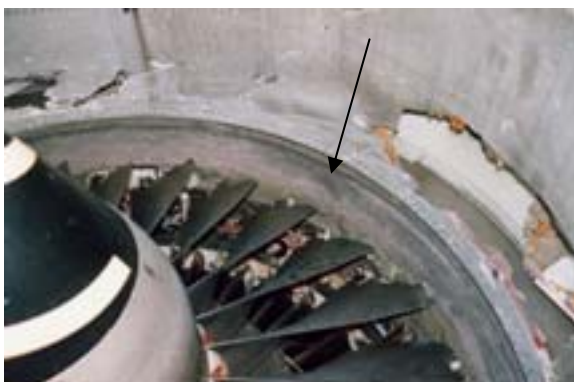
Fig. 5. View of the fan containment shroud showing the released blade impact point.

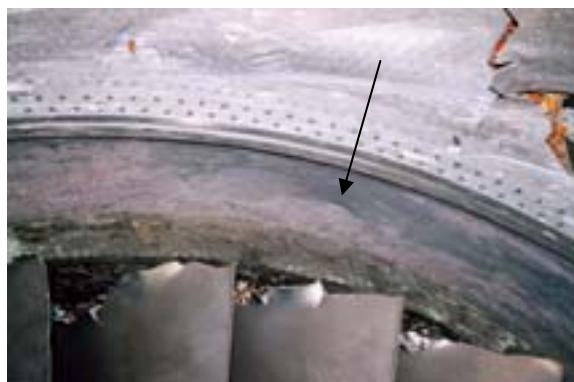
Fig. 6. Closer view of the blade primary impact point. Alignment with the blade pitch angle can be seen.

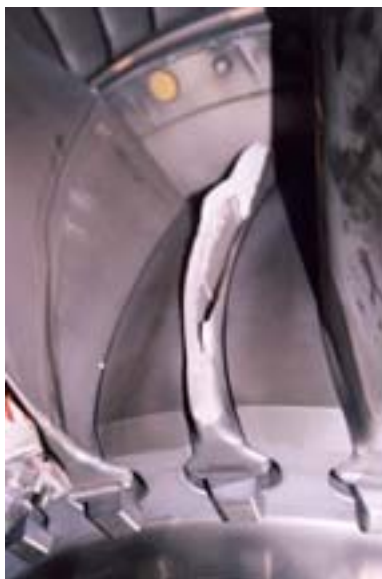
Disassembly of the fan centrebody assembly and removal of the annulus filler plates allowed the full width of the fractured number-9 blade to be examined. At the blade forward (leading) edge, the failure had occurred flush with the cylindrical surface of the rotor hub and tapered outward; ending approximately thirty millimetres above the hub at the rear (trailing) edge (figure 7). After removing the clamping ring, the blade stub and adjacent blades were easily removed from the rotor, with no significant seizure or lock-up noted (figure 8). The inside of the clamping ring showed evidence of impact against the forward end of the number-10 blade root block (figure 9); this blade being the trailing blade immediately behind the failed item.

Fig. 7 **Left** - Fractured blade stub after removal of the annulus filler plates.

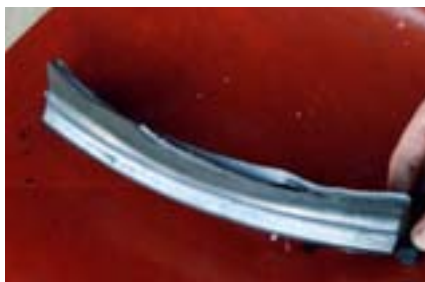
Fig. 8 **Top Right** – Blade stub after removal from the rotor disk.

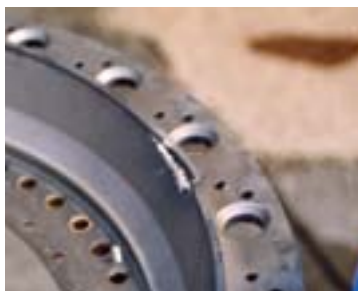
Fig. 9 **Bottom Right** – Blade retaining ring showing impact damage from the blade behind the failed item.

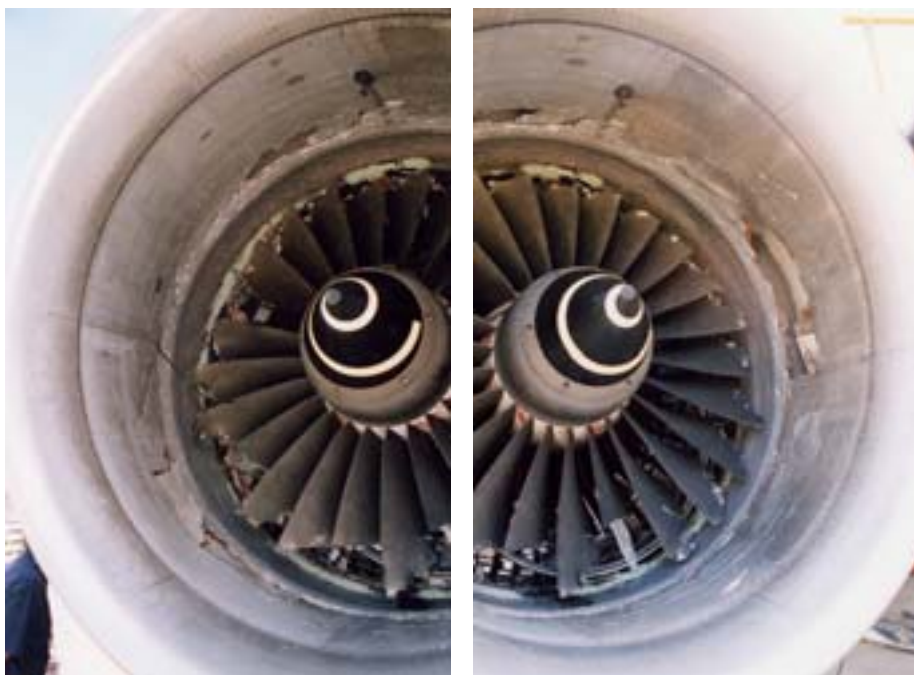
Figs. 10 & 11.
General view of the intake cowl inner walls.

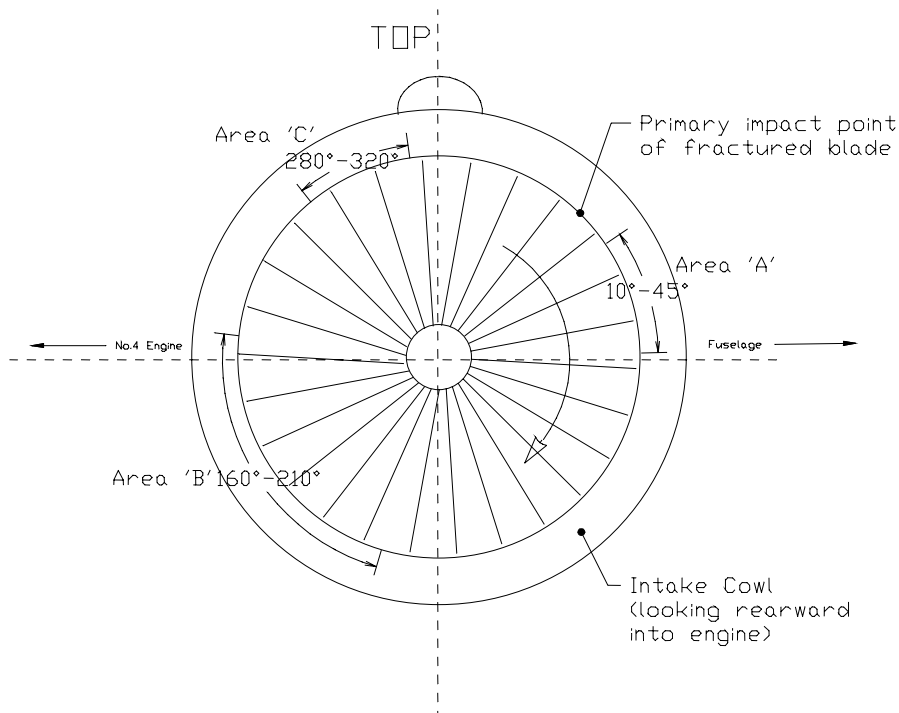
The intake (nose) cowl of the number-3 engine had been extensively damaged as a result of the engine failure. Internally, three dominant areas of major disruption and tearing of the acoustic lining were apparent, with each extending through to the external panels of the cowl. Figures 10 and 11 show the general level of damage sustained inside the engine intake. The three areas of major disruption were measured and characterised as follows. Figure 12 shows the locations as identified.

Fig 12 (Below)
Illustration of the three principal areas of major perforation damage sustained by the intake cowl.

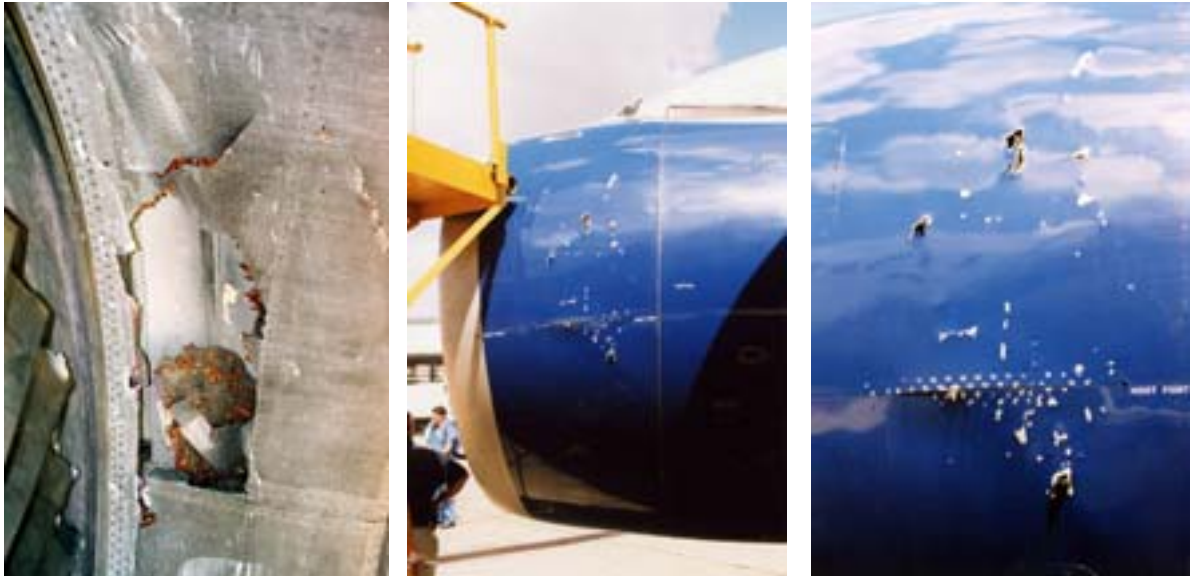
- Area ‘A’ 10° - 45° from primary impact point.

This damage presented as a punctured and impressed area of acoustic panelling measuring 88 x 35 centimetres, located between the fan case flange and the first circumferential intake cowl bulkhead (figure 13). The location of the damage corresponded with an area of multiple small punctures and indentations of the outer cowl skin on the left side of the engine (figures 14 & 15). An axial rivet line along an internal member had separated along a length of around 30 centimetres.

Figs. 13, 14 & 15. Damage sustained by left side of the intake cowl (Area A) – several minor punctures and the separation of the axial riveted seam.

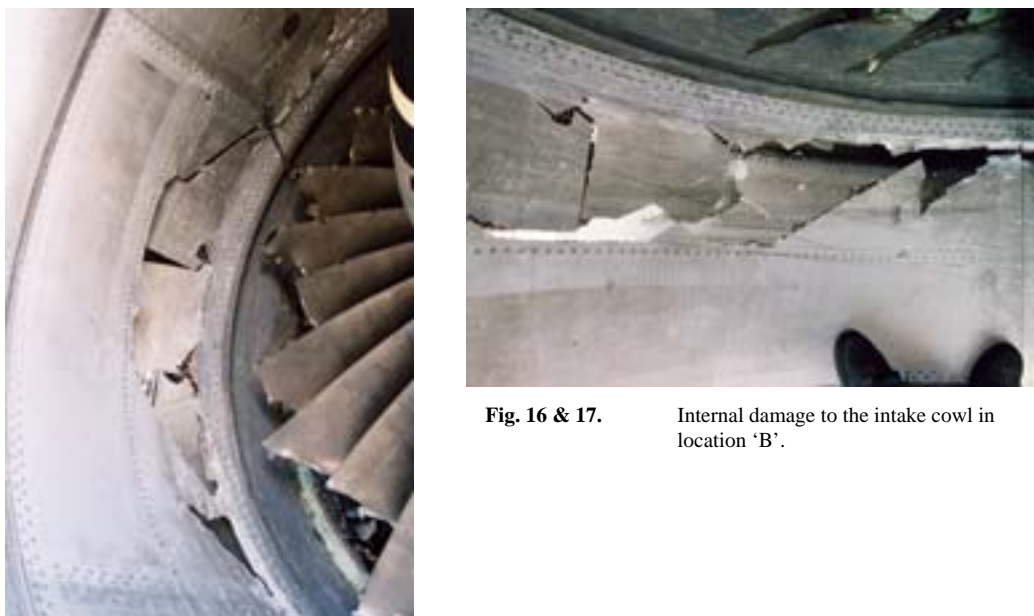
A larger area of damage similar to area ‘A’, measuring 130 x 26 centimetres and again located between the fan case flange and the first cowl bulkhead. Several large angular cuts in the internal acoustic lining characterised this area of damage (figures 16 & 17). Externally, the escaping fragment/s had torn away a large irregular area of cowl skin measuring 131 x 60 centimetres (figures 18 & 19), exposing the internal cowl void and the internal surfaces of the damage acoustic linings.

Fig. 16 & 17. Internal damage to the intake cowl in location ‘B’.

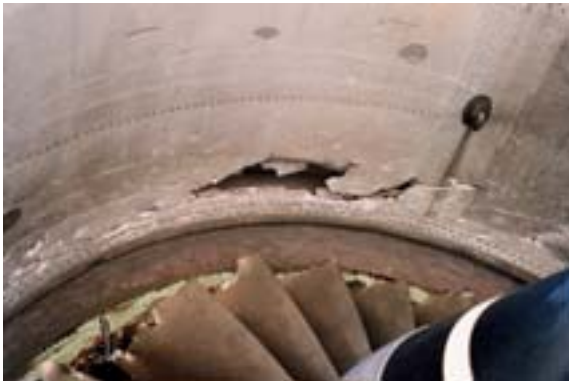
Fig. 20 (Top Left).

The smallest of the three major regions of damage, this area measured 75 x 15 centimetres and presented as a ragged tear within the acoustic liner adjacent to the inlet air probe body (figure 20). The passage of an energetic debris fragment through this area was evident from the ruptured engine strut forward fairing (figure 21) and the cowling skin beneath (figure 22). The debris damaged several wiring loom sections located within the fairing – those are detailed in section 1.6.

Damage to the upper internal surface of the intake cowl.

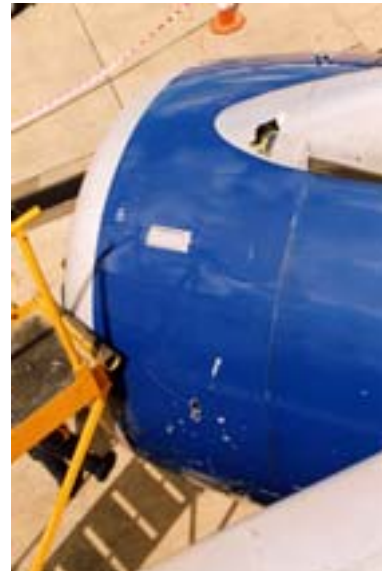
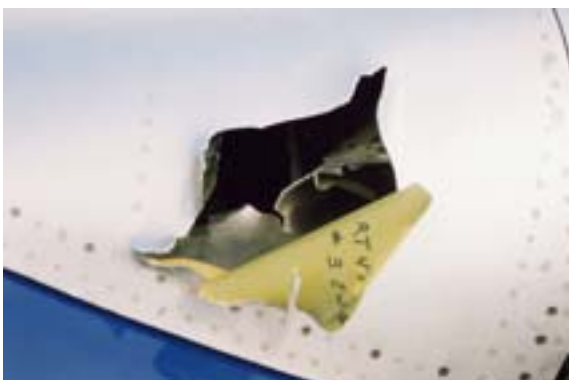
**Fig. 21 (Top Right)
Fig. 22 (Bottom Left)**

Perforation damage produced by debris travelling through the intake cowl and pylon forward fairing.

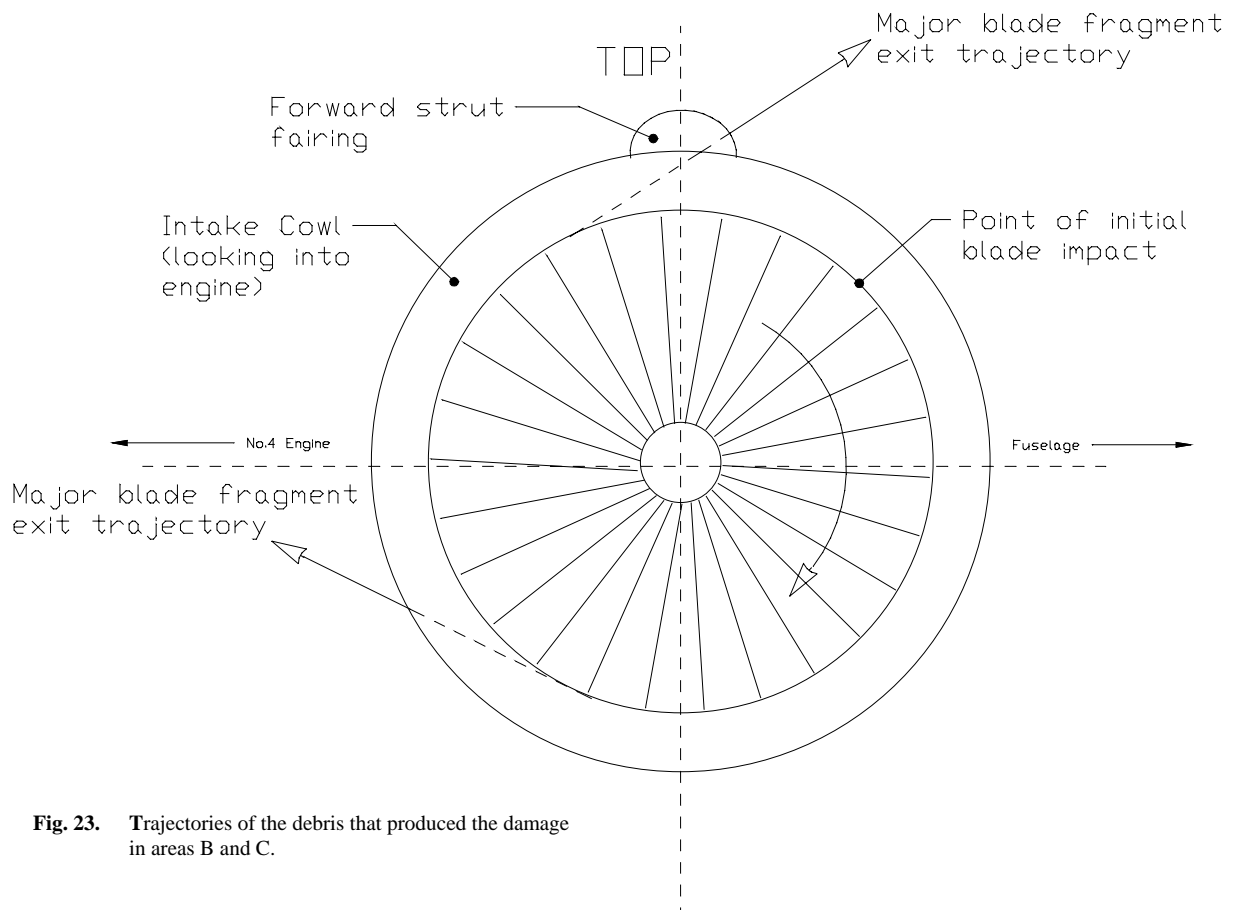
While the fan shroud showed no evidence of a failure to contain the initial blade impact, it was apparent from the intake cowl damage that two major sections of fan blade debris had punctured and escaped the intake cowl during the engine failure event. Figure 23 illustrates the approximate trajectories that these fragments followed. The liberated blade fragments both subsequently struck and damaged the aircraft structure (section 1.6).

Fig. 23. Trajectories of the debris that produced the damage in areas B and C.

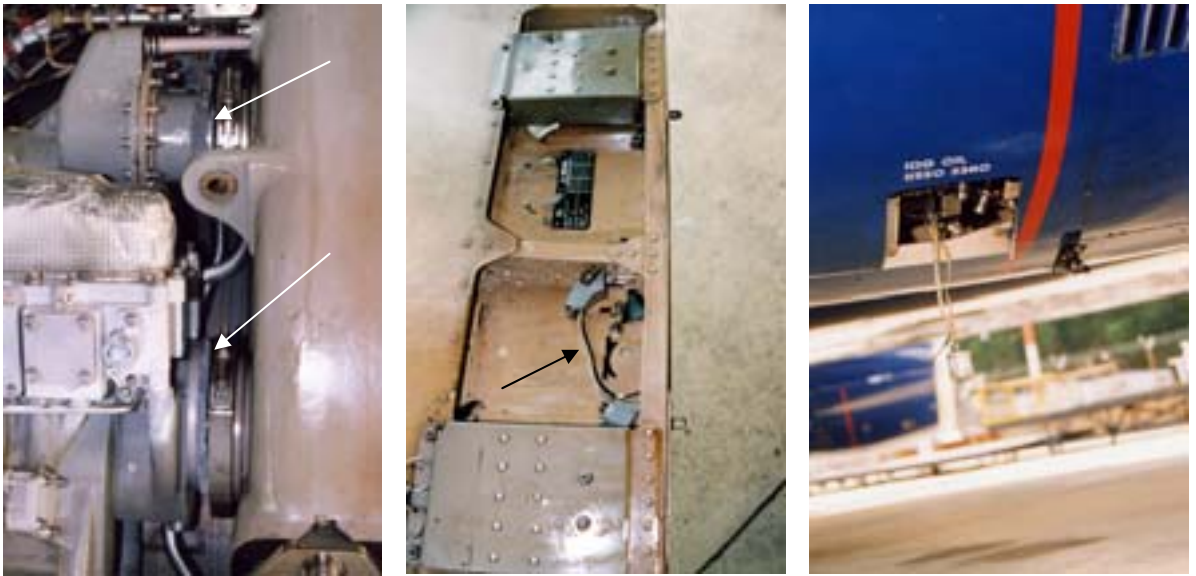
Fracture and separation of the fuel pump and generator drive housings from the accessory gearbox (arrowed).

Components and debris from the engine found within the base of the fan case cowls (arrowed).

Impact damage on the inside of the left fan case cowl.

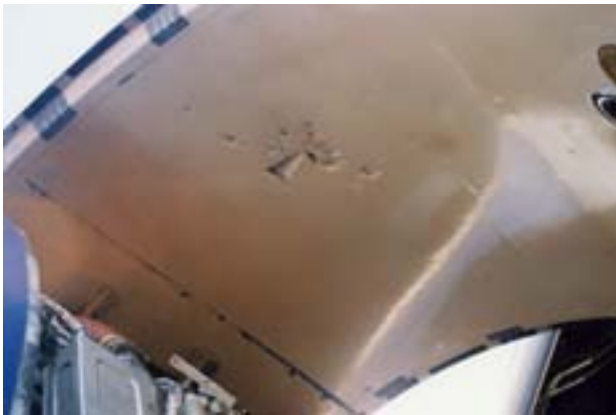
Fig. 27 (Top Right).

Loss of the IDG oil access door and one of the filler caps.

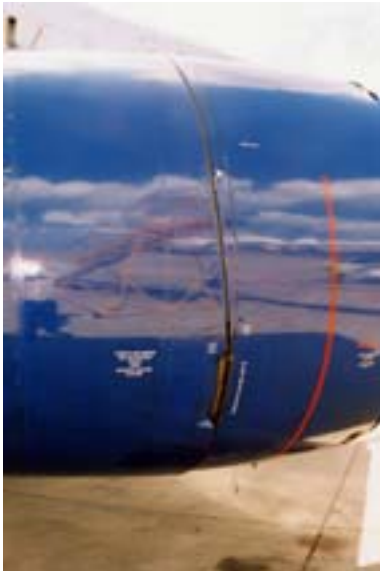
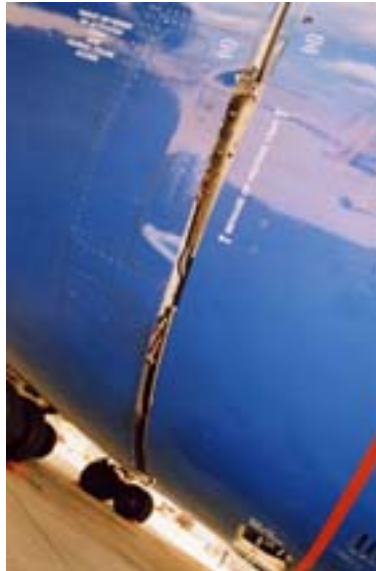
Fig. 28 (Left)
Fig. 29 (Right)

The number-3 engine thrust reverser assembly had moved axially during the failure event and was found approximately twenty-five millimetres rearward of the normal stowed position (figures 28 and 29). Through the opening thus created between the reverser sleeve and the fan case, it was evident that several rows of rivets between the thrust reverser assembly and the rear of the fan case had failed under shear loading. When compared dimensionally against the undamaged number-2 engine, the reverser assembly was found to be radially out of position and axially misaligned by up to fifteen millimetres. To check the integrity of the thrust reverser gearbox locks and the air-motor brake, a series of attempts was made at manually winding back the reverser sleeve with any two of the three devices unlocked (so as to test the remaining 'locked' unit). The result of these tests showed the assembly was actually jammed in the position found, with the manual drive unable to wind back the reverser sleeve, even with all three units unlocked.

Rearward movement and distortion of the thrust reverser doors.

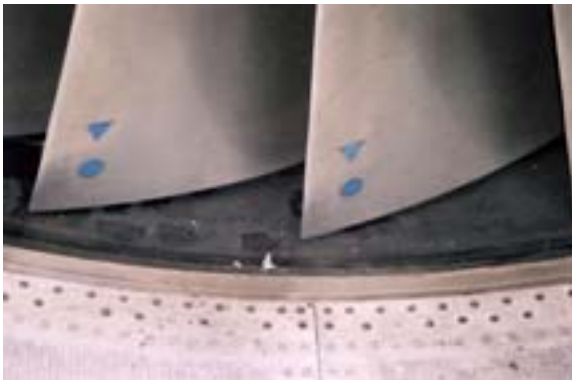
The number-4 engine (outboard of the failed engine) showed evidence of having ingested a small amount of liberated debris. Scratches and marks on the intake cowl lip and centrebody (spinner) were consistent with being produced by small fragments, such as that found embedded within the fan attrition lining at the 6 o'clock position (figure 30). A single fan blade also showed a small nick in the leading edge.

Fig. 30. Small fragment of blade debris found embedded within the fan attrition lining of the number-4 engine.

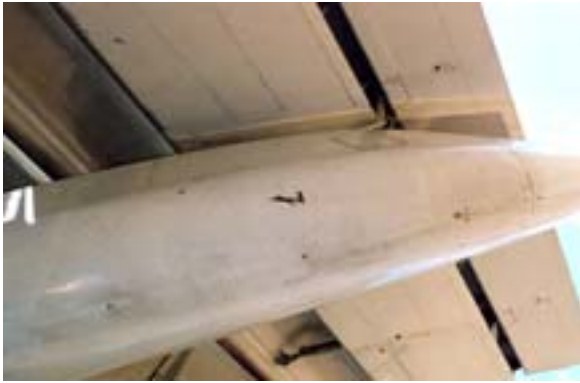
Fig. 33. Localised perforation and scoring of the number-five canoe fairing.

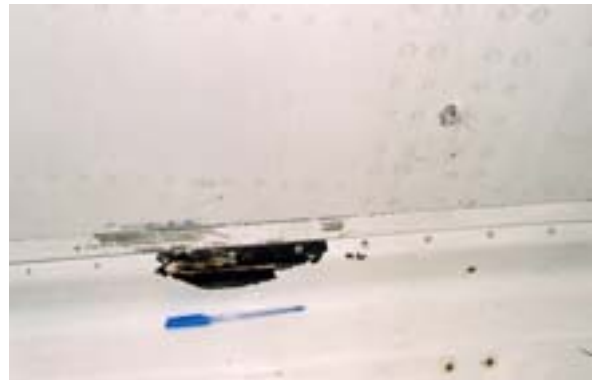
The right side of the fuselage sustained a single significant debris impact at the station 1140 bulkhead position, between stringers S26R and S27R (figure 34, approximately seventy-five millimetres below the cabin floor level and at the centre of the wing chord). Multiple gouges and scratches of the wing surface lead up to the impact point and the composite material strips at the wing – fuselage interface showed impact damage just aft of the fuselage impact (figure 35). Further scratches and scrape marks lead away from this area and over the trailing edge of the wing.

Figs. 34 (Left) & 35 (Right). Impact damage found on the fuselage and trim panels at station 1140, above the wing root.

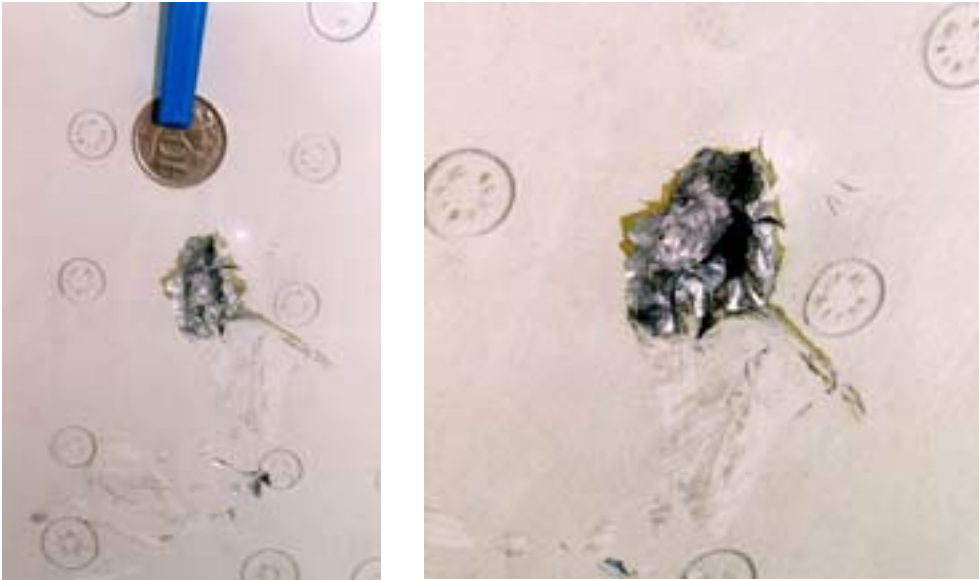
The principal fuselage impact damage presented as a ragged, circular gouge around twenty millimetres in diameter (figure 36). Perforation of the skin had occurred at the centre of the impact and the surface of the underlying station 1140 bulkhead could be seen through the hole (figure 37).

Figs. 36 (Left) and 37 (Right). View of the damaged fuselage area – perforation of the skin is evident at the centre of the damage.

To permit the return of the aircraft to the operator's maintenance facilities, temporary amelioration of the damage was effected by dressing and abrasive blending of the area to remove any roughness and reduce the stress-raising influence of the region. A sample of the skin material obtained during that process was examined using energy dispersive x-ray mapping techniques and confirmed the presence of traces of a titanium based alloy embedded into the aluminium skin material (figures 38-40). This confirmed that the damage was produced by impact with a titanium alloy component, most likely a fan blade fragment from the failed engine.

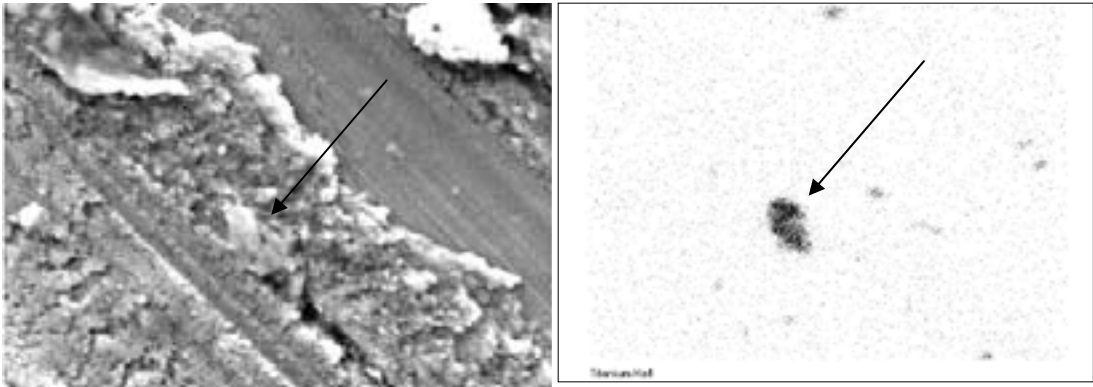
Scanning electron (left) and x-ray map (right) images of an area on the fuselage damage surface showing an embedded Titanium alloy (fan blade) fragment.

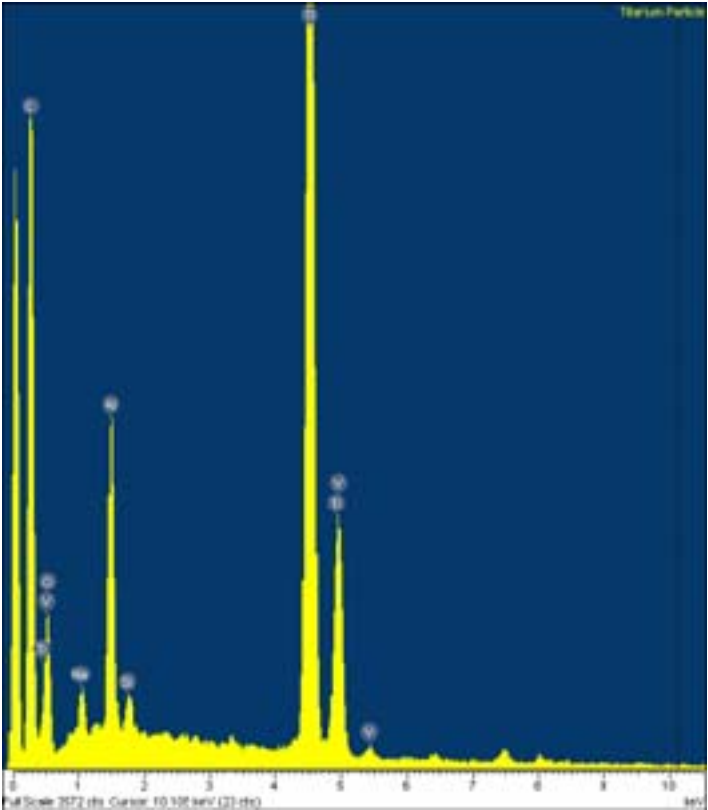
Fig. 40 (Left).

X-ray spectrum of the embedded particle, confirming it as a Titanium – Vanadium – Aluminium alloy.

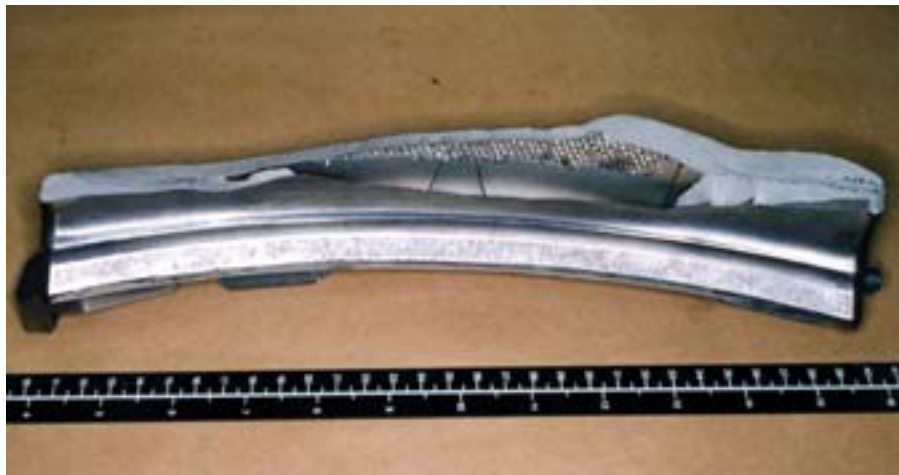
Fig. 41. Stub of the fractured blade after general laboratory cleaning. Leading edge is to the left.

The dovetail root load-bearing surfaces of the blade stub showed no suggestion of non-uniform seating or surface galling. The surfaces of the blade below the aerofoil section showed the uniform grey coating of dry lubricant used to promote even blade bedding and resist surface galling.

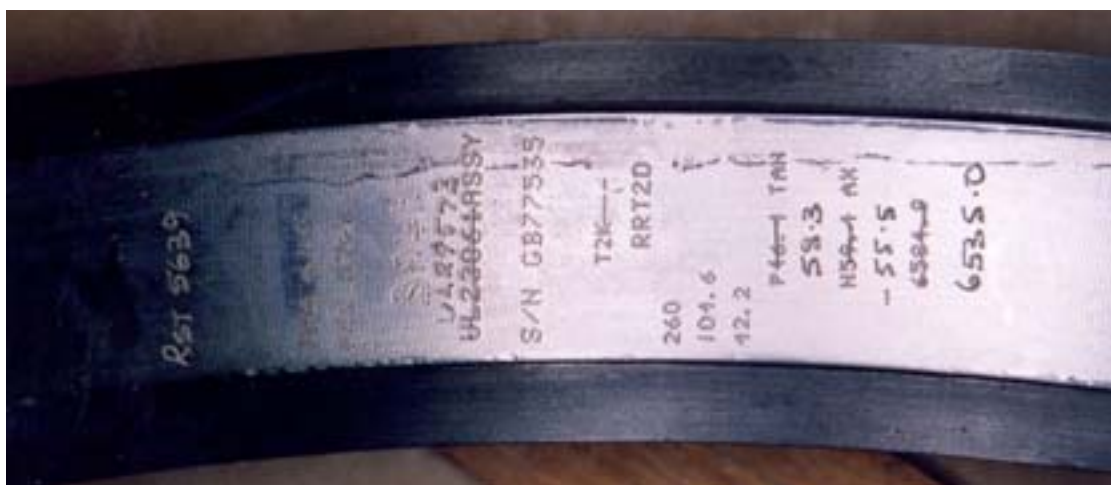
Fig. 42. Identification engraved / stamped on the underside of the failed blade.

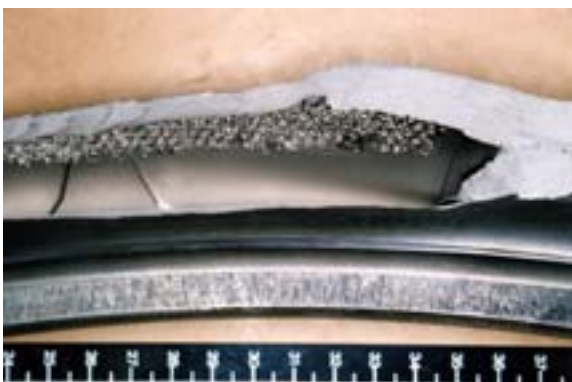
Fig. 43. Inside surfaces of the exposed blade cavity, showing remnants of the internal honeycomb material.

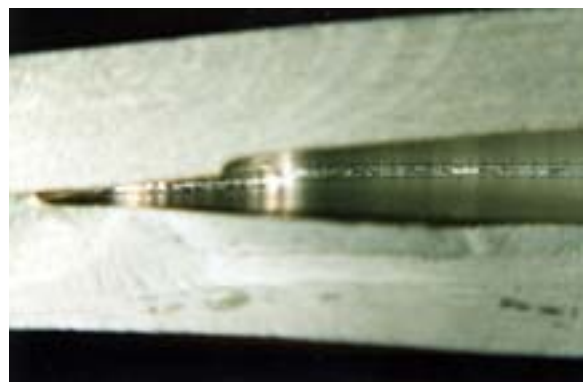
Fig. 44. Edges of the internal cavity, showing a continuous fillet of a metallic alloy.

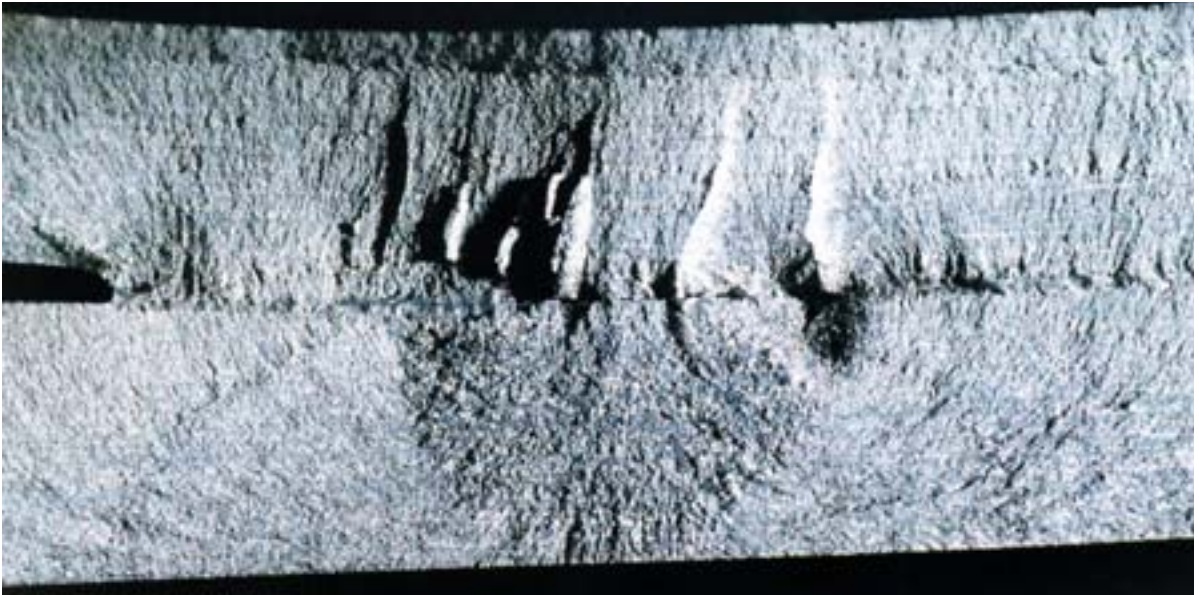
Primarily, the blade stub presented a broad, flat area of progressive fracture, extending from behind the base of the leading edge and progressing across approximately two-thirds of the blade chord on the convex side. This area contained a regular array of conchoidal crack progression marks, leading away from an origin at the centreline of the forward solid section of the blade. At low magnifications, approximately forty crack arrest marks were counted along the convex surface between the origin and the limit of fatigue cracking. Beyond this, the region presented angular surfaces typical of ductile overload (tensile shear) failure.

Fig. 45. Obliquely lit view of the blade fracture surface, centred over the fatigue initiation site. Note the thumb-nail-shaped area of initial crack propagation to the external (convex) surface.

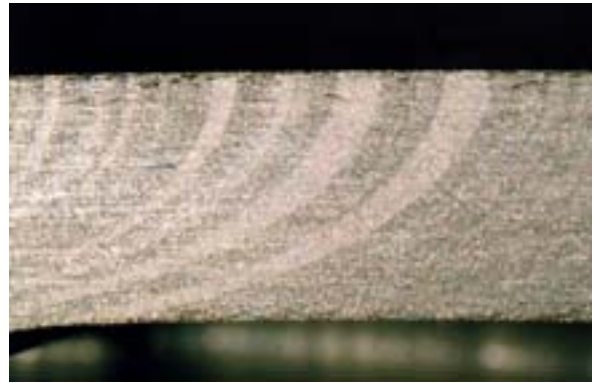
Information provided by the engine manufacturer depicted the construction of the RB211-524 series fan blades as a diffusion-bonded composite of two Ti6Al4V titanium alloy plates, separated at the centre by a metallic honeycomb filled cavity. The base of the cavity was exposed by the blade fracture, with remnants of the bonded honeycomb evident on one side (figure 43). The interface of the two plates forming the sides of the blade section showed an even and uniform fillet of a metallic compound around the periphery (figure 44). The bond-line formed by the joining of the two titanium plates could be observed extending from the forward edge of the cavity to the leading edge of the blade. The origin of the progressive cracking was found along this line, approximately seven millimetres forward of the cavity edge (figure 45) and forty millimetres back from the blade leading edge. Evidence of bond-line separation or incomplete fusion was found at the crack origin and appeared as an elongated void measuring around eight millimetres along the blade axis (figure 46). Associated with this area was a thumbnail-shaped region of semi-crystalline fracture that extended outward to the external (convex) aerofoil surface. Beyond this point, the development of characteristic fatigue cracking beach-marks became apparent, with periodic arrest-marks attesting to the cyclic nature of the crack growth (figure 47).

Fig. 47. Clearly defined fatigue crack arrest marks extending away from the initiation region.

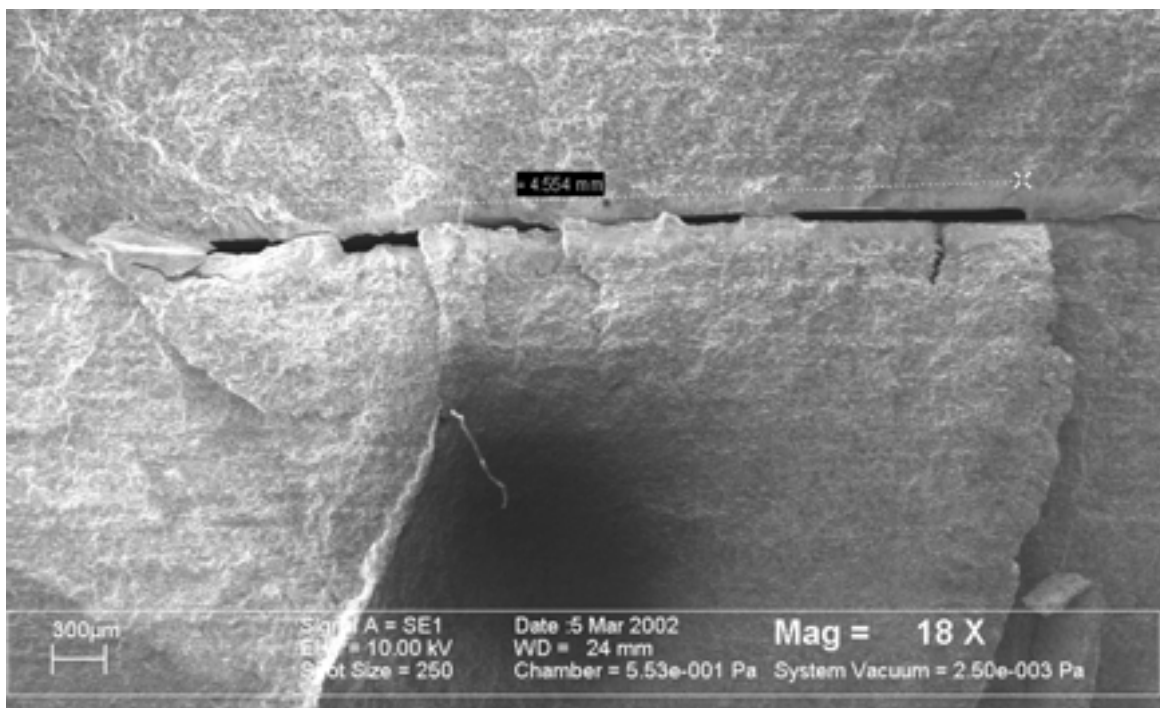
Scanning electron microscopy of the crack initiation region confirmed the presence of the void at the centreline interface and allowed accurate measurement of the exposed area (figure 48). Examination at higher magnifications revealed the void to have smooth internal surfaces and uniform, rounded edges - confirming it to be an area of incomplete fusion or lack-of-bond at the plate interface (figure 49). Along the interface to either side of the void was a half-millimetre wide band of material exhibiting fine, brittle fracture morphology (figure 50). Cracking was evident within this band adjacent to the edges of the void.

Fig. 48. Scanning electron image of the void at the blade panel interface. Total exposed length was approximately 4.5mm.

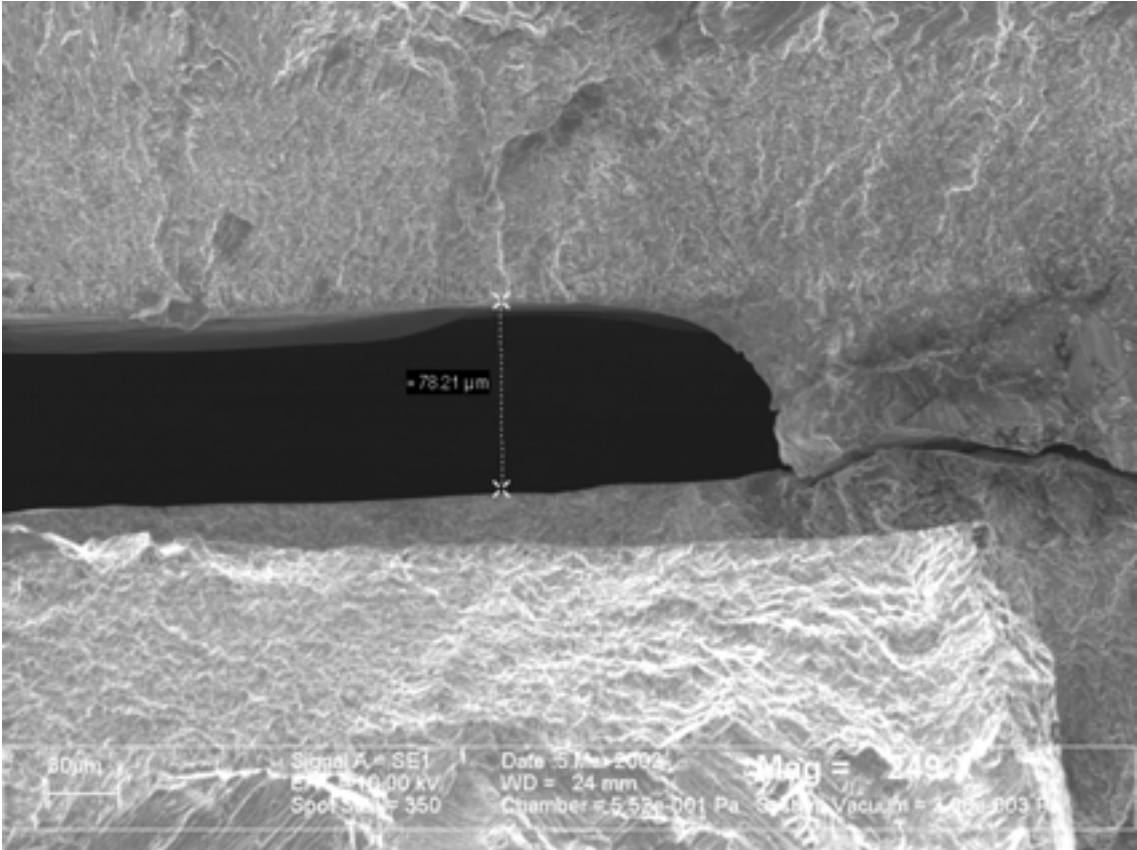
Fig. 49. Higher magnification electron image of the void inner edge. A clear, rounded end to the cavity suggested its formation during blade manufacture.

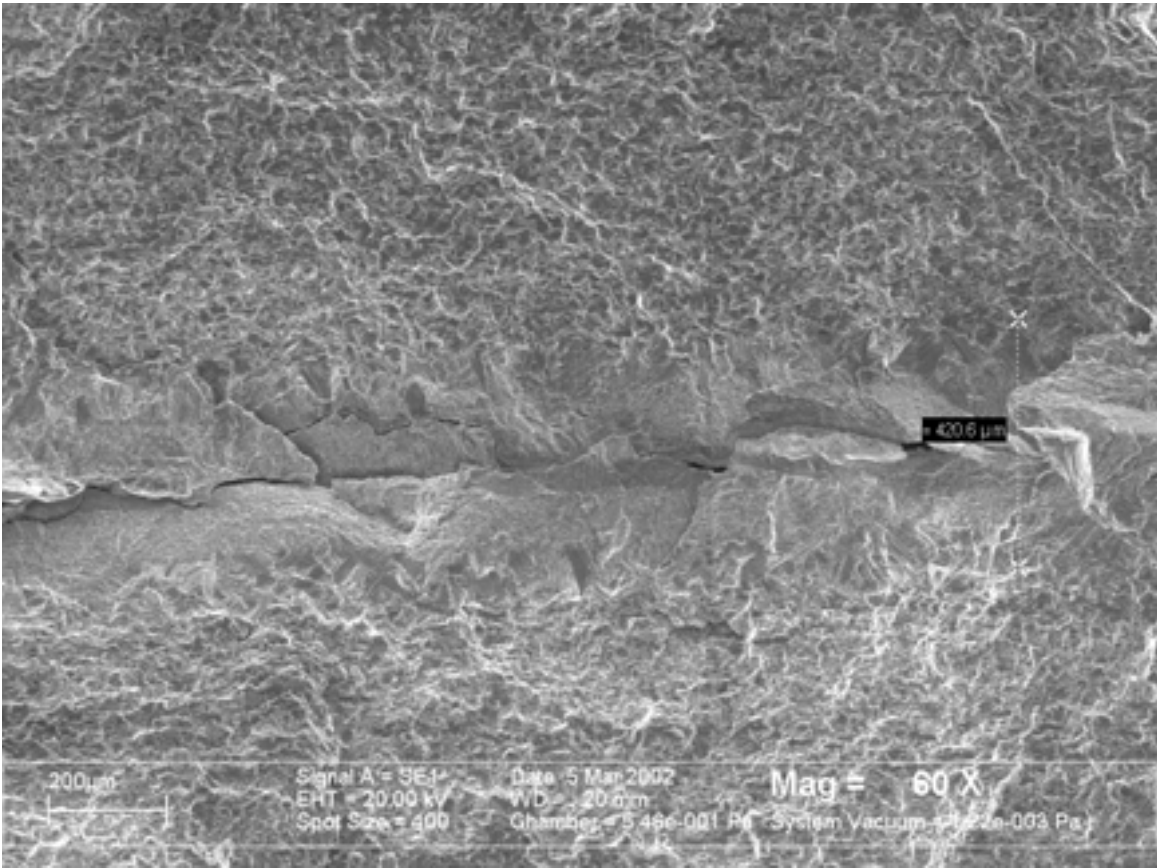
Fig. 50. Band of brittle fracture morphology extending along the blade panel interface. Note the cracking present within this region.

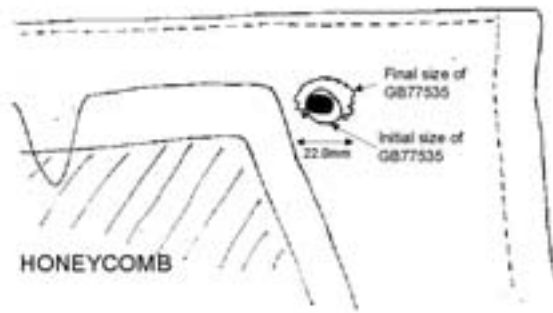
Following discovery of the lack-of-bond defect at the fracture initiation site, information was received from the engine manufacturer that confirmed the existence of a 14mm x 12mm incompletely bonded area on the original production radiograph taken during the blade manufacturing process (figure 51). After the failure, separation of the blade section along the interface showed that the original defect had grown to approximately 22mm x 16mm during service, as a result of debonding of the material surrounding the original flaw (figure 52).

Fig. 51. Tracing sketch of the original production radiographic image, showing the lack of bond defect and its subsequent growth.

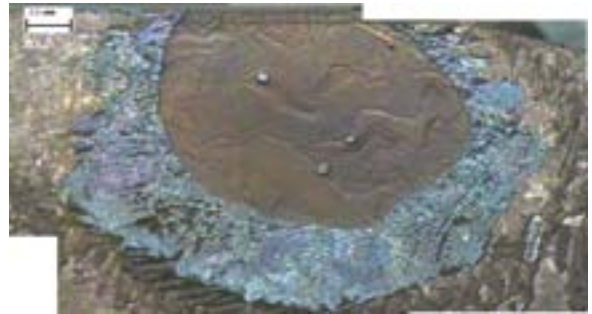
Fig. 52. The lack of bond defect after separation along the blade panel interface. The blue region shows the extent of further disbond that occurred after the blade was introduced into service.

The blade defect identified during the engine failure analysis was characterised as an isolated region of incomplete bond between the two plates making up the basic blade structure. From the results of non-destructive inspection performed during blade construction, the engine manufacturer had been aware of the location and size of the defect and had allowed the blade to be put into service on the basis of concessional acceptance criteria.
