## How safe is Australian aviation?

## If in doubt, don't take-off

ATSB investigation AO-2011-016

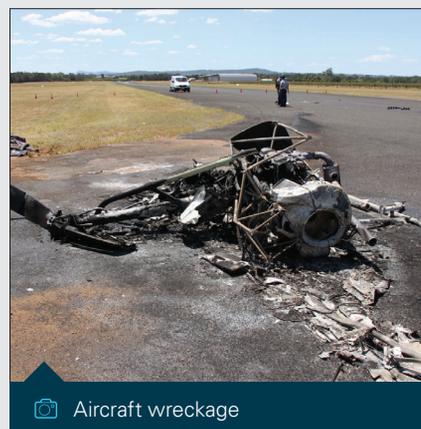
The ATSB's investigation found that a flight control fastener had detached, making the aircraft uncontrollable. The ATSB was unable to determine the specific reason for the separation as a number of components could not be located in the wreckage.

The fatal injuries sustained by the instructor and passenger were caused by the post-impact fire. The investigation identified that a large number of R44 helicopters, including VH-HFH, did not have the upgraded bladder-type fuel tanks. These tanks reduce the risk of post-impact fuel leak and subsequent fires.

Aircraft wreckage

This accident reinforces the importance of thorough inspections by maintenance personnel and pilots. The investigation identified that self-locking nuts used in many aircraft, including R22, R44 and R66 helicopter models, can become hydrogen-embrittled and fail. The Robinson Helicopter Company and the Civil Aviation Safety Authority (CASA) have published information advising pilots and maintenance personnel that any cracked or corroded nuts be replaced.

The ATSB also urges all operators and owners whose R44 helicopters are fitted with all-aluminium fuel tanks to replace those tanks with bladder-type fuel tanks as soon as possible. Compared to the all-aluminium tanks, the bladder-type tanks provide improved cut and tear resistance and can sustain large deformations without rupture. The safety benefits of incorporating the requirements of manufacturer's service bulletins in their aircraft as soon as possible cannot be underestimated. ■

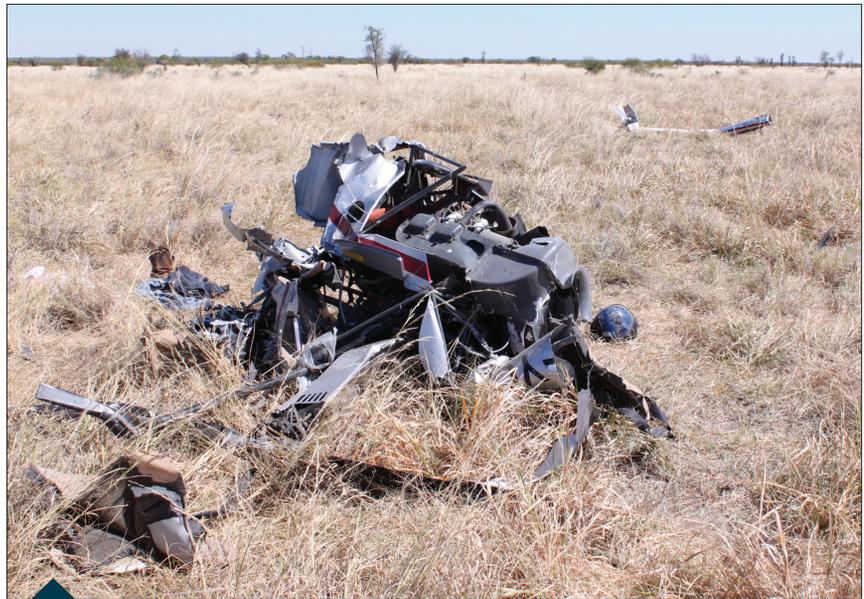
About halfway into the flight, the pilot inadvertently allowed the helicopter to develop a high rate of descent, resulting in a collision with terrain.

The subsequent investigation found that the pilot's licence had not been endorsed for flight under the night Visual Flight Rules (VFR). Also, there was no evidence that the pilot had received any night flying training, although anecdotal reports suggested that this was not the first time the pilot had flown at night. An examination of the helicopter found no

R22 helicopter wreckage of VH-YOL
