Aviation Short Investigation Bulletin Fourth Quarter 2011

ATSB Transport Safety Report
Aviation Short Investigations
AB-2012-019
Final

AB-2012-019

AO-2011-056: VH-NXE, Engine failure

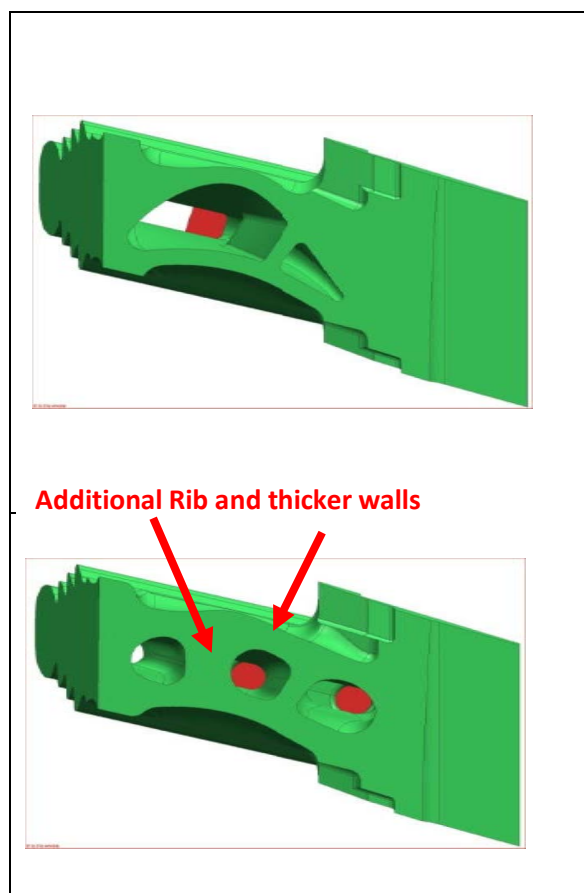
A subsequent modification to the blades (designated 'Mk II') was introduced to lower the fatigue stresses within the blade, by adding a rib and increasing the shank wall thickness to further stiffen the cooling channel structure (Figure 4).

Figure 4: Cross-section of LIP standard (top) and Mk II standard (bottom) blades

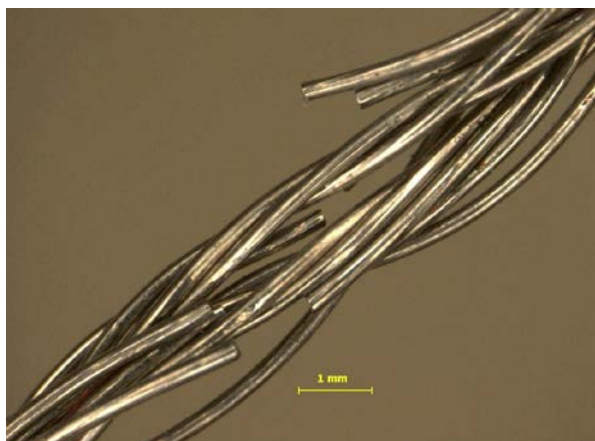
The yaw damper and autopilot were re-engaged on the ground. The engineer stated that he then applied a light force to the rudder pedals and immediately heard a loud bang in the rear fuselage. Upon investigation, a rudder trim actuator control cable was found to have failed.

A metallurgical examination of the cable conducted by the Australian Transport Safety Bureau (ATSB) revealed that the cable had failed through a combination of fatigue and overstress (Figure 2). While there was some evidence of pre-existing wear or fraying (Figure 3), this was considered normal.

Figure 2: Overstress and fatigue fractures

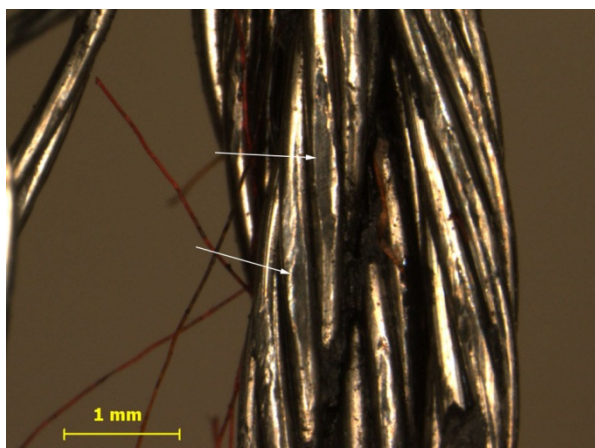
Figure 3: Abrasion wear on cable strands

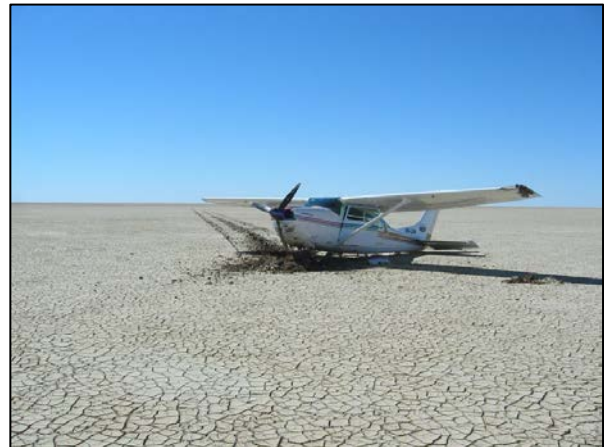
Figure 1: VH-LAN after landing

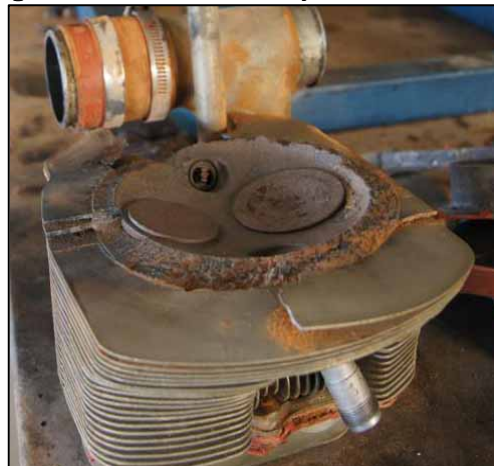
After all occupants had exited the aircraft, the pilot conducted a cursory examination of the engine and noted damage to the number-4 cylinder and its associated fuel injector.

The cylinder head and the fuel injector supply line had fractured and separated. The aircraft was eventually recovered and the engine removed for further examination.

circumference in the area of the cylinder head (Figure 3).

Figure 3: Failed number-4 cylinder

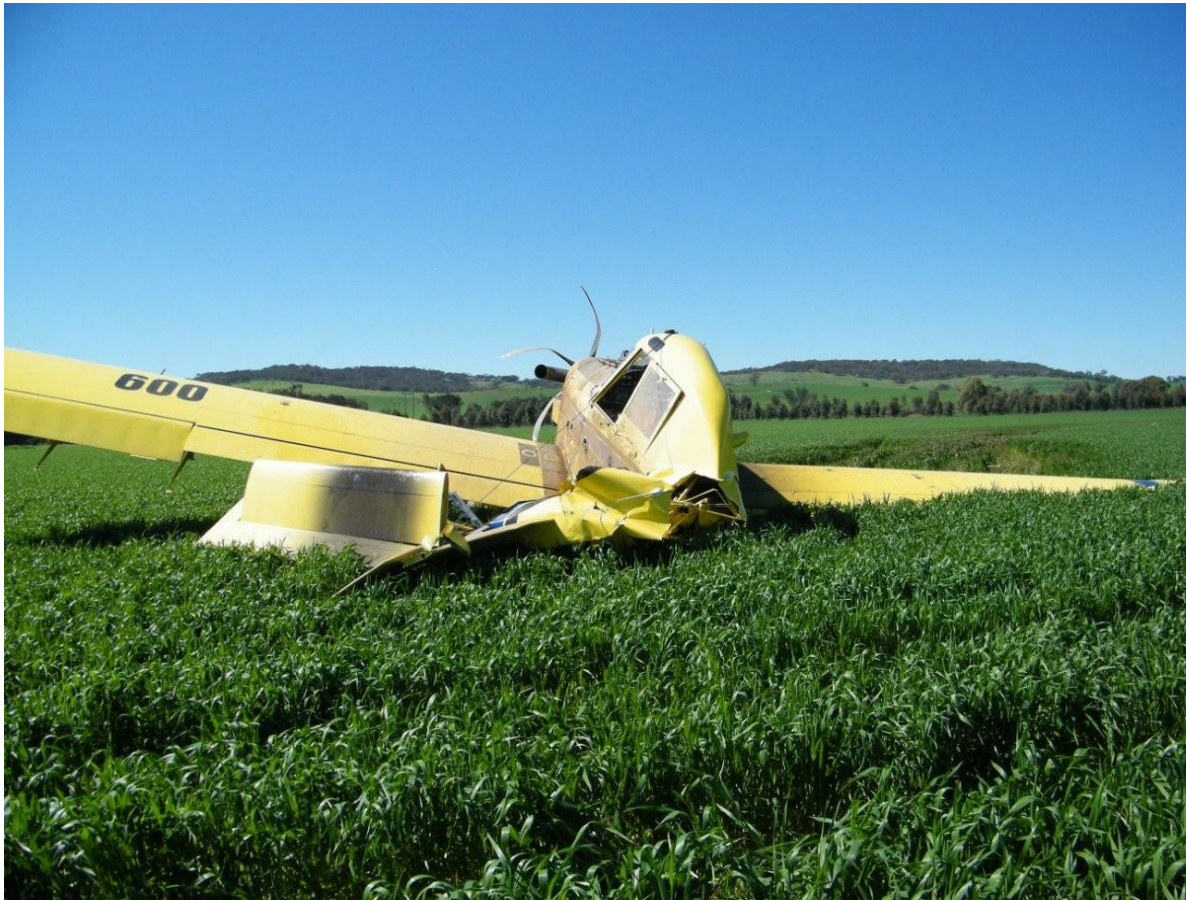
Figure 2: Accident site of VH-NIW

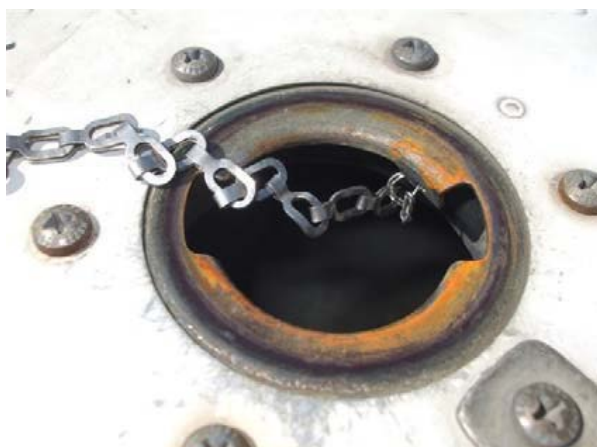
The right fuel tank receptacle lip showed signs of significant water contact in the form of surface rust (Figure 1). The receptacle was also found to be distorted, with the forward lip appearing to have been pushed down along its inner edge.

Figure 1: Right fuel cap receptacle

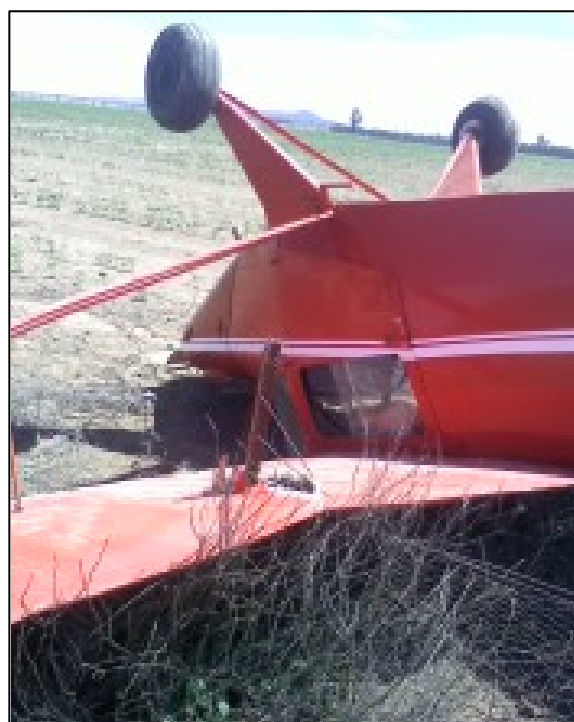
The pilot was unable to regain control of the aircraft which subsequently struck a fence about 600 m down the runway on the left side of the runway and flipped over, coming to rest inverted. There were no injuries sustained, however, the aircraft incurred damage to the propeller, one wing strut and the wing surfaces (Figure 1).

Figure 1: Wreckage close-up

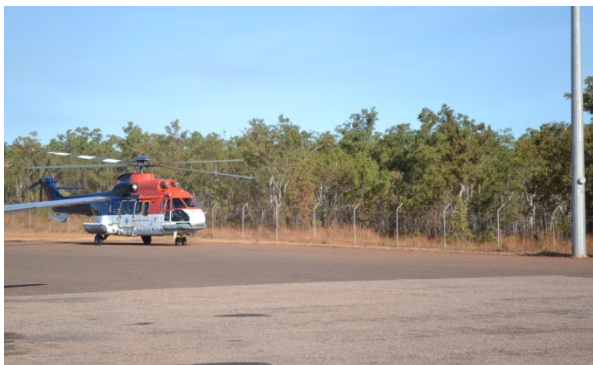
Figures 1, 2, 3: Accident sequence (Right wingtip of rear parked Metro appears in left of images)

Almost immediately there was a 'tick tick' sound then loud crunching sounds. The main rotor blades had struck the light pole (Figure 3) and started to break apart with debris flung about. The helicopter was rapidly propelled towards the light pole, toppling over onto its left side while vibrating vigorously and shedding blade debris in all directions.

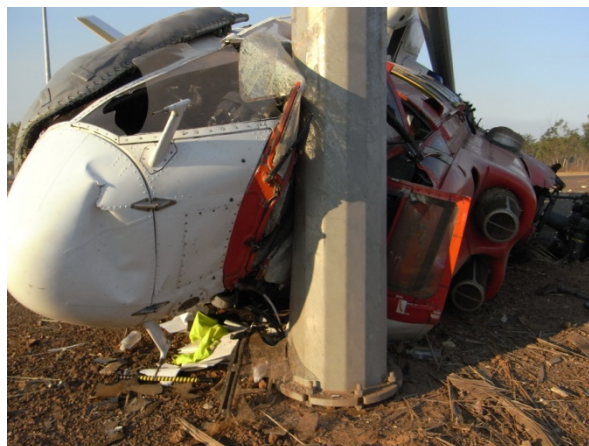
The priority for the PIC was to grab the overhead engine shutdown handles. But that was too difficult until the helicopter came to rest on its side (Figures 4 and 5). The PIC was then able to pull hard on the handle, successfully shutting down both engines.

Figure 4: Helicopter wreckage

The light pole bent where the main rotor blades had struck it. The upper section fell onto the helicopter with electrical wiring exposed, but unpowered. The left side of the cockpit was pushed inwards from contact with the light pole. The helicopter's tail section was also damaged.

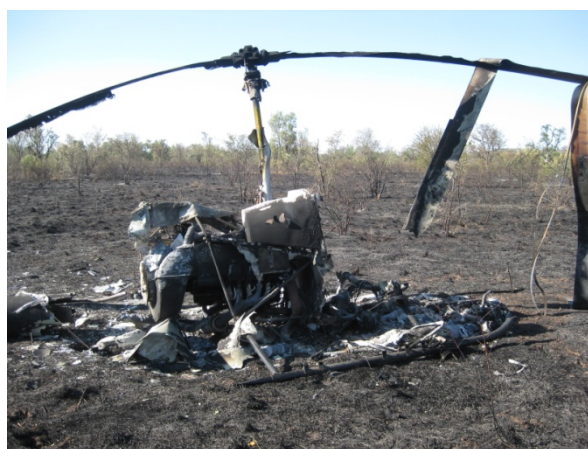
Figure 1: Accident site

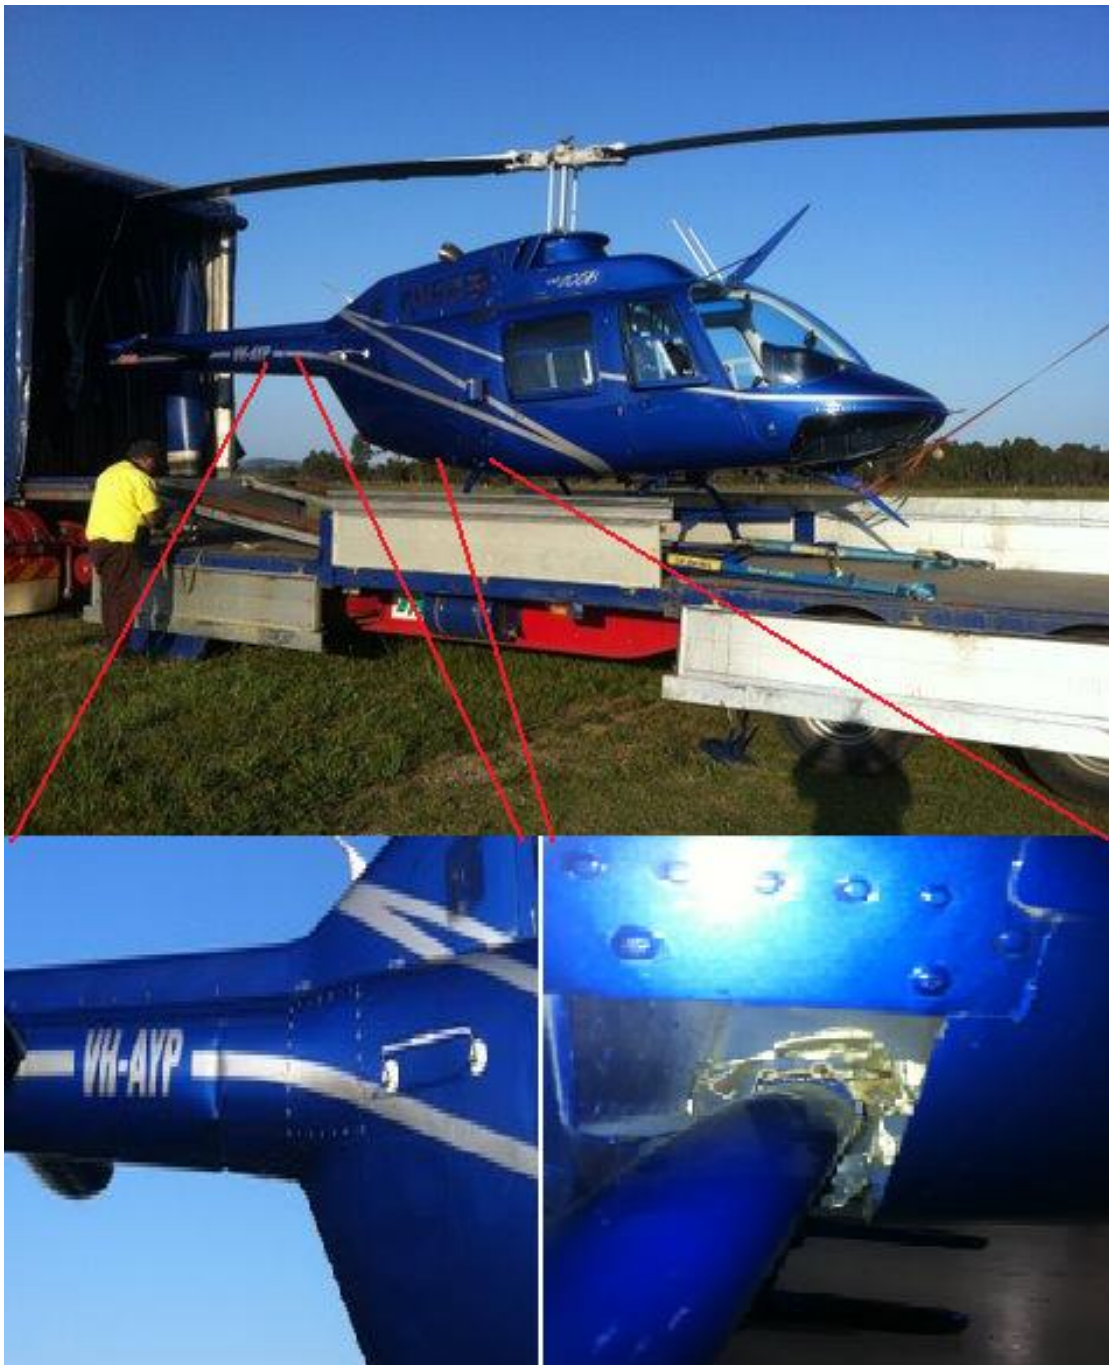
Figure 1: Damage to the tail boom and skids, VH-AYP

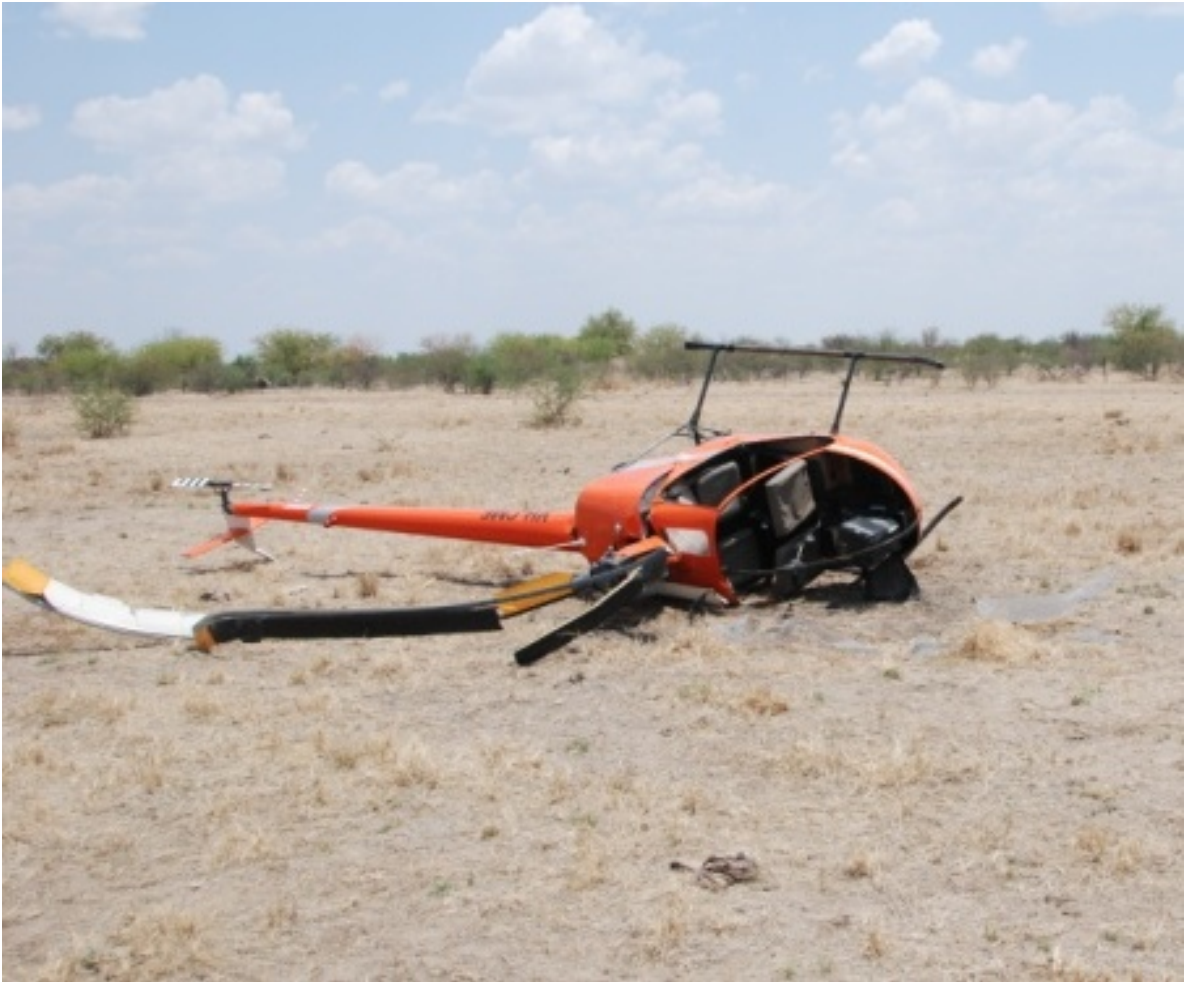
Figure 1: Accident site, VH-CME

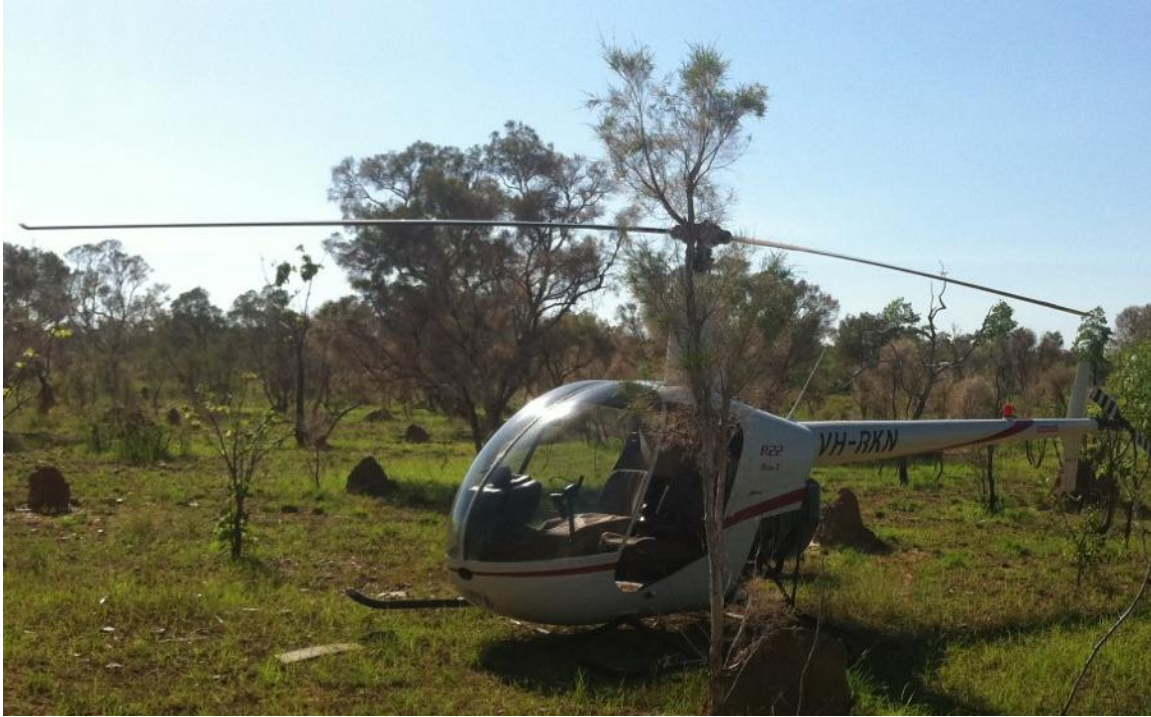
Figure 1: Accident site, VH-RKN
