Australian Government
Australian Transport Safety Bureau

Aviation Short Investigation Bulletin

Issue 12

ATSB Transport Safety Report
Aviation Short Investigations
AB-2012-105
Final

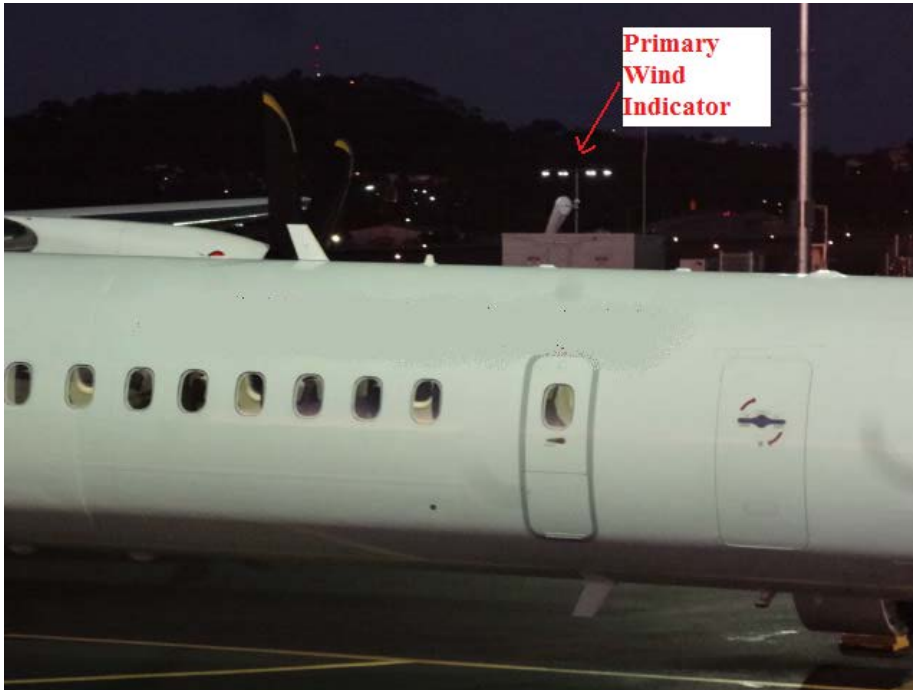
Figure 2: Windssock view from parking bay 2

The crews commented that they could not recall seeing or specifically looking for the windsock flashing warning, indicating the runway lights were about to turn off. However, all crew noted that the windsock was difficult to see from the parking bays and on taxi out to the runway. In addition, all crew stated that the presence of an aerodrome weather information service (AWIS), which provided actual weather conditions via a radio broadcast on a frequency separate to the CTAF and PAL frequency, made it unnecessary for them to turn their attention to the windsock to obtain information on wind speed and direction.

All crew also noted that on line up for runway 10, the illuminated primary windsock is over half way down the runway and behind the terminal flood lighting. There was higher ground containing bright lighting behind the windsock. The combination of these things obscured any flashing warning (Figure 3). All crew stated that they would be more likely to look to the closer unlit windsock

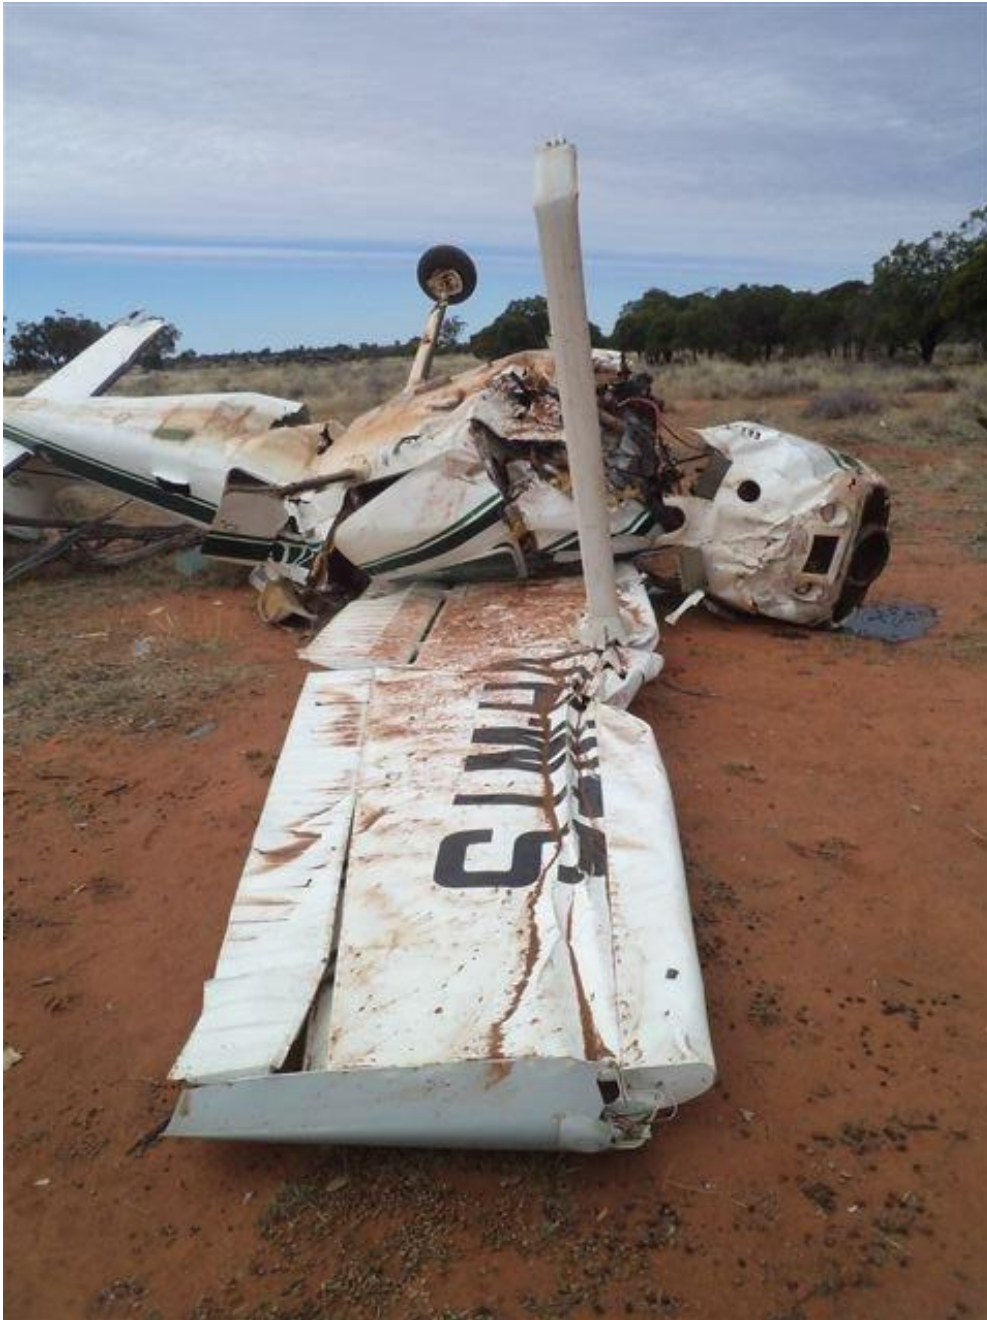
Figure 2: VH-WTS

On 19 June 2012, at about 0815 Eastern Standard Time¹, the pilot of a Cessna Aircraft Company 182P aircraft, registered VH-WTS (WTS), departed Mayvale Station, about 53 km east-north-east of Cunnamulla, Queensland, for an aerial inspection of the property. Shortly after becoming airborne, at about 80 to 100 ft, the pilot recalled the aircraft losing airspeed and then clipping a tree during the subsequent forced landing. The pilot's next recollection was being on the ground, out of the aircraft and unable to stand. The aircraft had collided with the ground and came to rest inverted (Figure 1).

Following the accident, a considerable amount of water was found in fuel samples taken from a number of locations in the aircraft's fuel system. Water was also found in a sample taken from the drum.

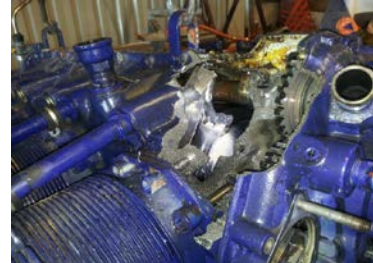
VH-FCK engine damage

The engine was removed from the aircraft and disassembled by a contracted maintenance organisation. The assessment by the maintenance organisation at the time of writing this report was that the failure was a result of a No. 6 connecting rod, big end cap bolt failure (Figure 1).

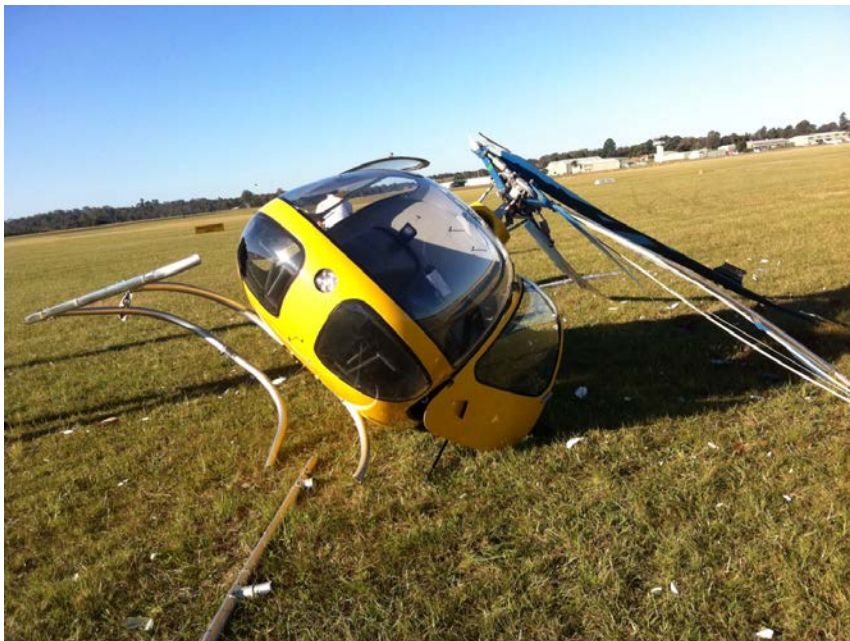
Figure 1: VH-ZZT

The helicopter collided with terrain in a left skid-low, nose-high attitude, and came to rest on its side. Both occupants exited the helicopter. The instructor was not injured, however, the student sustained some minor soft tissue injuries. The helicopter was seriously damaged (Figure 1).

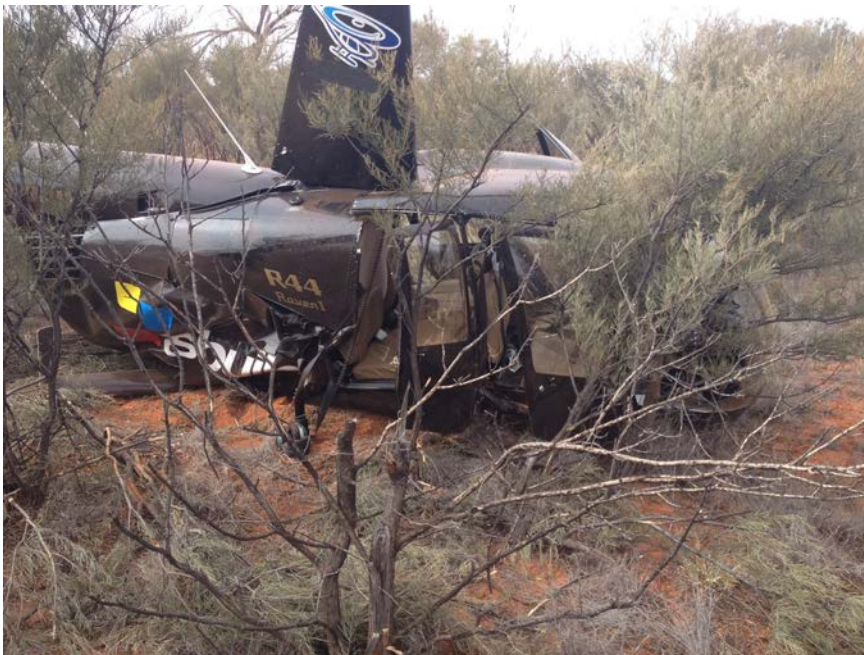
Figure 1: VH-HOU

On 10 June 2012 at about 1245 Central Standard Time¹, a Robinson Helicopter Company R44 Raven 1, registered VH-HOU, was seriously damaged, following a reported loss of power and collision with terrain near Maryvale, Northern Territory. The helicopter was providing support and aerial filming of a competitor participating in the annual Finke Desert race.

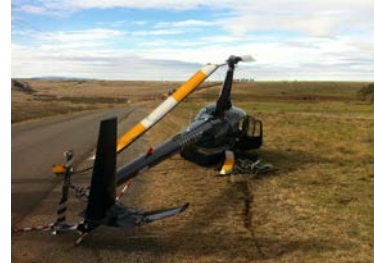
Accident site

The pilot was not injured, however the helicopter sustained serious damage.
