Hard landing – Cessna 172S, VH-EOP

Moorabbin Airport, Victoria – 2 September 2012

ATSB Transport Safety Report
Aviation Occurrence Investigation
AO-2012-114
Final

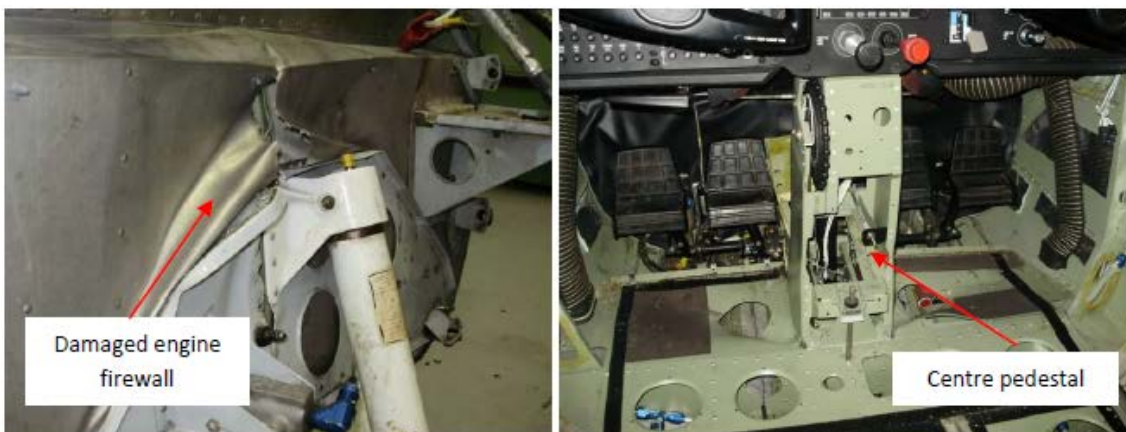
Figure 1: Aircraft damage

A detailed examination determined that, as a result of the hard landing, the aircraft sustained damage to the propeller and engine firewall. The centre pedestal had been raised by about 1.3 cm, which had jammed the elevator control and distorted the aileron control (Figure 1). The examination was unable to determine why the control column did not move during the hold-off, as reported by the pilot.
