Aviation Short Investigation Bulletin

Issue 13

ATSB Transport Safety Report
Aviation Short Investigations
AB-2012-141
Final

Publication date 27 November 2012

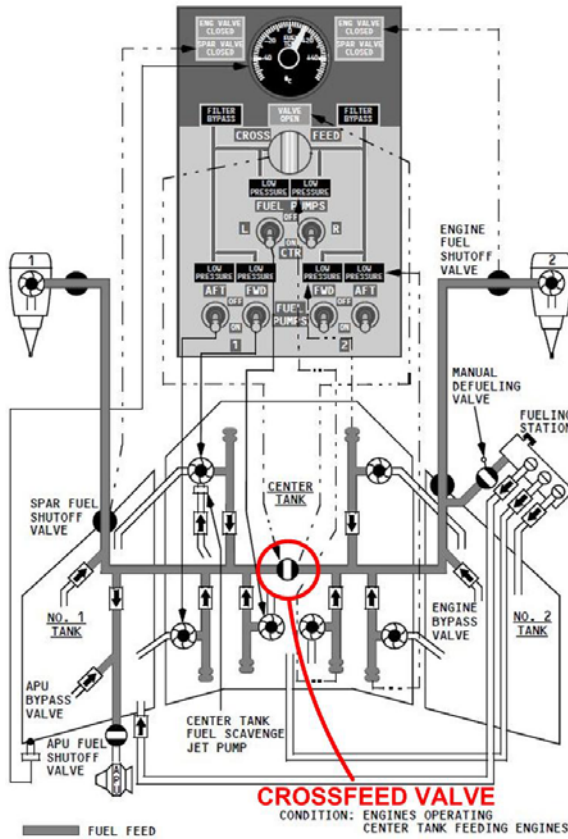
Figure 1: Fuel system schematic

The crossfeed valve was installed on VOL since manufacture. At the time of the occurrence, the aircraft had a total time in service of 31,858 hours. Due to the reported history of crossfeed valve malfunction, the valve was removed from the aircraft and dispatched to an overhaul organisation for rectification. The subsequent inspection identified wear to the sealing materials and Teflon within the valve body as consistent with the existence of a leak within the valve. However, the overhaul organisation was unable to confirm whether the sealing material degradation would explain a high volume fuel leakage rate. The condition of the valve spline was not identified. The worn sealing material and Teflon was replaced by the overhaul organisation with the incorporation of the modified valve body assembly.

Virgin Australia Airlines had previously established an inspection program for the crossfeed valves in accordance with Boeing recommendations.

The operator also has a program in place to replace existing crossfeed valves with the modified version at scheduled maintenance servicing. This program is currently under review for acceleration.

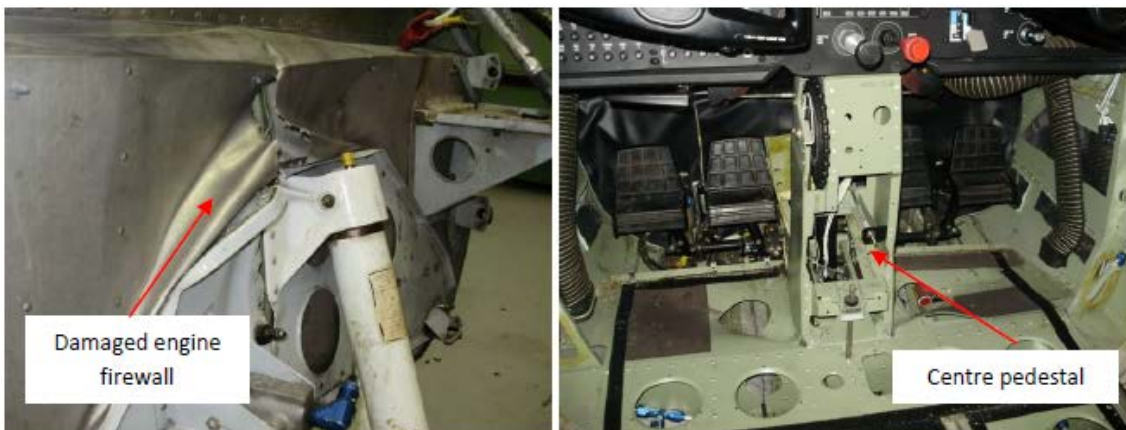
Figure 12: Aircraft damage

A detailed examination determined that, as a result of the hard landing, the aircraft sustained damage to the propeller and engine firewall. The centre pedestal had been raised by about 1.3 cm, which had jammed the elevator control and distorted the aileron control (Figure 1). The examination was unable to determine why the control column did not move during the hold-off, as reported by the pilot.

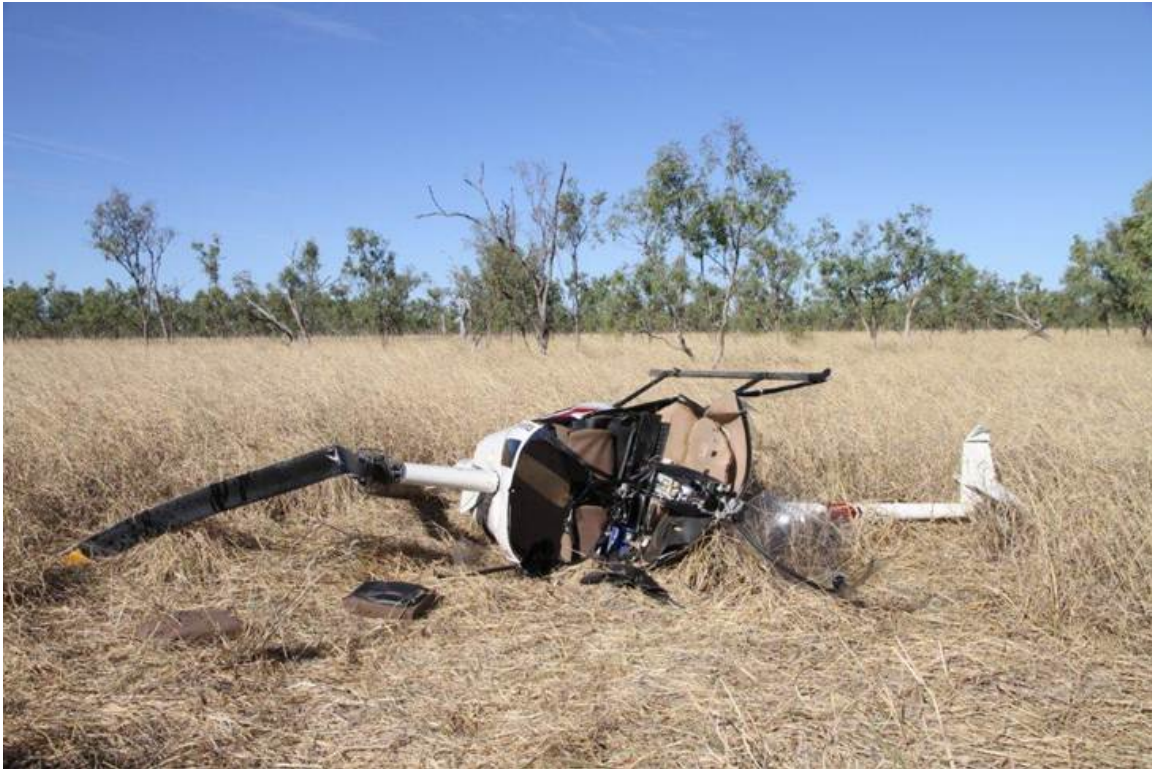
Figure 13: Accident site

At 0840 Eastern Standard Time¹ on 6 July 2012, during mustering operations near Miranda Downs aeroplane landing area (ALA), Queensland, the right skid of a Robinson R22 Beta (R22) helicopter, registered VH-STK (STK), struck a tree, causing the aircraft to collide with terrain (Figure 1). The pilot, the only occupant, was seriously injured and the helicopter sustained substantial damage.
