Propeller strike involving Fairchild SA227-DC, VH-WBQ

Granny Smith aerodrome, Western Australia, 22 August 2012

ATSB Transport Safety Report
Aviation Occurrence Investigation
AO-2012-106
Final

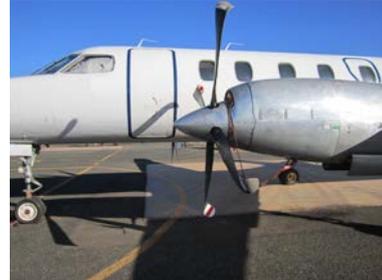
Propeller damage

After shutdown, the crew inspected the aircraft and determined that the left propeller had contacted the ground. The aircraft sustained damage to the left propeller blades and spinner, and the left landing gear doors (Figure 1).

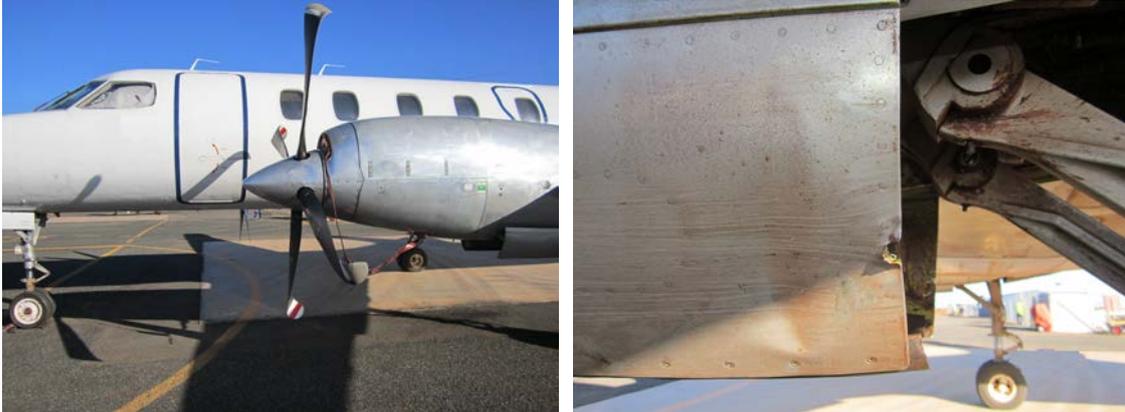
Figure 1: Propeller and landing gear door damage

The operator examined the aircraft and believed that there was an uncommanded retraction of the left landing gear on, or just after touchdown, which resulted in the left wing dropping. Right aileron was applied, which raised the left wing, and with the forward momentum of the aircraft, the left landing gear extended. The crew could not recall hearing the landing gear warning horn activate during the landing.

The reason for the uncommanded left landing gear retraction could not be determined.
