# Inadvertent landing gear retraction involving Aero Commander 500-S VH-YJS

Toowoomba Airport, 21 August 2012

**ATSB Transport Safety Report**  
Aviation Occurrence Investigation  
AO-2012-110  
Final

**Report No.** AO-2012-110

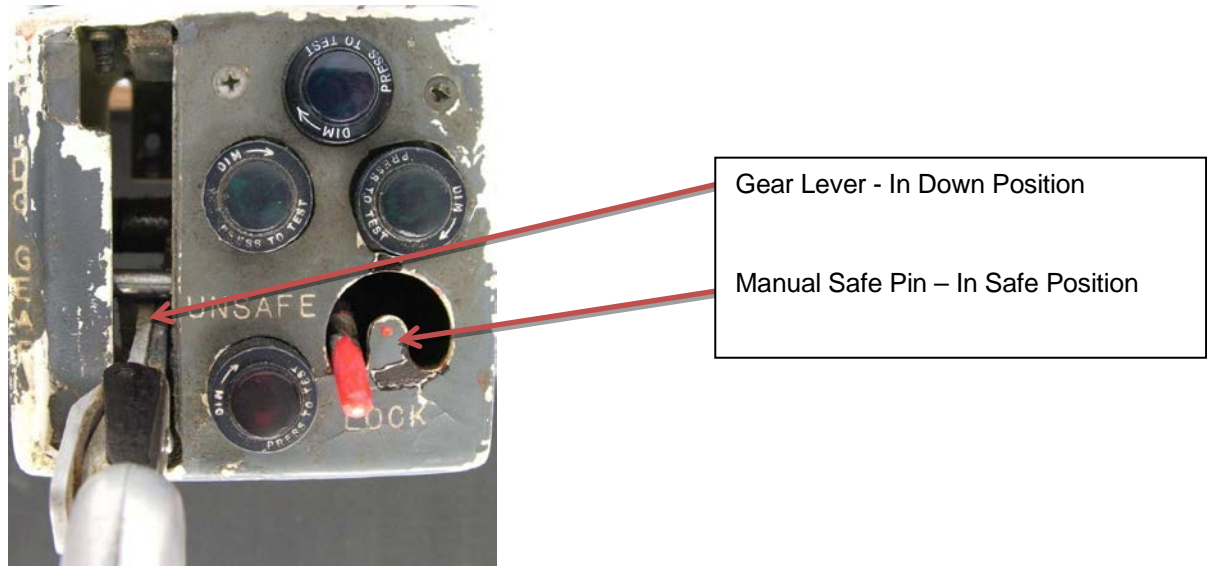
**Figure 1: Gear Selector**

To lower the landing gear, the aircraft checklist required the pilot to move the gear handle to the down position and confirm that the landing gear was down and locked. Confirmation that the landing gear was down was through the illumination of three green lights which corresponded to, the two main gear and nose gear. The pilot was then required to position a manual safe pin to the locked position (Figure 1). The manual safe pin was a design feature to prevent inadvertent movement of the gear selector to the UP position.

Movement of the gear selector to the UP position opened a solenoid which released 1000 psi pressure from down actuators. To move the gear selector to the UP position required the following actions:

- if the manual safe pin was in the safe position; movement of the safe pin from the locked position to the unlocked position (Figure 1)
- squeeze the safety lock
- movement of the gear handle to the left to release indent pin
- movement of the gear handle to the UP position

The pilot thought that while intending to retract the flaps he may have inadvertently retracted the landing gear and there were two possibilities as to how this happened;

- Either he did not place the safety pin in the safe position when the landing gear was extended in accordance with the checklist or alternatively;
- He unconsciously repositioned the safety pin as part of a well rehearsed muscle program used to operate the landing gear selector.

The manual safe pin was a design feature intended to prevent inadvertent retraction of the landing gear. However as a design feature, its effectiveness could be reduced over time, as it could be operated without conscious awareness. That is, once a pilot put their hand on the undercarriage lever, the safe pin could be repositioned to the unsafe position without further thought. The aircraft design did not incorporate a squat switch<sup>5</sup>, a design feature that prevents retraction of the landing gear whenever there is weight on the aircraft wheels.

- Modification of the landing gear control to an automatic gear control lock once gear is selected down and or an alarm to sound if the gear control is not manually locked after gear selected down. The alarm will be a voice alarm - "Check Gear- Check Gear"

latest incident, the ATSB has been advised by the operator that retrofitting a squat switch to prevent retraction of the landing gear while there is weight on the aircraft wheels is a priority.
