## InFocus

## The Dangers of Dust Devils

## Ditching highlights the need for good flight planning and monitoring

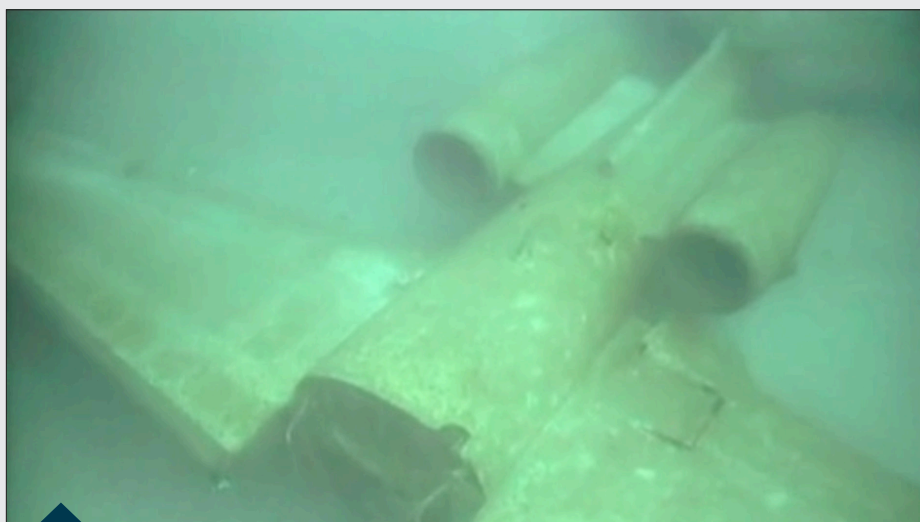
Wreckage of the aircraft off Norfolk Island

The crew attempted a night approach and landing on Norfolk Island, but the weather conditions prevented them from seeing the runway or its visual aids, and therefore, from landing. After four failed attempts, the PIC elected to ditch the aircraft in the sea 3km south-west of Headstone Point on Norfolk Island, before its fuel was exhausted. The aircraft broke in two after ditching. All the occupants escaped from the aircraft and were rescued by boat, although two sustained serious injuries.

As a result of this accident, the operator changed its guidance for the management of previously unforecast deteriorating destination weather. Satellite communication has been provided to crews to allow more reliable remote communications and its flight crew oversight systems and procedures have been enhanced. CASA is also developing a number of Civil Aviation Safety Regulations covering fuel planning and in-flight management, the selection of alternate destinations and extended diversion time operations. ■

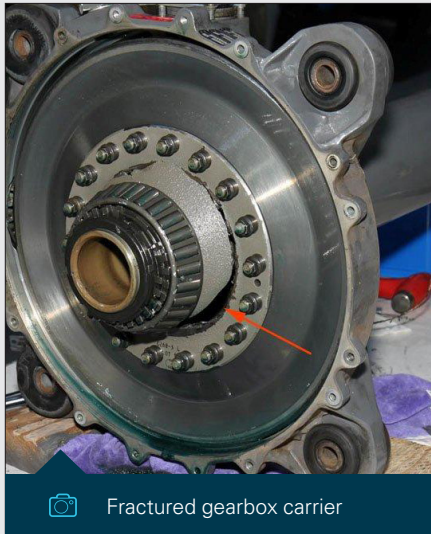
The ATSB's investigation into the loss of the main rotor drive on a Robinson R44 Raven II helicopter found that it was associated with corrosion and subsequent fatigue failure of the main rotor gearbox (MRGB) gear carrier as a result of water present in the main rotor gearbox.

The helicopter manufacturer advised that there had been a similar instance of corrosion-related gearbox failure in an R44 helicopter. In each case the aircraft had been operated in similar climatic conditions in Australia's tropical north and had been stored outside.

The helicopter manufacturer has now modified the design of the gear carrier to incorporate a metallic cadmium surface plating to improve the corrosion resistance of the assembly.

- that operators and maintainers request their maintenance facility conduct a MRGB oil inspection for any contaminants such as water, rust or paint
- where appropriate, store the rotorcraft under cover, or cover the main rotor mast and head assembly during inclement weather conditions
- during lengthy periods of storage or inactivity in tropical conditions, take additional preservation action – seek advice from Robinson Helicopter Company
- in the event of a MRGB warning chip light indication, land the helicopter immediately and have the issue investigated by a LAME in accordance with the manufacturer's instructions
- report all water, rust and paint contamination of the MRGB oil system and any corrosion to CASA. ■
