# Inadvertent thrust lever asymmetry during the take-off roll involving an Airbus A320, VH-JQX

Sydney Airport, New South Wales | 6 February 2012

**ATSB Transport Safety Report**  
Aviation Occurrence Investigation  
AO-2012-022  
Final

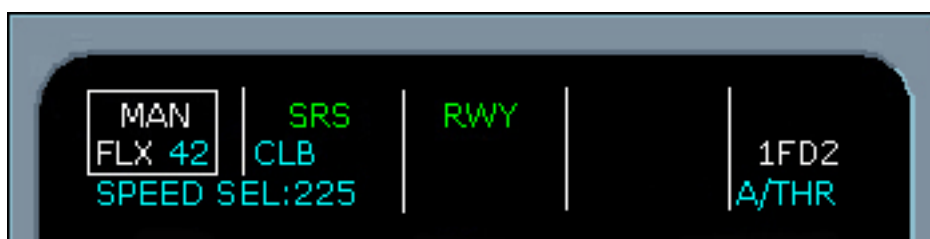
**Figure 2: FMA display at takeoff with an example flex temperature entered**

The PF advanced the thrust levers to the FLX/MCT detent, as the takeoff was being conducted as a reduced thrust takeoff and used a FLEX temperature to calculate the required thrust setting. After setting the thrust, the PF called ‘MAN FLEX 62, SRS, runway, autothrust blue’ from the flight mode annunciator (FMA), which indicated that autothrust was engaged in FLX mode, with a FLEX temperature of 62, SRS mode<sup>4</sup> was engaged, runway heading was set and autothrust was armed (Figure 2). This was a standard call from the PF at the commencement of the takeoff.

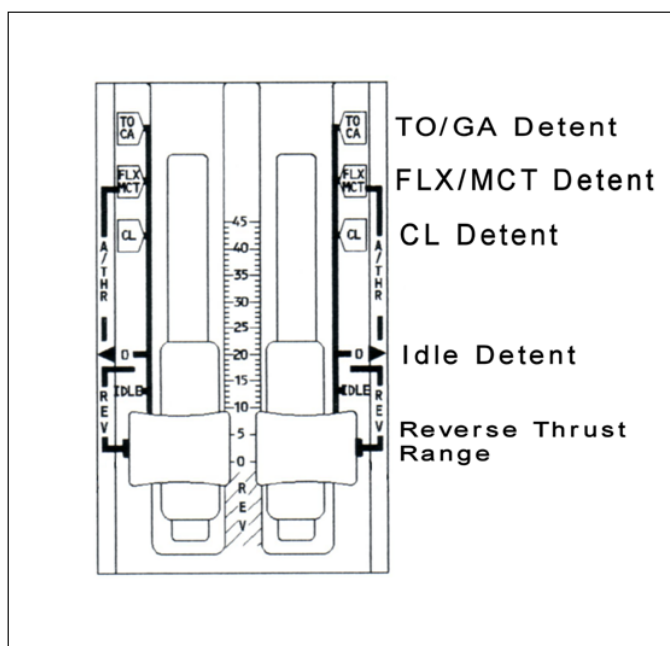
**Figure 3: Thrust lever overview showing detents**

The A320 has five detents for the throttle levers (Figure 3). If the auto thrust is armed, it changes to being activated when the thrust levers are set between the IDLE and climb (CL) detents. As the takeoff was a flex temperature takeoff, the auto thrust was armed, but not yet activated, as the thrust levers were in the FLX/MCT detent, which is beyond the CL detent.
