## Making safe transport even safer

# Aviation Safety Bulletin

**The ATSB has released its latest bulletin of short investigation reports. This edition of the Bulletin highlights valuable safety lessons for pilots, operators and safety managers. Several investigations from the Bulletin are featured below.**

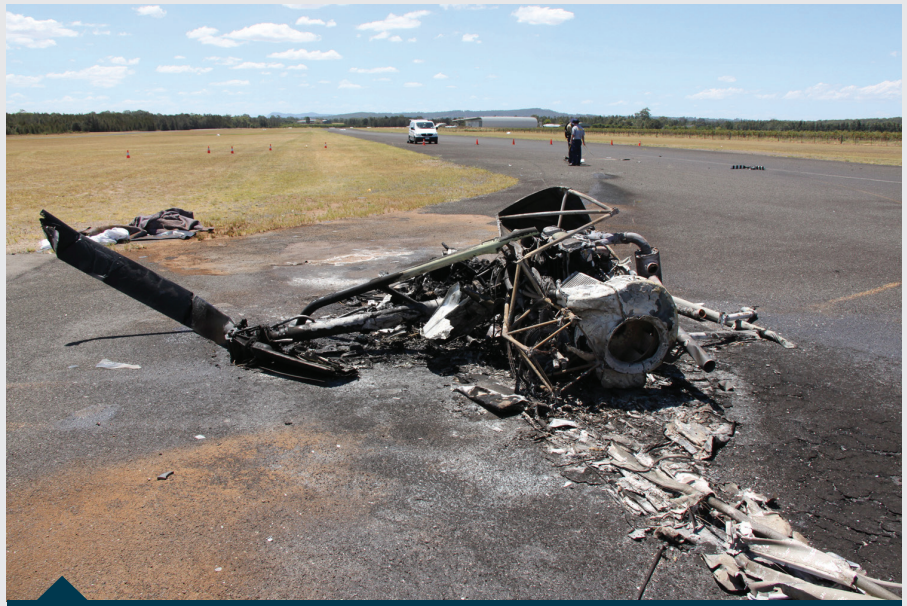
**Two fatal R44 helicopter accidents in Australia have demonstrated the potential danger of the all-aluminium fuel tank.**

Wreckage of the R44 helicopter after crashing at Cessnock Aerodrome

***The ATSB strongly encourages all operators and owners of R44 helicopters fitted with all-aluminium fuel tanks to consider replacing these tanks with bladder-type fuel tanks as detailed in the manufacturer's Service Bulletin 78B as soon as possible.***

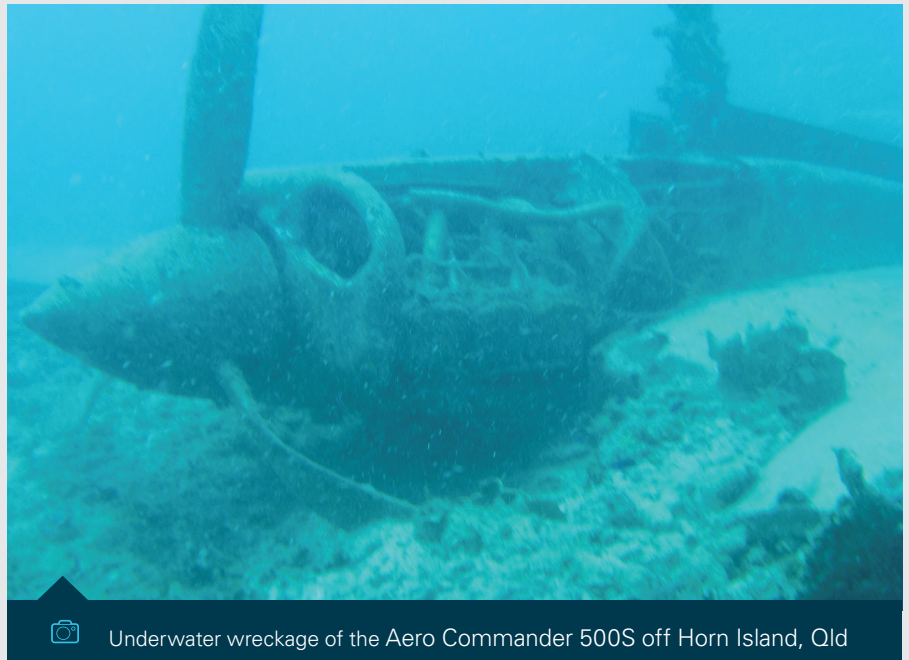
The ATSB investigation found that the aircraft had not broken up in flight and that it had impacted the water at relatively low speed and a near wings-level attitude, consistent with it being under control at impact. There is insufficient evidence to determine why the aircraft impacted the water, however,

Underwater wreckage of the Aero Commander 500S off Horn Island, Qld

several aspects of the flight increased risk. The pilot had only four hours sleep the night before the flight and the operator did not have any procedures or guidance in place to minimise the fatigue risks of early starts. In addition, the pilot, who was also the operator's chief pilot, had either not met the recency requirements or did not have an endorsement to conduct the types of instrument approaches available at Horn Island and other locations.
