Loss of separation involving Boeing 737, VH-VZC and Boeing 737, VH-VOT at BLAKA

93 km south-south-east of Brisbane Airport, Queensland | 29 July 2011

Aviation Occurrence Investigation AO-2011-090 Final – 6 March 2013

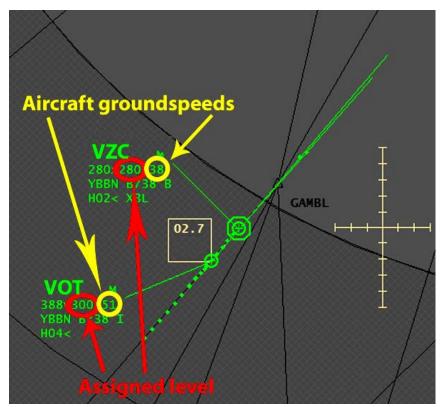
Figure 1: Proximity of the aircraft at 0746:34

At 0746:31, VZC was maintaining FL280 and VOT was 2.7 NM (5.0 km) behind and 10,800 ft above VZC. At 0746:34 there was 130 kts closing groundspeed between the aircraft as VZC had reduced speed and VOT had not (Figure 1).

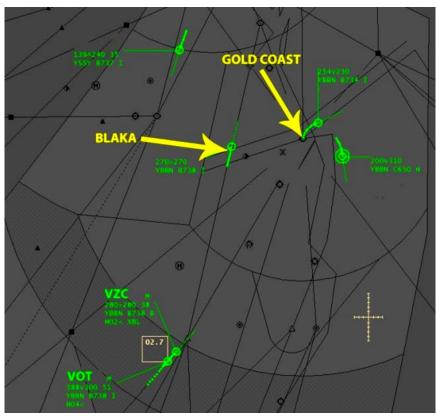
Figure 2: GOL sector traffic at 0746:34

The GOL controller had four other aircraft on frequency, with one of those aircraft tracking overhead BLAKA to enter a left holding pattern and two operating in a right holding pattern overhead the Gold Coast for arrival into Brisbane. The fourth aircraft had departed Brisbane for Sydney, New South Wales (Figure 2). From 0746:54 to 0752:02, the GOL controller managed the aircraft sequence out of the Gold Coast holding pattern, in addition to the southbound aircraft out of Brisbane.

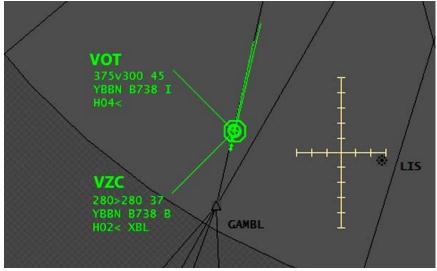
Figure 3: Proximity of the aircraft at 0748:03

During that period, at around 0748:03, VOT overtook VZC with a groundspeed 80 kts faster than VZC and at a height of 9,500 ft above VZC (Figure 3). The

controller reported that they did not observe VOT overtake VZC or recognise that the aircraft had changed positions in the sequence. They subsequently processed VOT as if it was the first and lower aircraft in the arrival sequence.

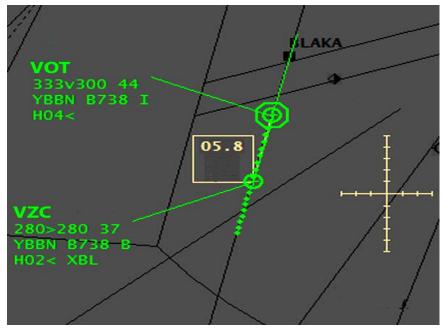
At 0752:09, the GOL controller assigned VOT descent to FL270, which resulted in a loss of separation assurance $(LOSA)^4$ between VOT and VZC. At that time, VZC was maintaining FL280, and VOT was 5.8 NM (10.7 km) ahead and 5,300 ft above VZC, and descending (Figure 4).

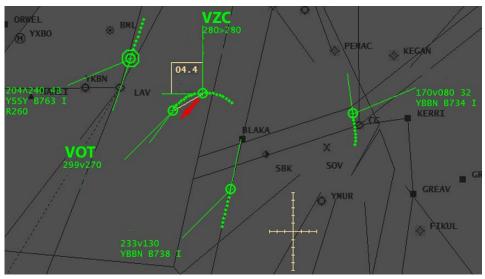
Figure 5: GOL sector traffic at 0755:31

At 0755:31, the GOL controller issued VOT's flight crew further descent to FL170 and required them to report prior to commencing the inbound turn in the holding pattern. At that time, VOT was 4.4 NM (8.1 km) ahead and 1,900 ft above VZC (Figure 5). The GOL controller continued to control the other aircraft under their jurisdiction and made numerous transmissions, including an apology to one flight crew for a delay in actioning their flight level request, as the controller was 'a bit busy before...'.

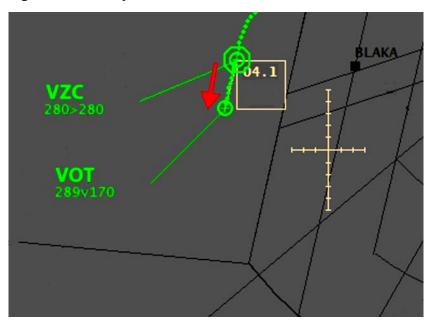
Figure 6: Proximity of the aircraft at 0756:55

At 0756:55, a loss of separation occurred between VOT and VZC, when separation reduced to 4.1 NM (7.6 km) and 900 ft as VOT descended through FL289 (Figure 6). The required separation minimum was 5 NM (9.3 km) by radar when there was less than 1,000 ft vertical separation.

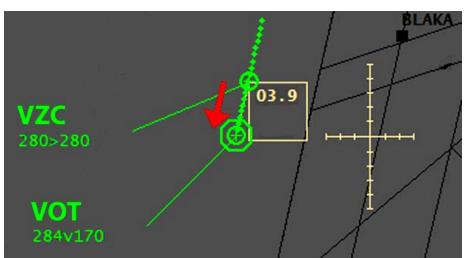
Figure 7: Proximity of the aircraft at 0757:34

At 0757:34, the separation between VOT and VZC had reduced to 3.9 NM (7.2 km) and 400 ft (Figure 7). The flight crew of VZC asked the controller for clarification of their newly assigned flight level, but the controller did not respond to the query at that time. The next GOL transmission was an instruction for VOT to climb to and maintain FL290, which that flight crew acknowledged. The controller then instructed VZC to descend to FL270, and the flight crew responded that they had previously been cleared to FL250. The controller then amended VZC's clearance to FL250. At 0758:00, the required vertical separation standard was re-established.
