Airspace related event involving Kingair, VH-VAH and Ag-Cat, VH-IFE

Swan Hill aerodrome, Victoria, 21 November 2012

ATSB Transport Safety Report
Aviation Occurrence Investigation
AO-2012-156
Final – 21 March 2013

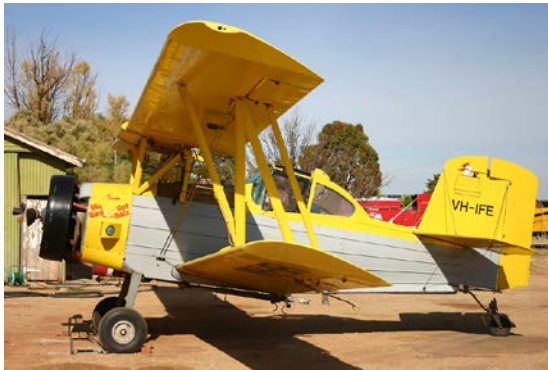
Figure 1: VH-IFE

At about the same time, an Ag-Cat aircraft, registered VH-IFE (IFE), was approaching the circuit at Swan Hill after completing crop spraying at Robinvale, New South Wales. IFE (Figure 1) was tracking south-easterly and maintaining about 100 ft above ground level. The pilot conducted a look-out for other aircraft operating in the circuit area and specifically checked, but did not see any aircraft on final approach for runway 26. IFE commenced a right descending turn, about 500 m from the runway 26 threshold.

IFE is a single-seat bi-plane aircraft that was not fitted with a radio. The pilot normally maintained a listening watch on a hand-held radio device. However, to avoid damage from the weather and chemicals he removed the hand-held radio when the aircraft was not flying. On this occasion, the pilot had inadvertently left the radio at home.

As a result of this occurrence, the operator of VH-IFE has advised the ATSB that, as a result of this occurrence they will be fitting the aircraft with a radio.

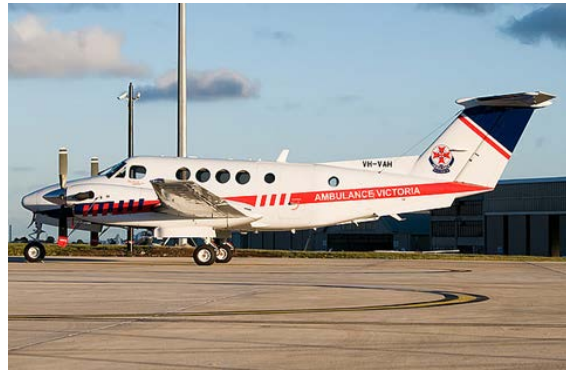
Figure 2: VH-VAH

At the same time, VAH (Figure 2) was about 1.5 NM from the same runway threshold, about 400 ft above the ground and configured for landing, when the pilot noticed IFE at low-level. He immediately made a radio broadcast, but did not receive a response. The pilot of VAH then elected to continue the approach and monitor the agricultural aircraft.

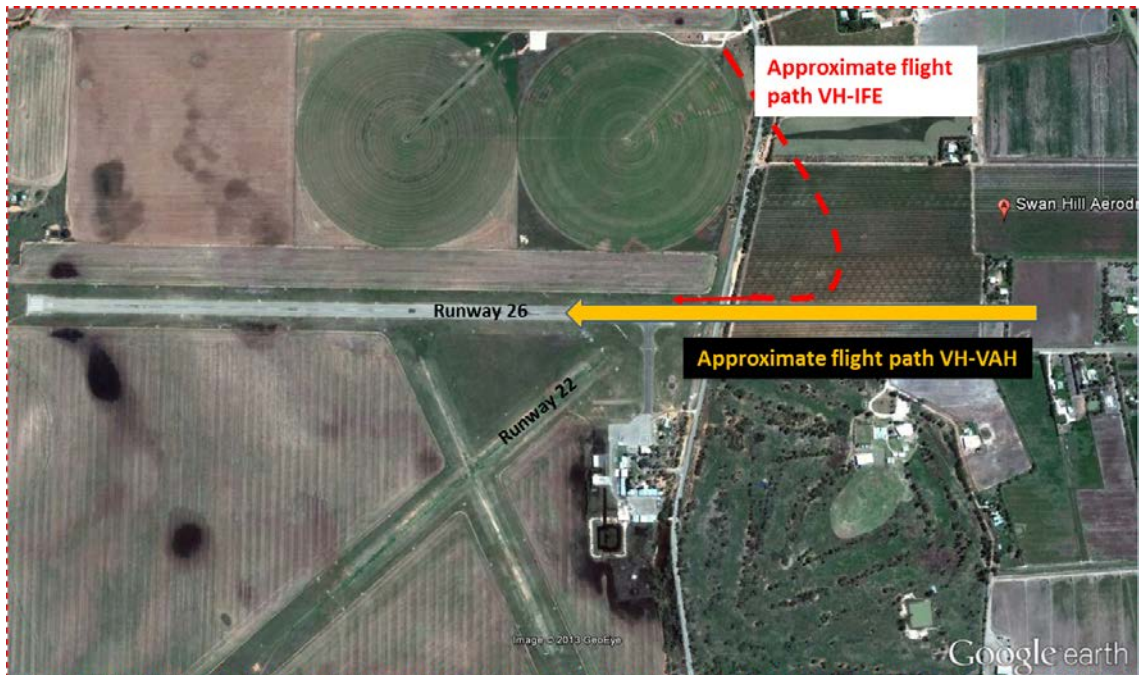
Figure 3: Approximate flight path of both aircraft at Swan Hill Aerodrome

The pilot of IFE continued a right descending oval approach (Figure 3) and landed short, on the grass to the right of the sealed section of runway 26. The aircraft then turned right and taxied back to the threshold, remaining close to the runway gable markers. At this point, the pilot of IFE then saw the lights of VAH on short final for runway 26. He manoeuvred to keep IFE as close to the northern gable markers as possible.

The pilot believed the aircraft was landing on runway 22 and would be clear of VAH, as he had observed IFE arriving from the north-west, then commence a curved approach. However, he was unable to establish communication with IFE to confirm this expectation. He was surprised when IFE continued the turn and landed on the grass on the right side of runway 26. At this stage, he felt it was safer to continue the approach and land further down the runway.
