Analysis of accidents involving VH-registered
non-factory-built aeroplanes 1988–2010

Part 2

ATSB Transport Safety Report
Aviation Research Investigation
AR-2007-043(2)
Final – 26 March 2013

Aviation Research Report
AR-2007-043(2)
FINAL

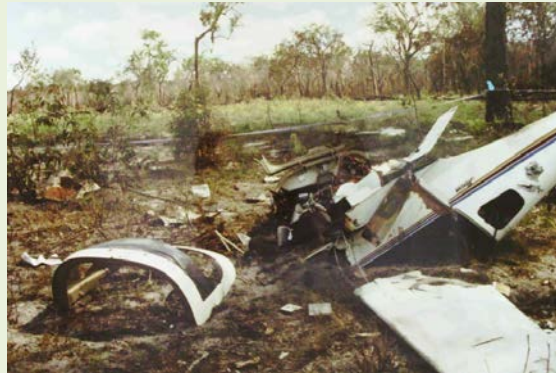
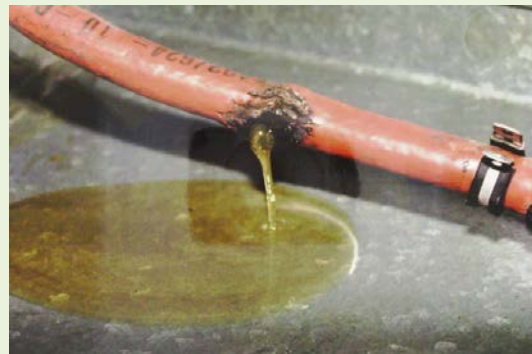
The pilot in command transmitted a MAYDAY to Brisbane Sector 3L, stating that the engine had lost oil pressure and that it was her intention to land on a road. After a search involving a number of aircraft, the wreckage of the aircraft was found in a recently cleared paddock surrounded by coastal scrub country. The pilot received fatal injuries.

On-site investigation indicated that the aircraft was banked left at more than 90 degrees, and was approximately 45 degrees nose-down at impact. The aircraft then cartwheeled and broke up when it struck a windrow of felled trees. The landing gear was extended at impact. Engine oil was streaked along the lower fuselage aft of the engine compartment.

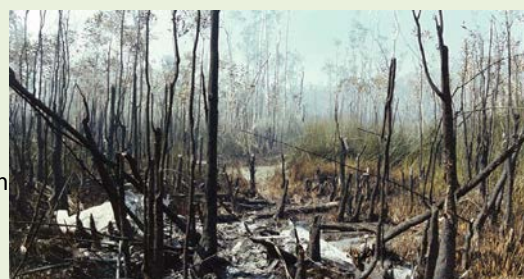
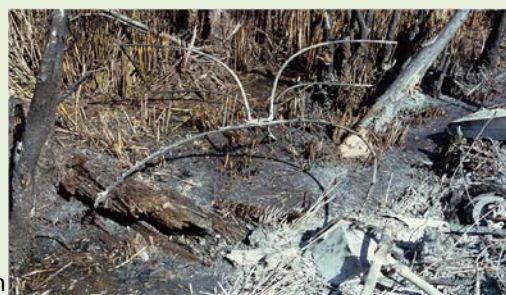
The aircraft was observed to take off and climb to about 500 feet before commencing a right turn. It then appeared to abruptly change attitude in pitch and roll a few times before adopting a nose low attitude and disappearing behind trees. The aircraft crashed into a shallow swamp and caught fire. On-site examination revealed that the aircraft struck the ground

in a steep nose and right wing low attitude. The pilot reported that the engine began running roughly and lost power shortly after take-off. An examination found no fault with the engine or carburettor; however, fire damage precluded testing of the magnetos. The aircraft attitude at impact was indicative of it being in a stalled condition.
