# Aviation Short Investigation Bulletin

Issue 16

AB-2013-028

Final – 21 March 2013

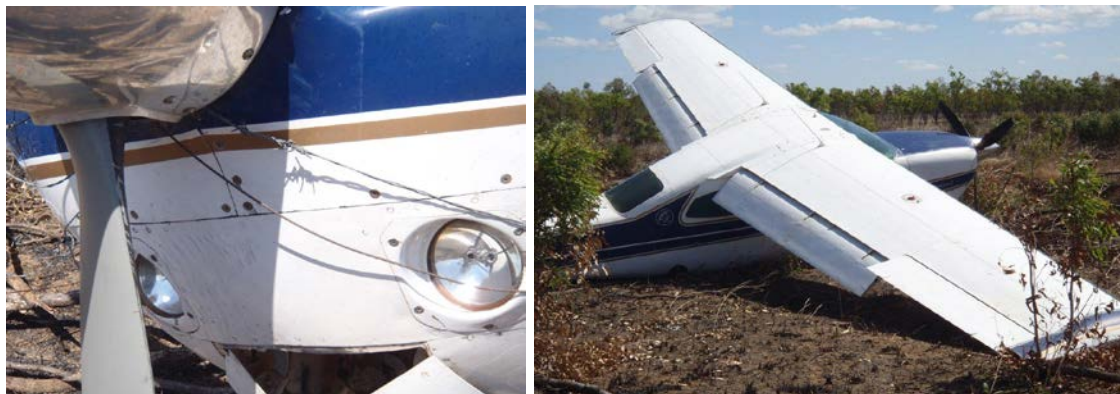
**Figure 1: Accident site**

The pilot stated that sun glare increasingly restricted visibility during the landing and he was unsure the amount of runway used. The aircraft touched down and the pilot applied heavy braking in short bursts. The pilot reported that the aircraft only slowed a little on the runway gravel surface and then the aircraft departed the end of the runway and travelled through two fences before coming to a stop. The aircraft came to rest on the right side of the fuselage, right wing and right horizontal stabiliser. The pilot secured the aircraft and the pilot and two passengers evacuated the aircraft. The pilot received minor injuries while evacuating the aircraft from barbed wire that had become entangled around the front of the aircraft (Figure 1). The two passengers were uninjured.

The operator inspected the runway, which was in good condition with a hard surface. The inspection found that the touchdown point was over half way down the runway. A runway edge marker had been run over by the left main landing gear tyre, before the aircraft came back onto the runway and then exited the end of the runway. The operator determined that the distance from the runway end to the second fence line was about 80 m. The flaps were observed to be at the full flap setting.

- During training greater emphasis will be placed on go-around procedures and identify situations when it would be used.
- Particularly during training increase awareness to consider the planning of circuit entry and ensure a backup is considered if conditions are not what was expected.
- Go-around procedures are practiced during in command under supervision (ICUS) training.

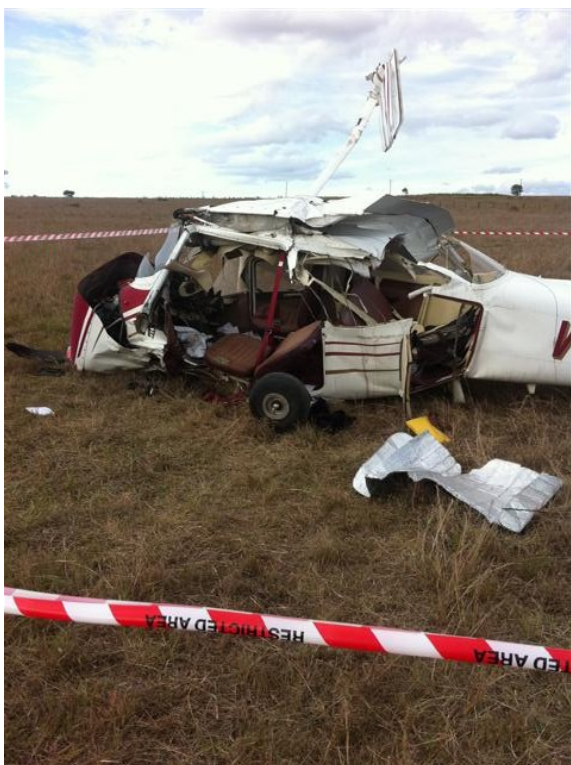
**Figure 1: VH-JGR**

On 7 November 2012, at about 1000 Eastern Standard Time<sup>1</sup> a Cessna 172N registered VH-JGR (JGR) departed Archerfield Airport, Queensland on a training flight. The purpose of the flight was to conduct solo pre-test revision, prior to the pilot performing the Private Pilot Licence (PPL) flight test. The aircraft was booked for 2 hours. During the flight, the aircraft impacted terrain and was substantially damaged (Figure 1).

The pilot was the only person on board and suffered severe injuries as a result of the accident and at about 1500, he was airlifted to hospital.

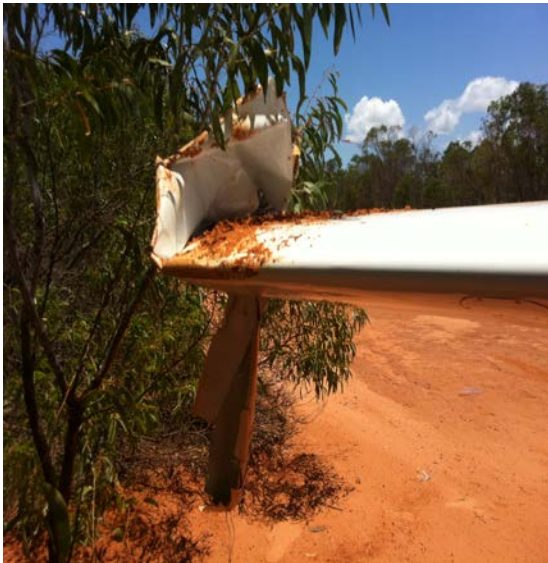
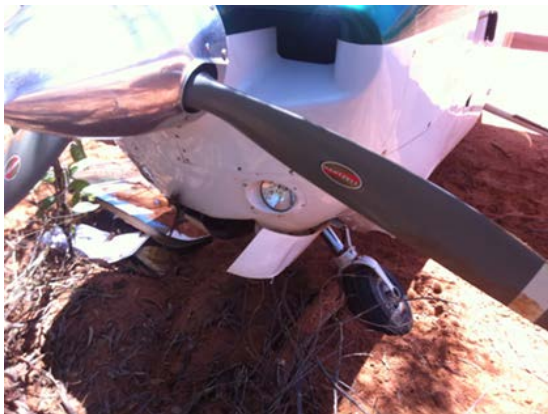
**Figure 1: Right wing and nose gear damage**

The pilot ensured the aircraft was safely shut down, and then assisted the passengers. One passenger received minor injuries and the aircraft sustained substantial damage.

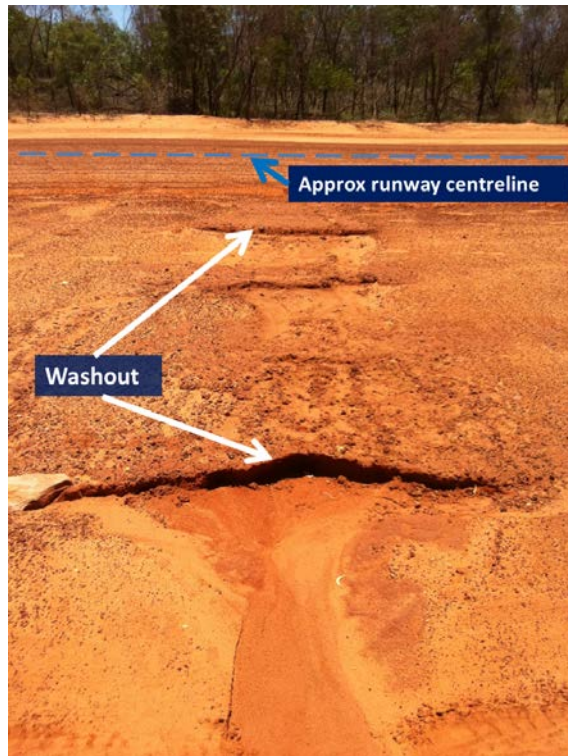
**Figure 2: Washout on edge of airstrip**

After the accident, the pilot of the second aircraft inspected the airstrip and reported substantial washout on the edge of the strip inside the cone markers (Figure 2).

The aircraft operator reported that Cape Leveque management closed the airstrip the day after the accident to grade the surface and repair the washouts.

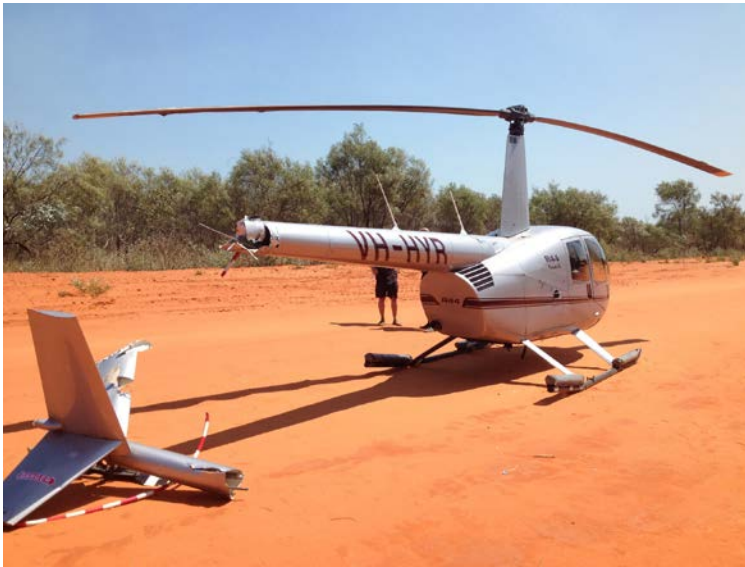
**Figure 1: VH-HYR**

The pilot planned on performing a power recovery<sup>7</sup> and terminated the autorotation at about 10 feet above the ground with 0 knots groundspeed,<sup>8</sup> at the same time winding on throttle to increase the engine RPM, however the engine did not respond. The low rotor RPM light and horn activated and the pilot increased the collective lever in attempt to utilise the remaining rotor RPM to cushion the landing. However, the helicopter landed heavily and the main rotor severed the tail boom. All occupants exited the helicopter without injury.

*Erratic operation is usually indicative of wiring damage or tachometer point problems. Wiring damage may be evidenced by crushing, pinching, or abrasion, all of which can result in grounding of one or both centre wire conductor(s) to the shielding or to structure. Tachometer point problems may be caused by contamination (due to over-lubrication of magneto cam follower felt), oxidation (such as from an obstructed vent plug or leaking magneto drive seal), or loose contact(s), in addition to installation or assembly errors.*

The ATSB did not attend the accident site or examine the aircraft and the reason for the accident could not be conclusively established. A malfunction within the governor assembly was not able to be ruled out. However, it is considered likely that the engine’s right magneto may have malfunctioned by providing an incorrect signal to the governor assembly which manifested as a governor failure.

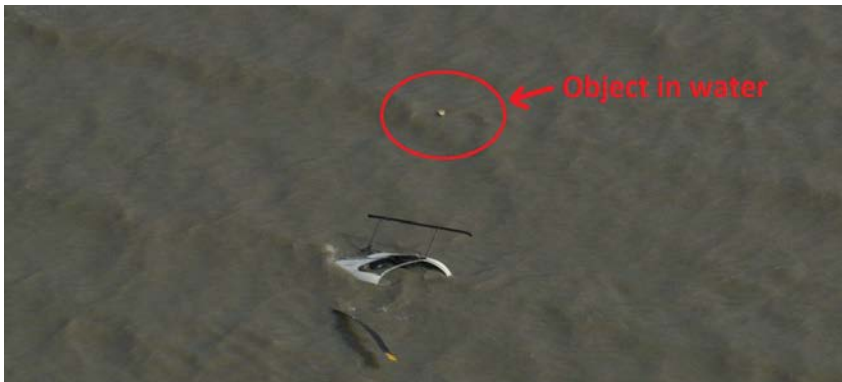
**Figure 1: VH-HTD**

The Australian Maritime Safety Authority (AMSA) was alerted to the accident by the aircraft's Emergency Locator Transmitter (ELT), which had activated during the accident sequence. A rescue helicopter was dispatched from Cairns and the pilot and two fishermen were located, at about 0600 the following day, 1.8 km from the accident site.

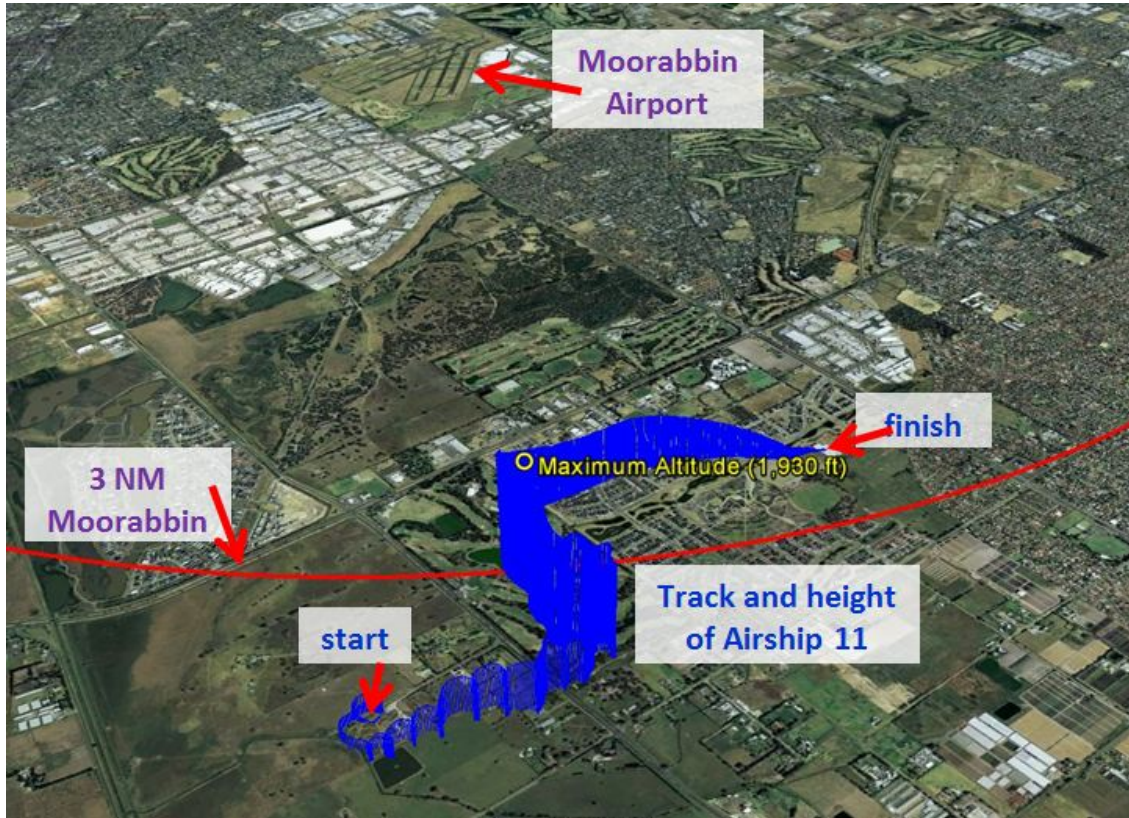
**Figure 1: Track and height of Airship 11**

The PIC elected to land the airship, however, the rearward centre of gravity resulted in the airship climbing. The PIC also noted that the airship's elevator controls were not responding. When climbing through 200 ft, the PIC determined that control of the airship had been lost although the data link was still functioning. The PIC reduced engine power to the idle position (the flight termination procedure<sup>5</sup>), but the airship continued to climb and track in a north-westerly direction toward the Moorabbin control area (Figure 1).

- **Control rod failure:** The loss of control was due to one of the tail-fin control rods becoming detached from a ball link. The rod had been incorrectly threaded into the housing when installed. A quality assurance check of the installation was not conducted.
- **Centre of gravity:** The crew had insufficient experience in setting up the airship and the manufacturer did not provide documentation for centre of gravity calculations.
