Collision between train BC151 and an excavator

near Maitland, NSW | 20 December 2011

ATSB Transport Safety Report

RO-2011-018

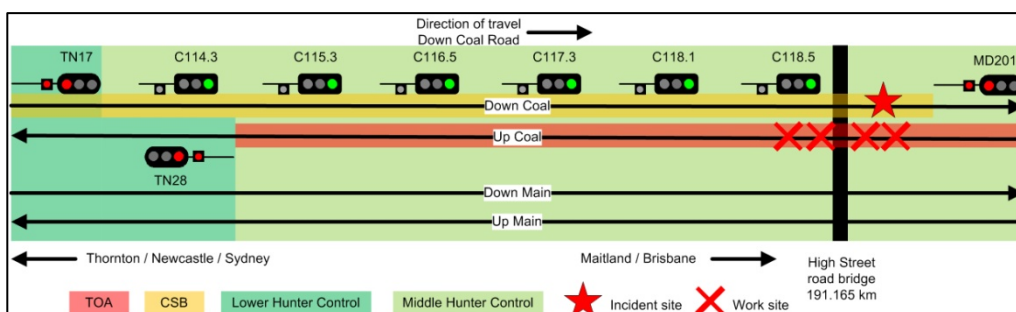
Figure 5: Diagram of network control responsibility versus authorities

Road for the period 0727 until 0800 by placing a block¹⁰ on controlled signal¹¹ MD220¹² located at Maitland and TN28 at Thornton Junction.

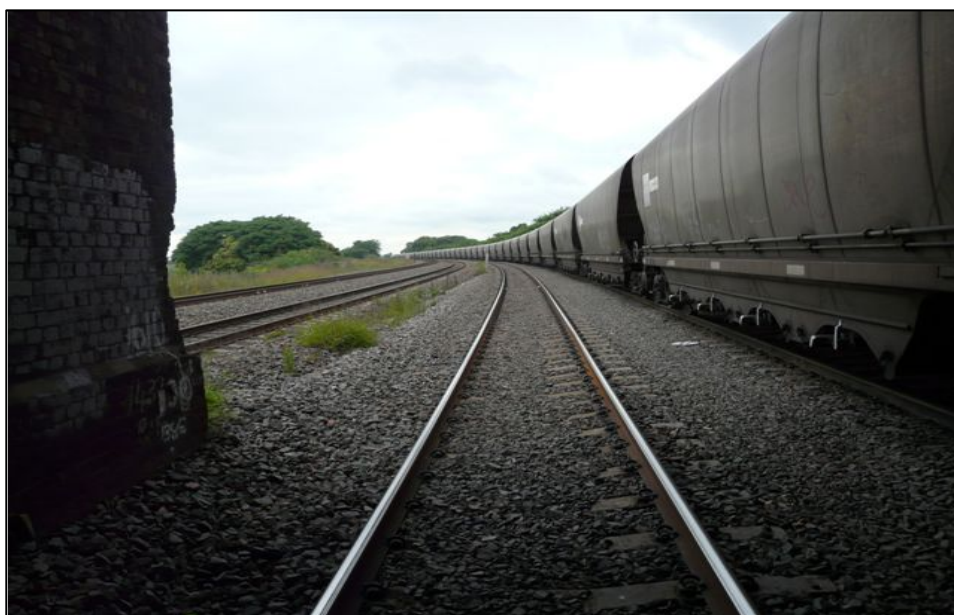
Figure 6: Visibility from the worksite, beneath High Street Bridge

Due to the curvature of the track, the High Street overbridge and the works being located in the vicinity of the bridge, the ability of the train crew on BC151 to clearly see the worksite on the approach was somewhat limited (Figure 6).

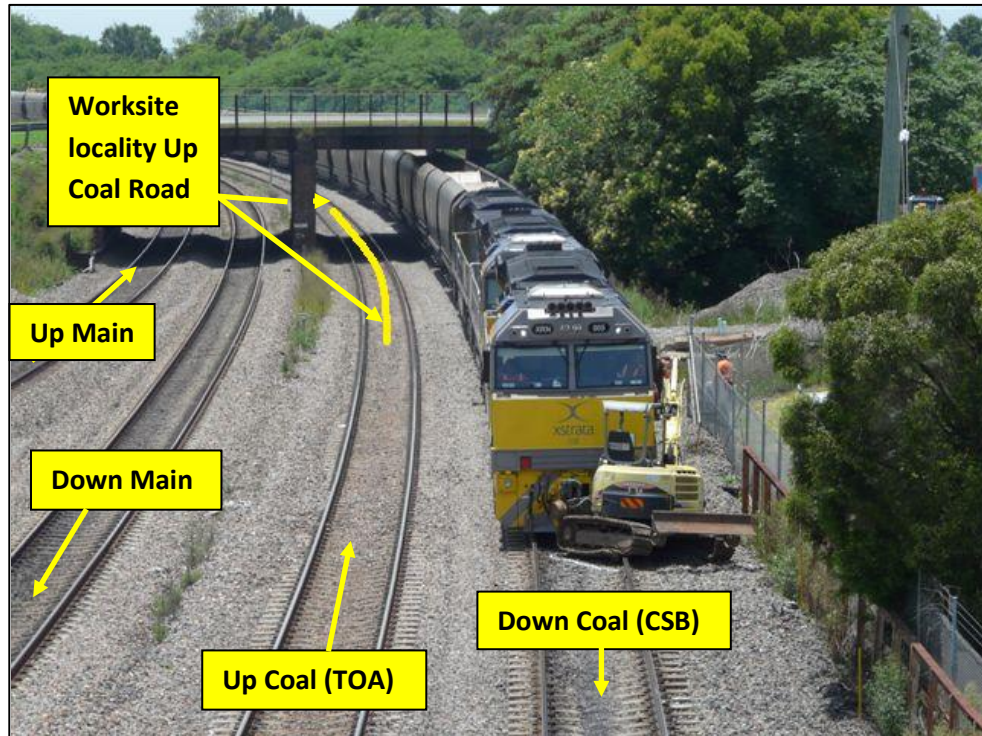
Figure 7: Collision aftermath

As the train approached the High Street overbridge, the drivers saw someone in an orange vest that appeared to be facing the other way. The locomotive horn was sounded for a short duration (a routine action when someone is observed on or near the track) and the drivers waited for a 'clearance' signal (a raised arm) to indicate all was well. The drivers then recognised that the person in the orange vest was waving people to get off the track, so they made a 'minimum' application to the train brakes. Moments after this brake application, the drivers sighted the excavator on the track beyond the bridge and increased the train brake application to an 'emergency application'. The two drivers then vacated their seats and sought refuge in the vestibule behind the driver's cabin. Moments later, the train collided with the excavator pushing it down the track a short distance (Figure 7).

The excavator was extensively damaged in the collision and there was minor damage to the lead locomotive. However, the train was able to resume its journey after a routine change of the crew had been carried out.

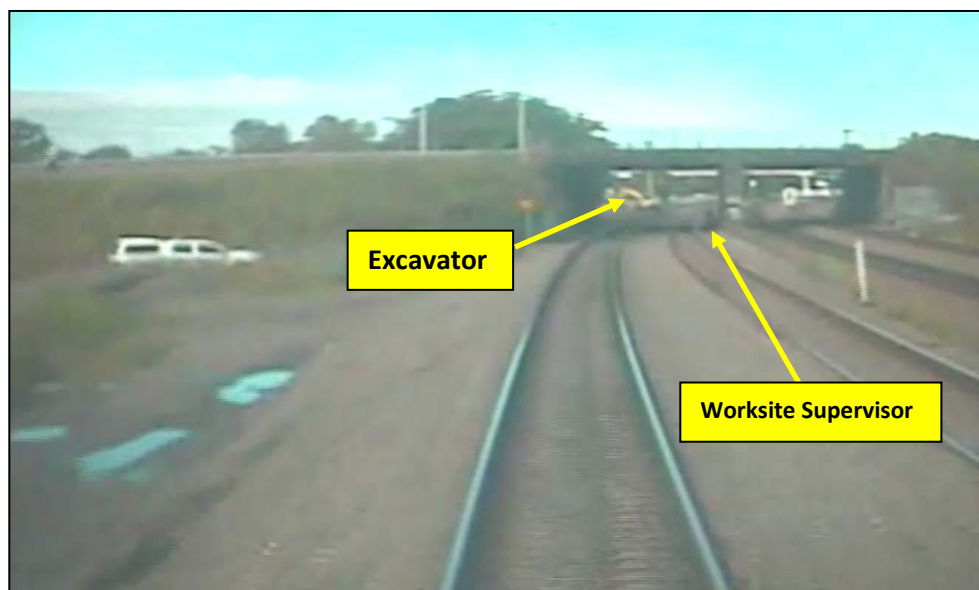
Figure 8: View from the locomotive, as the emergency brake was applied

The first recorded indication of diversion from routine train handling was when the horn of the lead locomotive was sounded for 1.5 seconds. The data shows that this took place 377 m and 24 seconds prior to impact. About 6 seconds later, and 270 m prior to impact, a minimum reduction brake application was made followed 8 seconds later by an emergency brake application. At the time of the emergency brake application, the train's speed was 61 km/h and the leading locomotive was 130 m from impact (Figure 8).

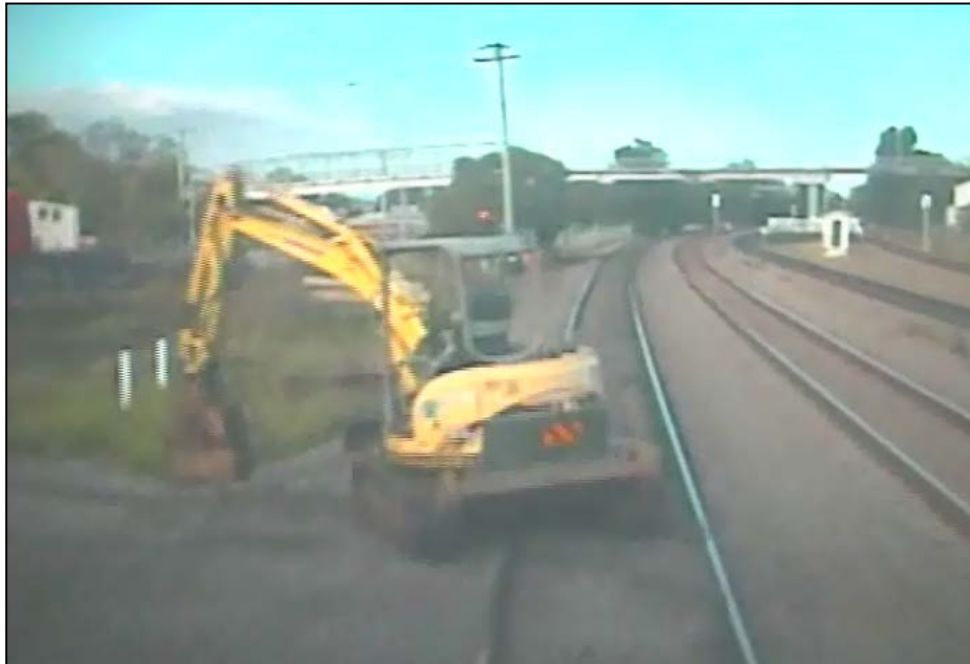
Figure 9: View from the locomotive just before impact

At the time of impact, the train's speed was 42 km/h. The train stopped 59 m beyond the point where it collided with the excavator.
