Australian Government
Australian Transport Safety Bureau

Aviation Short Investigation Bulletin

Issue 17

AB-2013-050

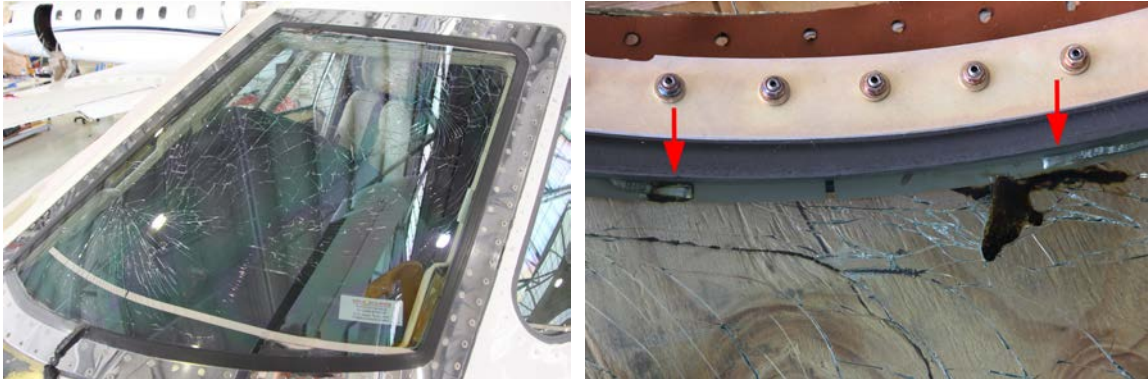
Figure 1: Shattered left windshield external (left) and internal (right)

The aircraft returned to Sydney on 26 January 2013 with no passengers on board. Subsequent examination of the left electrically heated glass windshield (part number 9914380-11) by the ATSB showed that the outer ply had shattered across the entire surface (Figure 1). A brown discolouration was observed towards the top right of the windshield (facing forward) along with staining around one of the soldered contacts (Figure 2). The damage was confined to the outer layer of the windshield.

The windshield from VH-RCA had likely been affected by moisture ingress resulting in a degradation of the electrical connection between the bus bar and the heating film. The ATSB is satisfied that the issues leading to the non-structural failure of windshield part numbers 9914380-11/-12 have been addressed by the manufacturer.

The above changes were incorporated into part number 9914380-13/-14 which was released to service in early 2008. There have been no reported cases of either of these failure modes in the -13/-14 windshields.

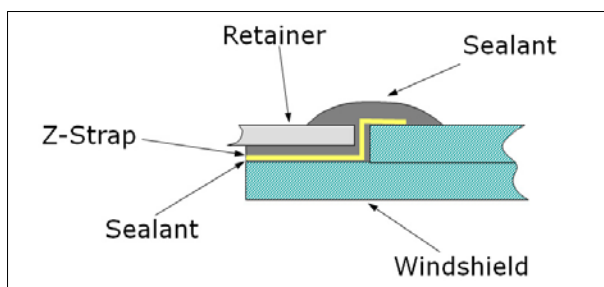
Figure 2: Schematic showing location of z-strap

The first issue was related to moisture ingress. Wear of the seal at the top of the windshield could allow moisture ingress to the bus bar and lead to degradation of the electrical connection between the bus bar and the heating film which could eventually begin to burn out. This could result in arcing that could eventually lead to failure of the outer non-structural face ply of glass. The manufacturer addressed the issue by adding a fiberglass z-strap along the boundary of the face ply to add an additional moisture protection layer and to also provide an indicator of seal wear.

The second issue was a breakdown of the bus bar at the bus bar solder joint as a result of differing thermal coefficients of expansion between the solder and bus bar material. Thinner bus bars (as a result of normal variation in production) were susceptible to progressively crack until the electrical circuit was opened and arcing began. The extreme heat and pressure build-up of locally vaporized interlayer material due to the arcing would then eventually lead to failure of the non-structural face ply. The issue was addressed by increasing the size and mass of the upper bus bar and moving it down sufficiently to allow for inspections if required.

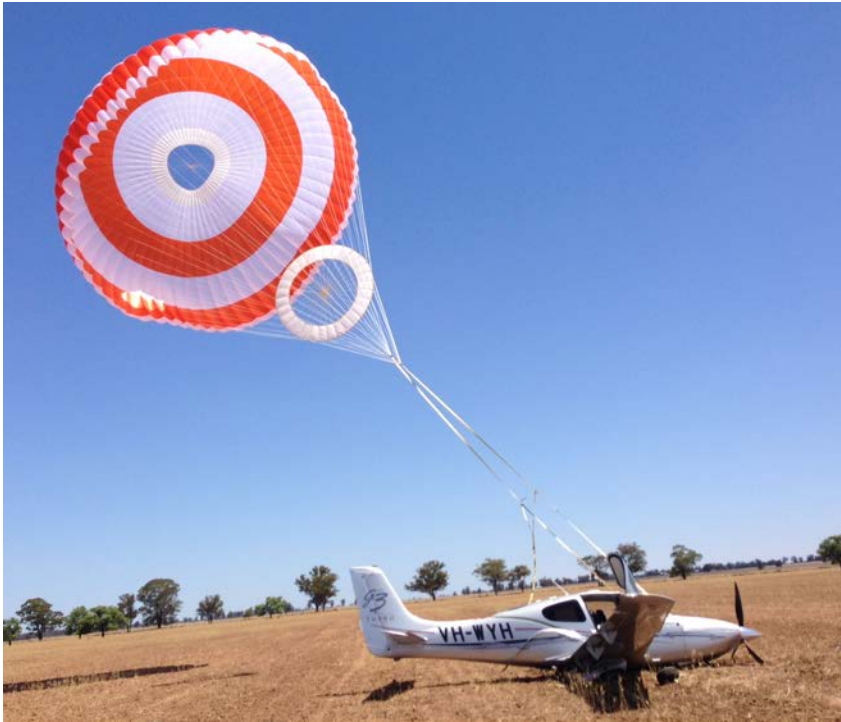
Figure 1: Parachute inflated at accident site

The pilot secured the cabin and about 16 seconds after the parachute deployed, the aircraft impacted the ground in a slight left wing low attitude (Figure 1). The pilot and passenger seat belt air bags deployed and the pilot and passenger exited through the passenger door. The pilot received minor injuries and the passenger was uninjured.

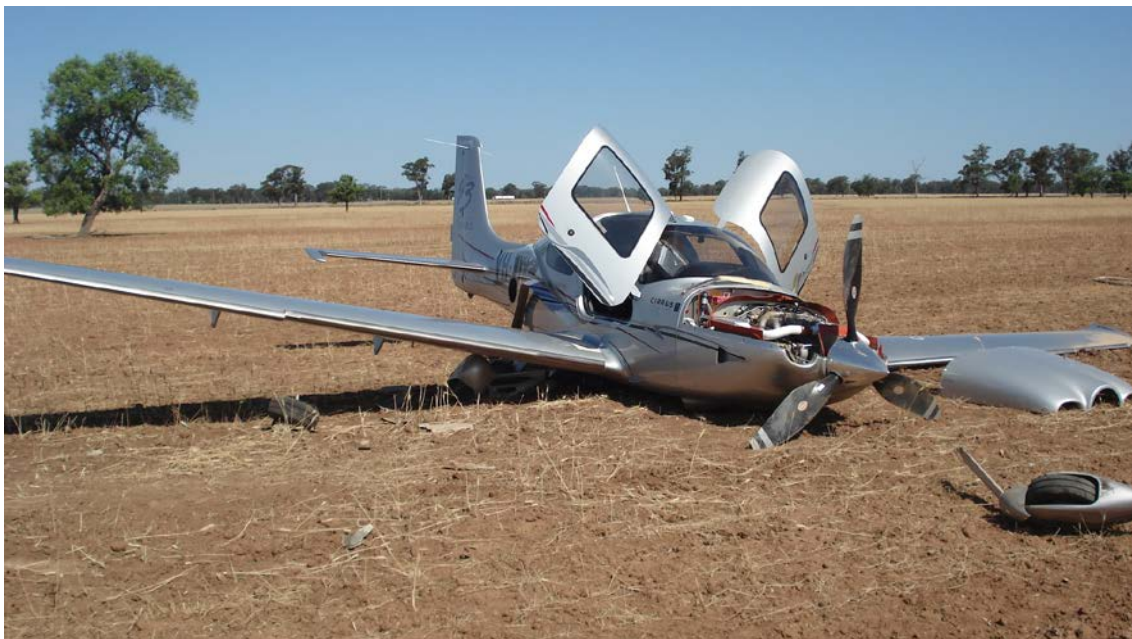
Figure 2: WYH at the accident site

The pilot inspected the paddock after the accident and found that it was very uneven with contour banks that were not visible from the air. The pilot believed that a safe landing on the landing gear would not have been possible.

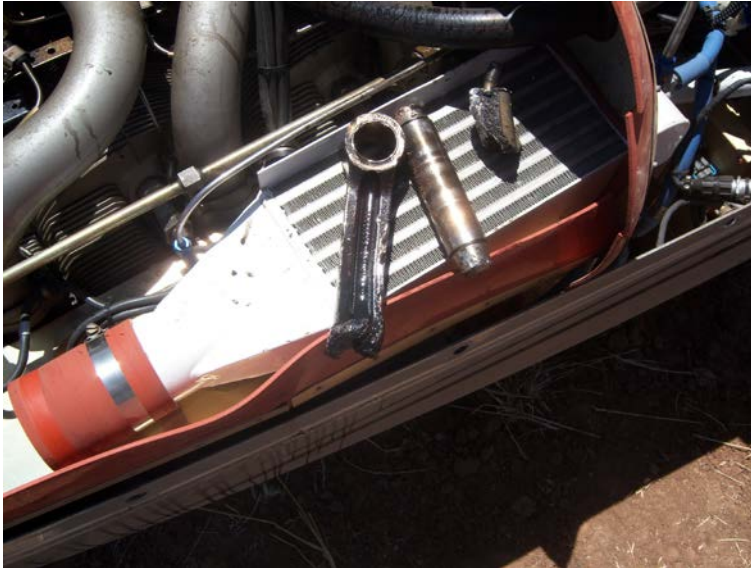
Figure 3: Engine number two cylinder failed parts

The engine was removed and examined at an engine overhaul facility. The inspection revealed that the number two cylinder connecting rod (Figure 3) had separated from the crankshaft due to extreme heat and ruptured the crankcase. A detailed examination did not identify any external oil leaks or internal defects that were not as a result of the lack of oil. 2.1 quarts of oil was drained from the engine sump.

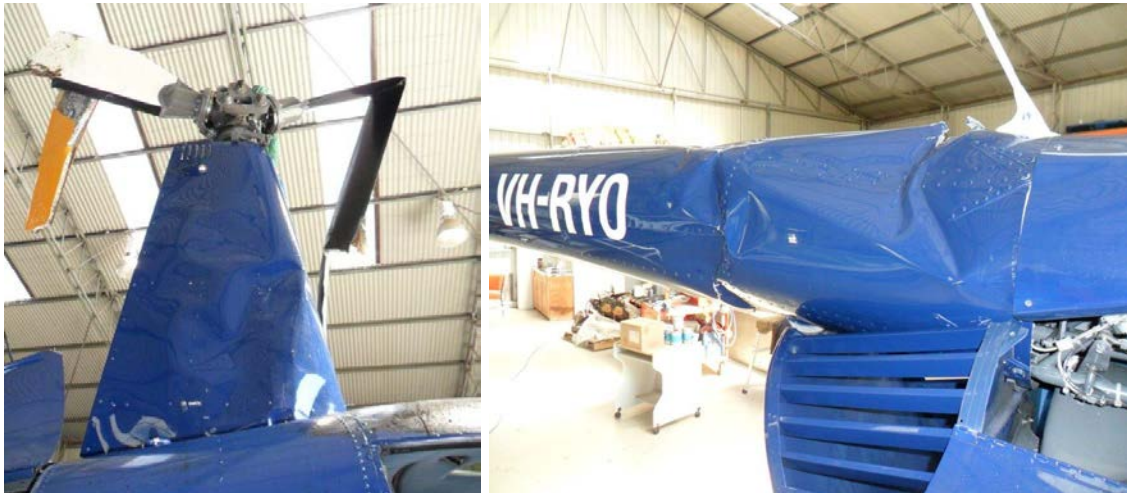
Figure 1: Helicopter damage

A witness reported hearing the rotor RPM behaving erratically and observing the helicopter pitching and rolling. The tail boom contacted the ground several times and the helicopter then rotated around the tail and came to rest on its right side.
