# Collision involving a motor vehicle and train 4460S

10 km south of Port Germein, South Australia | 19 March 2012

## ATSB Transport Safety Report

RO-2012-003

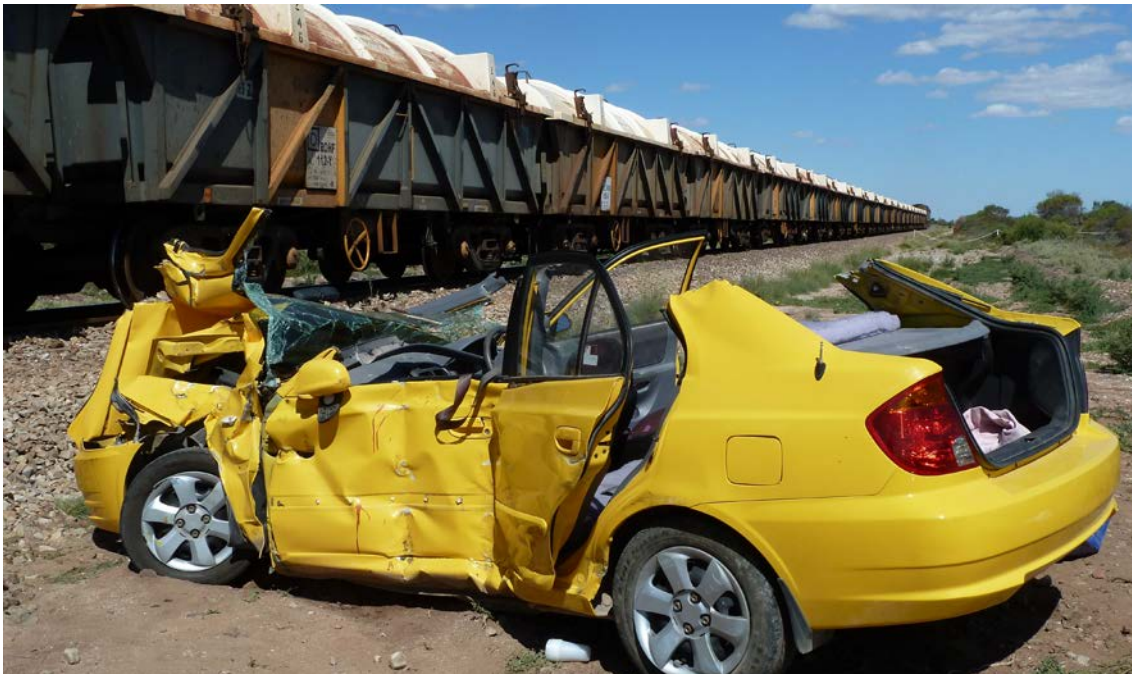
**Figure 1: Vehicle and train involved in collision**

At about the time the car entered the level crossing the train driver responded by making an emergency brake application. Moments later (0939) the train collided with the passenger side of the motor vehicle (Figure 1).

The impact had severely damaged the motor vehicle with the passenger being fatally injured and the driver sustaining serious injuries. The locomotive crew were shaken but not hurt. There was only minor damage to the lead locomotive (NR29) and negligible damage to the track and fixed infrastructure.

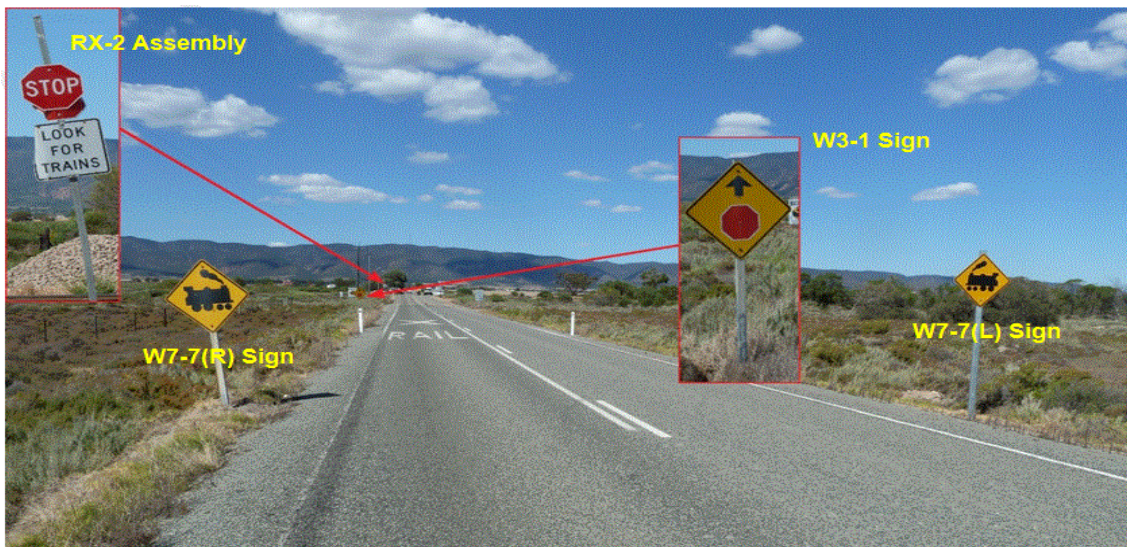
**Figure 3 Motorist’s view of level crossing, travelling in an easterly direction**

The traffic controls installed at the Port Flinders Causeway Road level crossing are passive controls (Figure 3) that require the road user to stop<sup>4</sup> the vehicle at the ‘Stop’ sign/line and detect the presence of a train through direct visual observation.

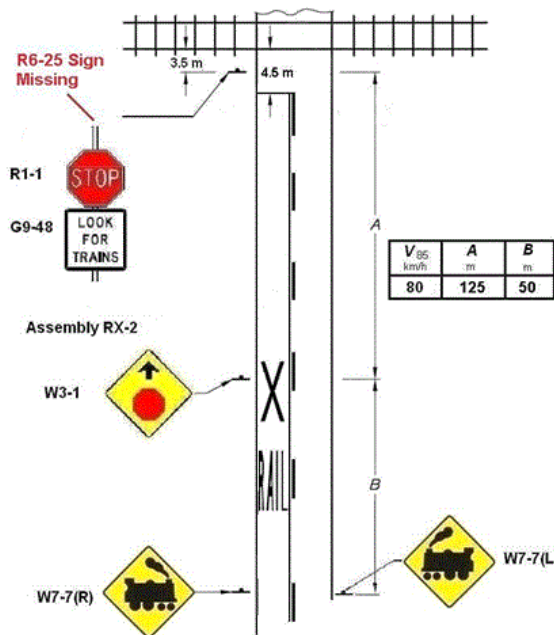
**Figure 5 Signage at level crossing**

There were some minor non-conformances, but these were unlikely to have been factors that contributed to the collision:

- The 'Railway Crossing' assembly (R6-25) was missing from the 'Stop' sign assembly (RX-2). This sign had been removed by persons unknown and had not been replaced during a routine maintenance cycle. However, the 'Stop' sign was still in place.
- The stop line was set back from the RX-2 assembly by about 1.0 m. The standard indicates that the stop line and RX-2 assembly should be adjacent to one another.
- The distance between the 'Railway level crossing ahead' signs W7-7 and the 'Stop Sign Ahead' sign W3-1 was 10 m less than specified in the standard. There was nevertheless more than adequate distance to sight all signs and stop at the crossing when travelling at the legal speed limit of 80 km/h.

The Australian Rail Track Corporation has advised that the signage at the Port Flinders Causeway Road level crossing had been reinstated.

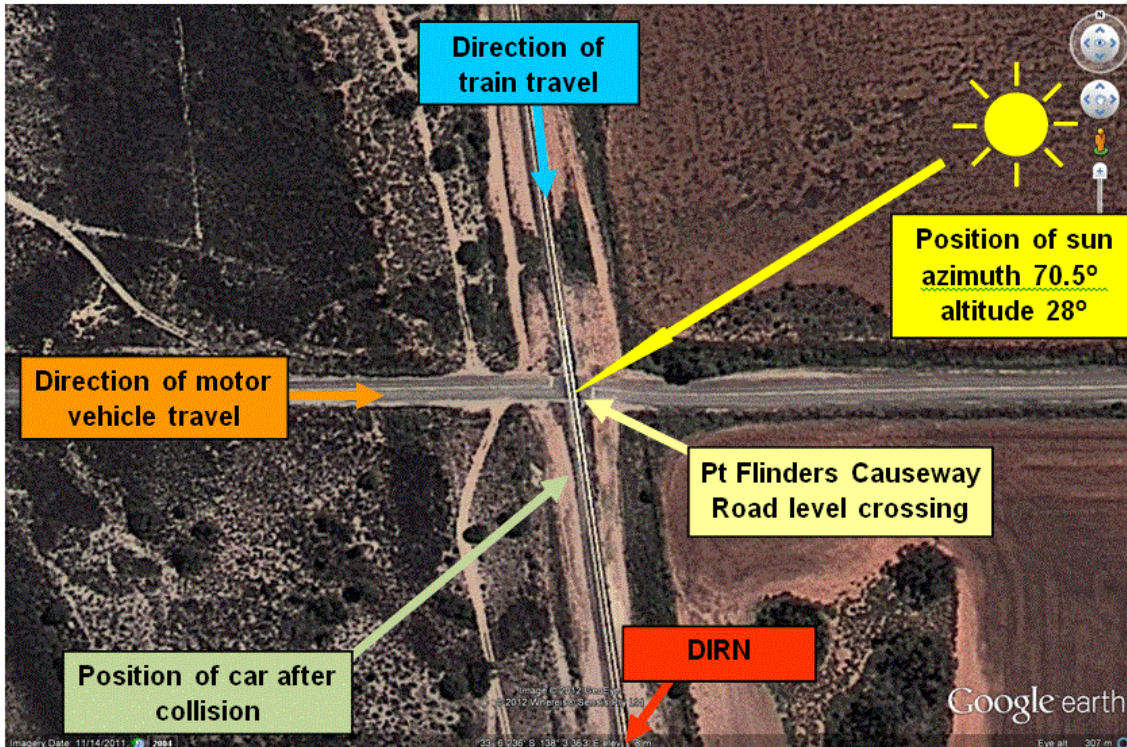
**Figure 7: Aerial view of the Port Flinders Causeway Road level crossing, South Australia**

The roadway crosses the level crossing at an angle close to 78 degrees (Figure 7). Australian Standard 1742.7-2007 prescribes that the maximum viewing angle measured at the stop line, when looking to the left for an approaching train, shall not exceed 110 degrees. An assessment of the Port Flinders Causeway Road level crossing's geometry revealed a viewing angle of 101 degrees for a motor vehicle stopped on the western side at the stop line. This is better than the 110 degrees specified by the standard and indicates that the amount 'head twist' required of the driver was not excessive.

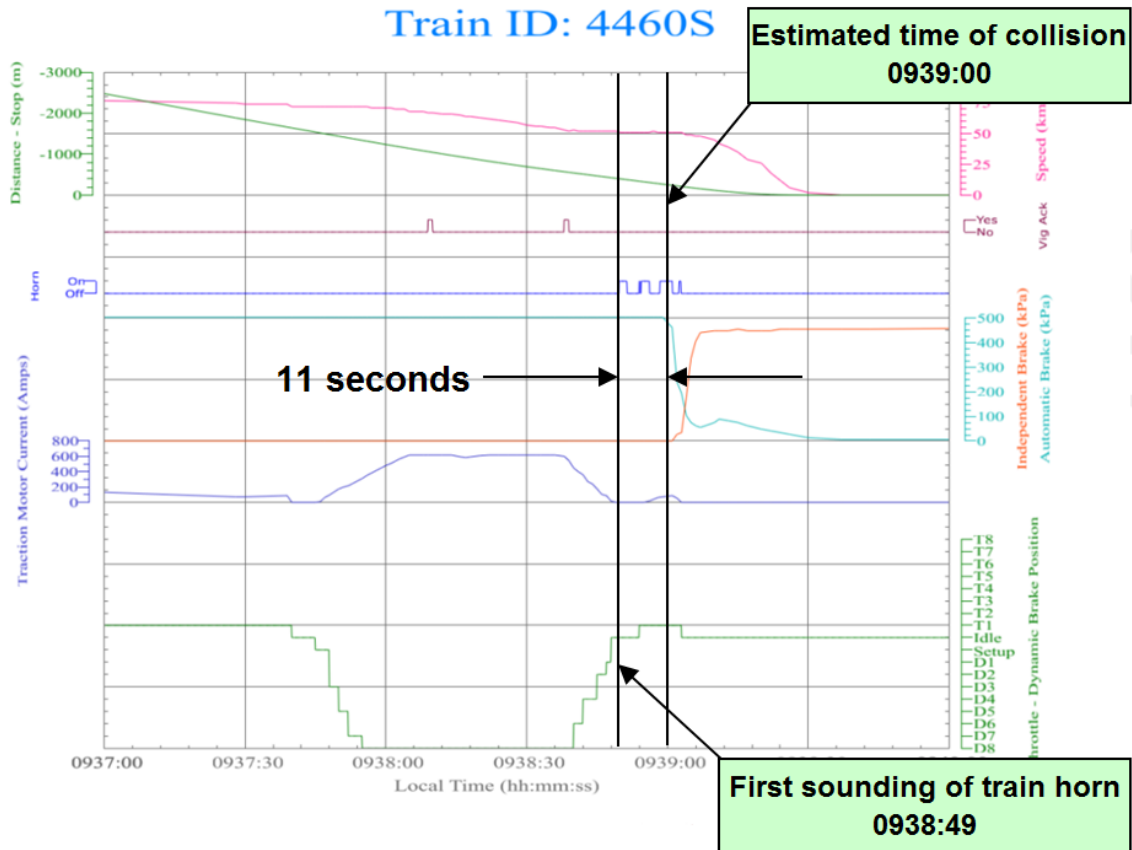
Figure 8: Extract from NR29 locomotive data log

The locomotive (NR29) data logger was a Wabtec Pulse system. Following the collision the data files were extracted and used to derive the graph at Figure 8. Captured data included time, speed, distance, brake, horn and vigilance activation.

- The data logger shows that the train horn was sounded as it approached the crossing. This was corroborated by the witness (driver directly behind the vehicle involved in the collision). The motorist involved in the collision also recalled hearing a horn in the period preceding the collision.
