Windshield cracking event involving Cessna Aircraft Company 750, VH-RCA

460 km south-east of Nadi, Fiji, 15 January 2013

ATSB Transport Safety Report
Aviation Occurrence Investigation
AO-2013-013
Final – 23 April 2013

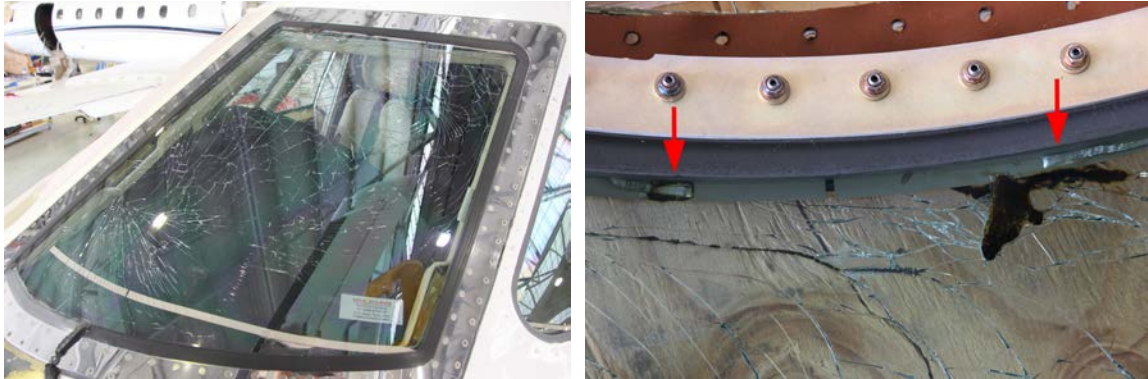
Figure 1: Shattered left windshield external (left) and internal (right)

The aircraft returned to Sydney on 26 January 2013 with no passengers on board. Subsequent examination of the left electrically heated glass windshield (part number 9914380-11) by the ATSB showed that the outer ply had shattered across the entire surface (Figure 1). A brown discolouration was observed towards the top right of the windshield (facing forward) along with staining around one of the soldered contacts (Figure 2). The damage was confined to the outer layer of the windshield.

The windshield from VH-RCA had likely been affected by moisture ingress resulting in a degradation of the electrical connection between the bus bar and the heating film. The ATSB is satisfied that the issues leading to the non-structural failure of windshield part numbers 9914380-11/-12 have been addressed by the manufacturer.

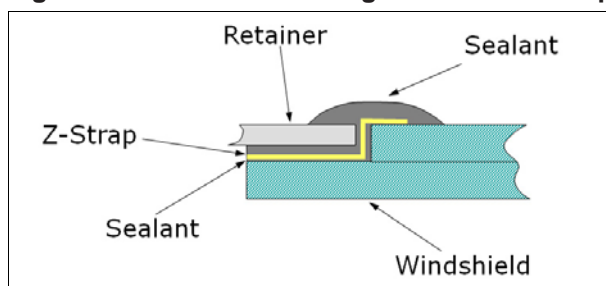
Figure 2: Schematic showing location of z-strap

The first issue was related to moisture ingress. Wear of the seal at the top of the windshield could allow moisture ingress to the bus bar and lead to degradation of the electrical connection between the bus bar and the heating film which could eventually begin to burn out. This could result in arcing that could eventually lead to failure of the outer non-structural face ply of glass. The manufacturer addressed the issue by adding a fiberglass z-strap along the boundary of the face ply to add an additional moisture protection layer and to also provide an indicator of seal wear.

The second issue was a breakdown of the bus bar at the bus bar solder joint as a result of differing thermal coefficients of expansion between the solder and bus bar material. Thinner bus bars (as a result of normal variation in production) were susceptible to progressively crack until the electrical circuit was opened and arcing began. The extreme heat and pressure build-up of locally vaporized interlayer material due to the arcing would then eventually lead to failure of the non-structural face ply. The issue was addressed by increasing the size and mass of the upper bus bar and moving it down sufficiently to allow for inspections if required.

The above changes were incorporated into part number 9914380-13/-14 which was released to service in early 2008. There have been no reported cases of either of these failure modes in the -13/-14 windshields.
