Australian Government  
Australian Transport Safety Bureau

# Reliability of the Robinson R22 helicopter belt drive system

**ATSB Transport Safety Report**  
Aviation Occurrence Investigation  
AI-2009-038  
Final – 30 April 2013

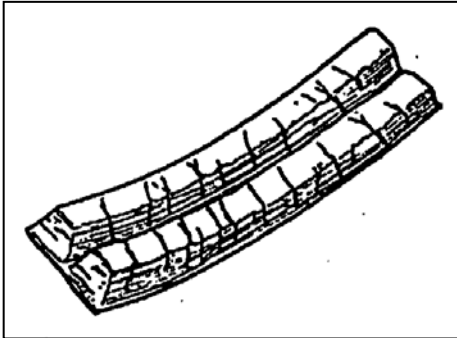
**Symptom: belts cracking**

- Belts are old and have reached the end of their service life.
- Belts are slipping, causing heat build-up and gradual hardening of the tensile undercord.
- High belt temperatures from belt slippage may also glaze the belt side walls.

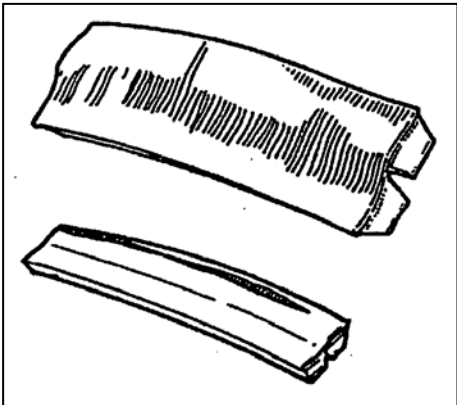
**Symptom: tie-band frayed or damaged**

- Belts have contacted an obstruction such as the belt guide plate.

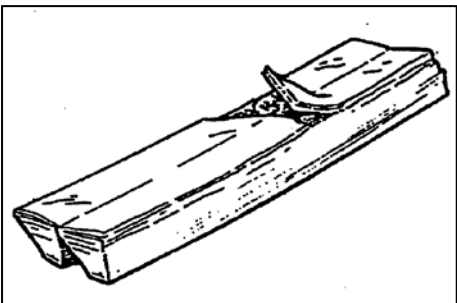
**Symptom: tie-band blistered or peeling**

- Dirt or sand or a foreign object has contaminated the drive sheaves.
- V-belts have reached the end of their service life.

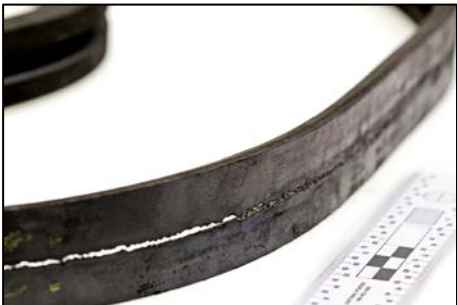
**Symptom: tie-band splitting**

- Excessive sheave wear may allow the v-belts to ride deeper into the grooves eventually damaging the tie-band.
- A belt that has rolled out of its sheaves can damage the tie-band in the manner shown.

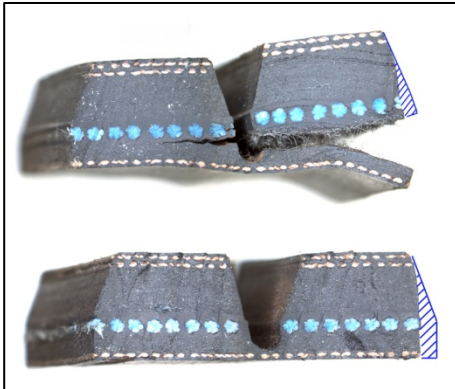
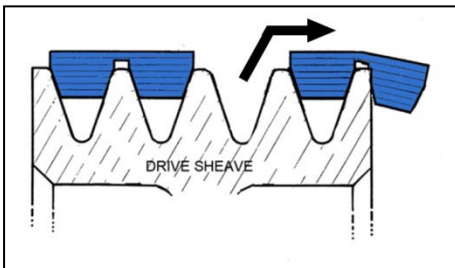
**Symptom: uneven wear**

- The edges of the belts should be carefully examined for evidence of unusual or excessive wear which is indicative of a tracking or alignment issue between the upper and lower sheaves.
- Under these circumstances, any misalignment of the drive system will produce uneven wear to belt flanks, which may eventually allow the belts to dislodge and climb or roll out of their sheave grooves.

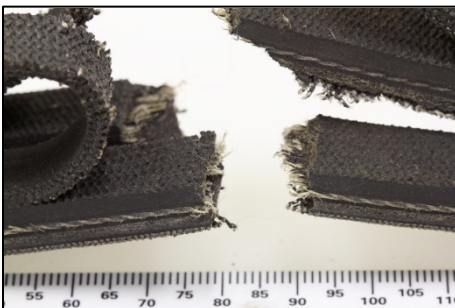
**Complete belt failure**

A tensile overstress failure can result from too much belt tension or excessive and continual shock loads to the drive. As outlined in the Robinson R22 POH, an amber caution 'clutch' light illuminates on the instrument panel whenever the clutch actuator is operating. If the belts stretch during flight, the clutch light will illuminate as the actuator adjusts the belt tension.

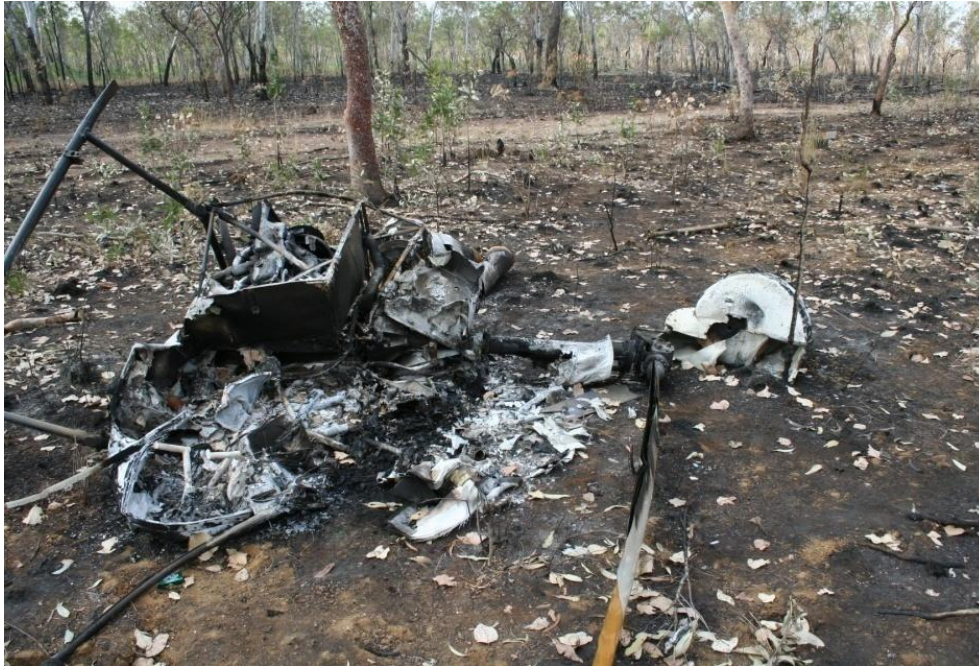
*number of safety factors relating to unsafe decision making; including the operation of the helicopter beyond the allowable weight and centre of gravity limits.*

**Figure 8: Burnt wreckage of VH-HCN**

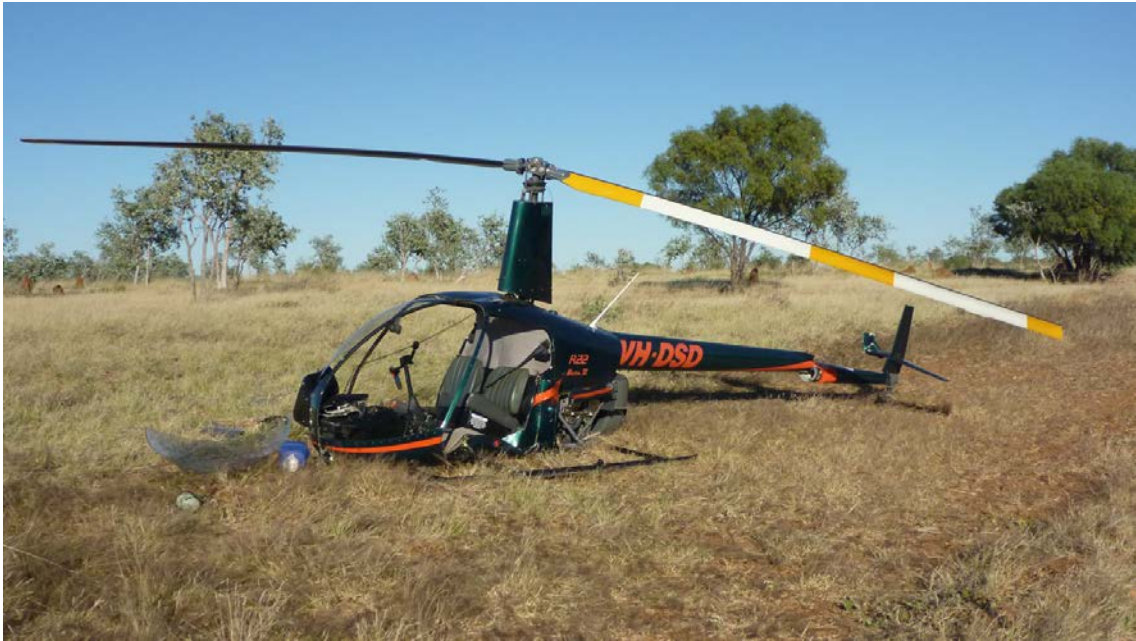
Recovery of data from the pilot's handheld GPS indicated that the belt failed which led to a rapid descent into terrain from about 120 ft AGL. The investigation determined that the forward v-belt had partially dislodged from the drive sheaves during the accident flight, resulting in consequential damage to the belt structure and its eventual failure. The sudden failure of the front v-belt also contributed to the failure of the rear belt and the subsequent complete loss of drive to the main rotor system (Figures 9 and 10).

**Figure 9: Following an in-flight failure of the v-belts, the helicopter impacted terrain with a high rate of vertical descent**

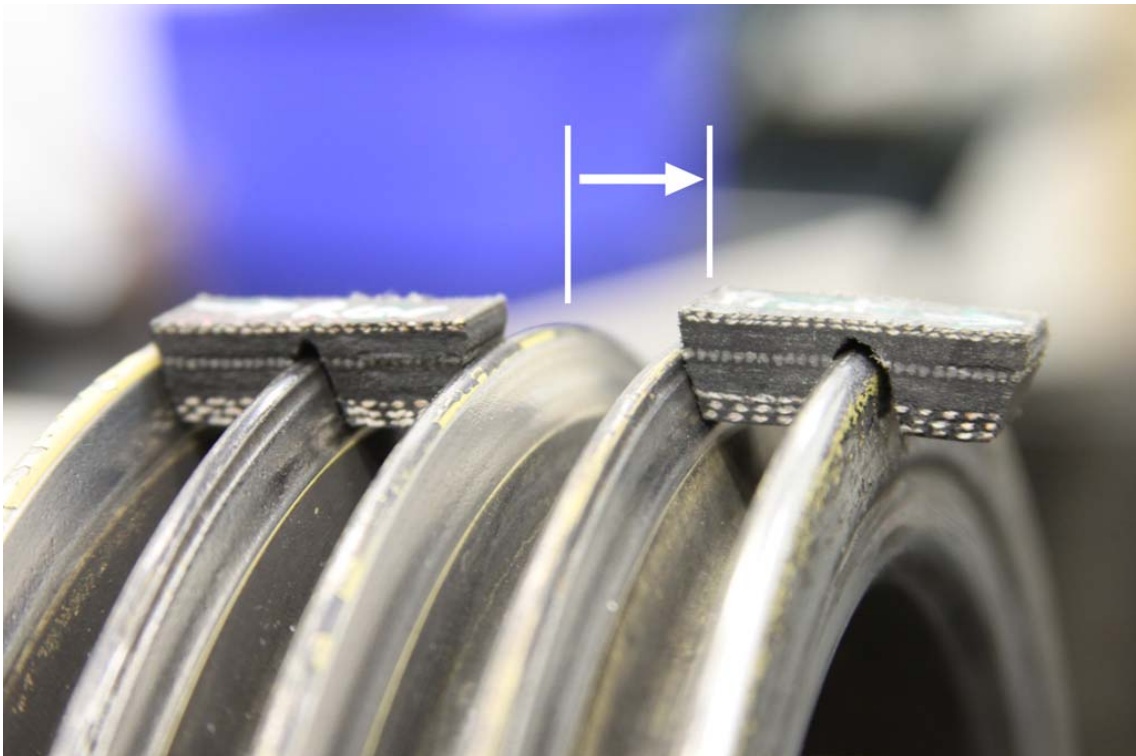
**Figure 10: Examination of the drive system from VH-DSD showed that prior to the accident the front v-belt had shifted forward and off the sheave.**

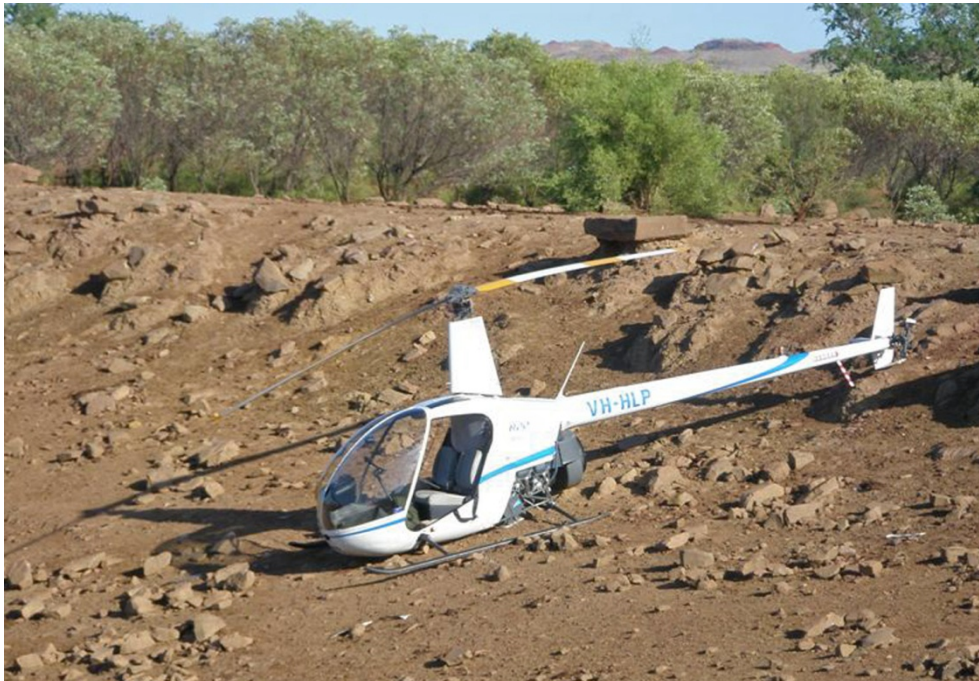
The pilot was inspecting the condition of pastoral dams when on approach to land at about 80 ft AGL, the low RPM horn sounded and the engine RPM rapidly increased. The helicopter impacted the dam wall with a high rate of descent. The pilot survived the accident (though with severe injuries) and subsequently reported that earlier in the flight the clutch light had illuminated briefly for about 3 seconds. There were no other warnings of an impending issue.

**Figure 11: The helicopter impacted terrain with a high rate of vertical descent**

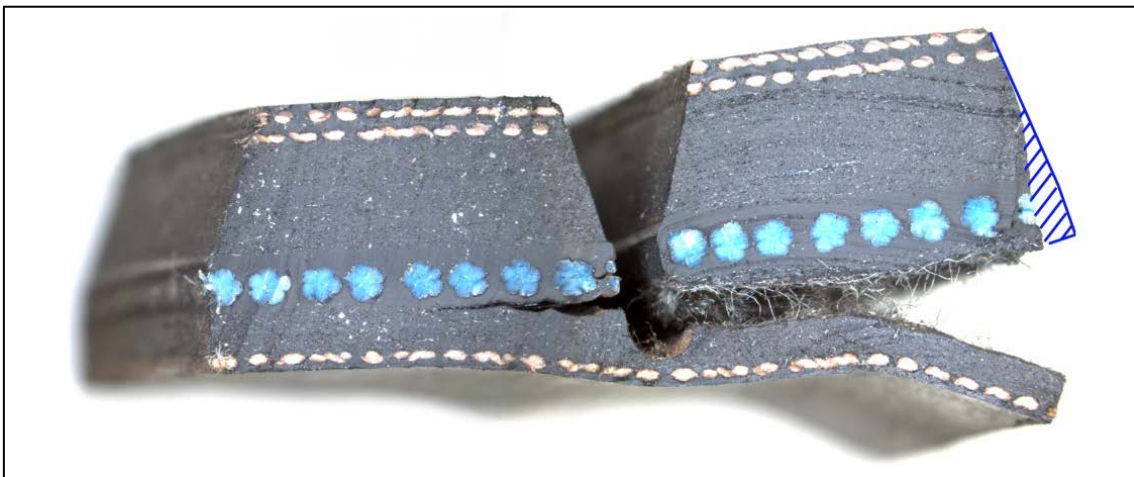
Post-accident inspection of the helicopter revealed that both v-belts had dislodged forward from their drive sheaves. Although maintaining a continuous loop, one half of the rear v-belt had completely separated from the backing material. A detailed examination of the drive belts revealed considerable wear had occurred to the flanks of each belt. Wear of that nature was indicative that both belts had been operating with a degree of side load during service which indicated the failure was related to misalignment in the drive system (Figures 11 and 12).

**Figure 12: A cross-section through the rear v-belt from VH-HLP noting that one half of the belt had completely detached from the backing, with significant wear through the belt flanks found (shaded region)**
