# Aircraft proximity event between a Piper PA-28, VH-PZK and a Cessna 441, VH-VEJ

Rottneet Island aerodrome, Western Australia, 23 September 2012

**ATSB Transport Safety Report**  
Aviation Occurrence Investigation  
AO-2012-126  
Final – 17 May 2013

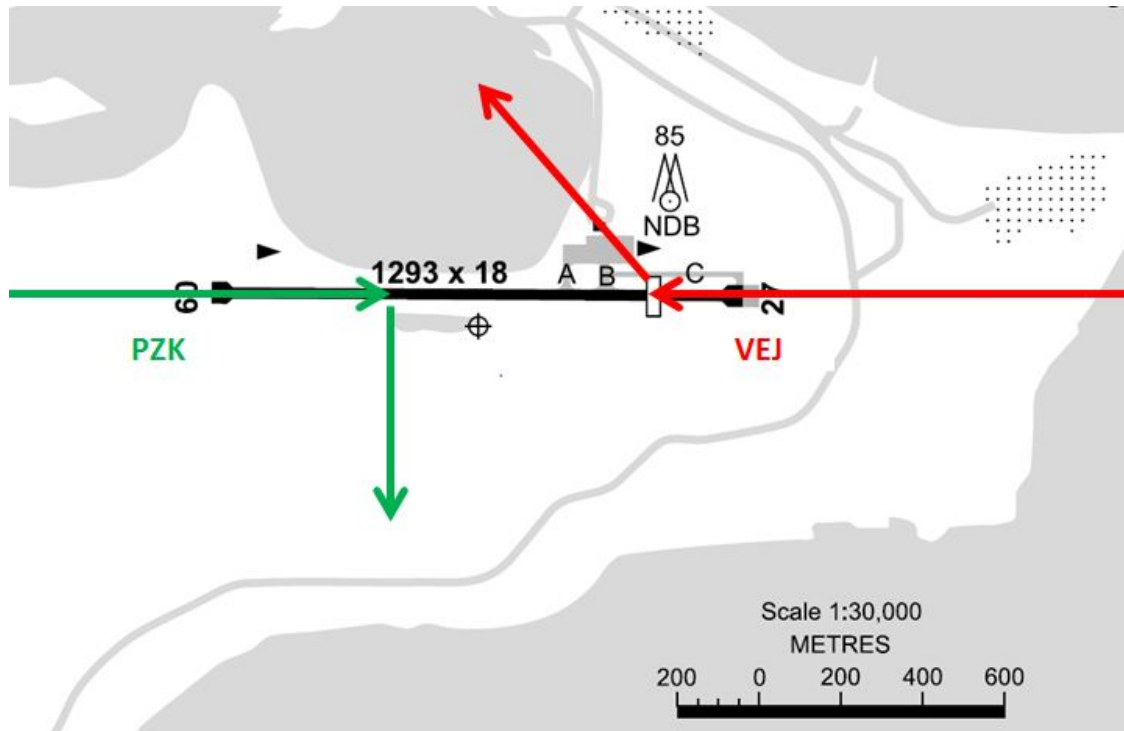
**Figure 1: Estimated track of VH-PZK (green) and VH-VEJ (red)**

At 1221 Western Standard Time<sup>3</sup>, as PZK approached the threshold for runway 09 at about 200 ft above mean sea level, the pilot observed an aircraft about 650 m ahead on the reciprocal heading at the same level. As the pilot of PZK initiated a sharp right turn, he observed the other aircraft also turn right (Figure 1). The other aircraft was later identified as VEJ. The lateral distance between the aircraft reduced to 0.2 NM.

The pilot of PZK then realised that, although he had earlier observed an aircraft depart from runway 09, he had not heard any radio broadcasts on the Rottnest Island CTAF. The pilot checked PZK's radio plugs and cables, and ensured that he had the correct frequency selected, but could still not hear any broadcasts. The pilot of PZK then conducted a number of orbits of the Island, broadcasting his intentions as required, prior to landing on runway 09 without further incident. VEJ conducted a number of other missed approaches to both runways before landing on runway 09 without further incident.

As a result of this occurrence, the aircraft operator of VEJ advised the ATSB that they will not conduct flight safety check flights during busy periods at non-towered aerodromes.

In conjunction with the aircraft operator of VEJ, CASA will ensure a NOTAM is issued for future flights to promulgate information applicable to this type of operation.
