# Aircraft proximity event between a Piper PA-44, VH-MHZ and a Hawker G36, VH-JKL

4 km WNW of Bankstown Airport, NSW, 19 January 2013

**ATSB Transport Safety Report**  
Aviation Occurrence Investigation  
AO-2013-019  
Final – 17 May 2013

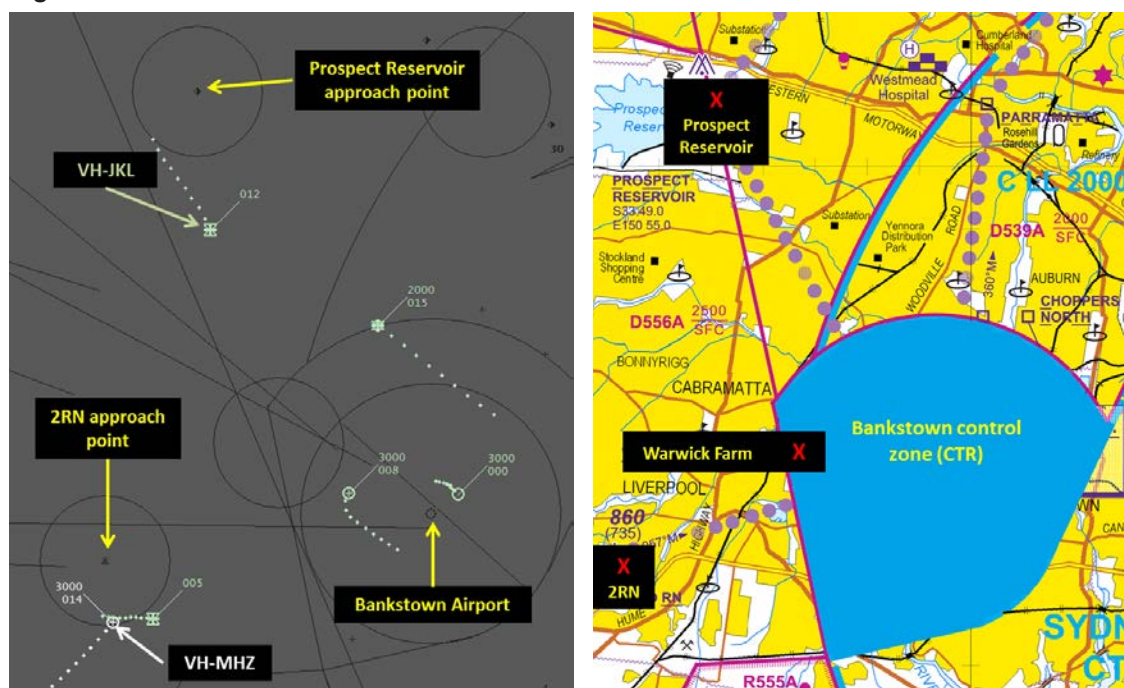
**Figure 1: VH-MHZ and VH-JKL inbound to Bankstown**

On 19 January 2013, the pilot and passenger of a Hawker G36 aircraft, registered VH-JKL (JKL), were conducting a private flight from Bathurst to Bankstown, New South Wales (NSW). When at the 'Prospect Reservoir' visual flight rules (VFR) approach point (Figure 1), at about 1025 Eastern Daylight-saving Time<sup>1</sup>, the pilot broadcast an inbound call to Bankstown Tower air traffic control (ATC). The pilot was instructed by ATC to join the final leg of the circuit for runway 11 Left and to report when at 3 NM.

At the same time, the pilot of a Piper PA-44 aircraft, registered VH-MHZ (MHZ), was conducting a ferry flight from Wedderburn (NSW) to Bankstown. At about 1026, when at the '2RN' VFR approach point, the pilot attempted to broadcast an inbound call to Bankstown Tower; however, the pilot reported that the call was over-transmitted. Shortly after, a second inbound call was broadcast, which the pilot reported was again over-transmitted.

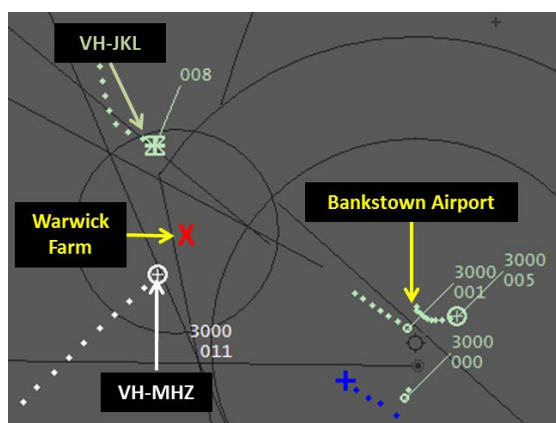
**Figure 2: Aircraft positions at 1028**

At about 1027, the pilot of JKL advised ATC that he was at 3 NM. About 30 seconds after, ATC attempted to establish communications with an unidentified aircraft (MHZ) observed at Warwick Farm. Airservices Australia surveillance data showed MHZ maintaining 1,100 ft and JKL descending through 800 ft, with 1.3 NM lateral separation (Figure 2). At the same time, the pilot of MHZ determined that communications with ATC could not be established due to radio congestion and he elected to maintain his current heading and altitude. The aircraft subsequently entered the Bankstown control zone (CTR) without an ATC clearance.

Soon after, the pilot and passenger of JKL observed an unidentified aircraft in their 2 o'clock<sup>2</sup> position at about the same altitude. The pilot and passenger continued to monitor the aircraft.

At about 1028, ATC advised the pilot of JKL of an unidentified aircraft to the south, about 0.5 NM away. The pilot replied to ATC that he would descend and monitor the aircraft. The pilot reported descending 50-100 ft and conducting a slight right turn. As MHZ passed overhead JKL, vertical separation reduced to 200 ft and then increased to 400 ft as JKL descended (Figure 3). The pilot of MHZ did not sight JKL as it was obscured by the nose of the aircraft.

The CASA VFR guide recommends that pilots should consider initiating radio contact with ATC far enough away from the CTR boundary to preclude entering Class D<sup>6</sup> airspace before two-way communications are established. This is particularly important when operating into busy airports such as Bankstown. The following publications provide information on Class D operations:
