Australian Government
Australian Transport Safety Bureau

Aviation Short Investigation Bulletin

Issue 18

AB-2013-070

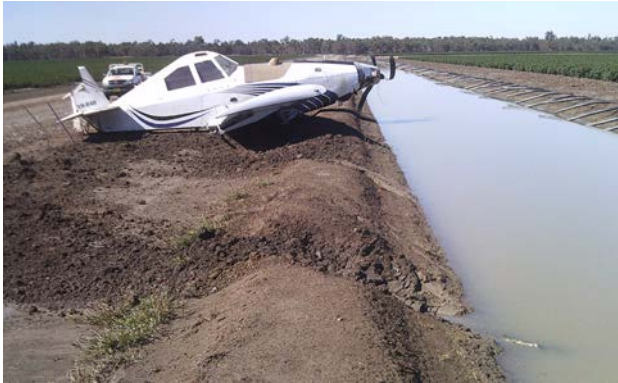
Figure 2: Accident site

The pilot was carrying out the final spray run (clean-up run), to use the last of the spray product on the edge of the field, before returning to the loading airstrip that was located about 1 km away. The pilot was flying from west to east, parallel to the main power line (Figure 1), which was located beside the field, outside of the area being sprayed. Another smaller power line with three wires ran diagonally across the field from the main power line and went for about 1 km across the field to a farm yard. When the pilot had run out of product, he pulled up to gain altitude before returning to the loading airstrip, when he struck the smaller power line that ran diagonally across the field. Two of the wires were cut by the aircraft's wire protection system and the third wrapped around the propeller hub, arresting the aircraft and pulling it around in a half circle, where it came to rest on the ground (Figure 2). The aircraft sustained serious damage, while the pilot was uninjured.

For this reason, the Aerial Agricultural Association of Australia recommends that an additional hazard check should be performed from a safe height prior to every change of direction or 'clean up run'. The extra safety check for wires is important, as the obstructions may appear new or different from the new direction of flight.

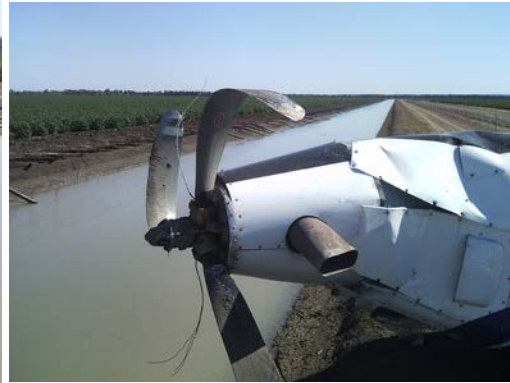
Power line wrapped around propeller

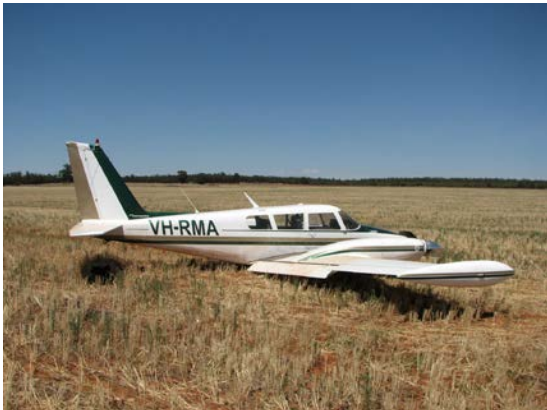
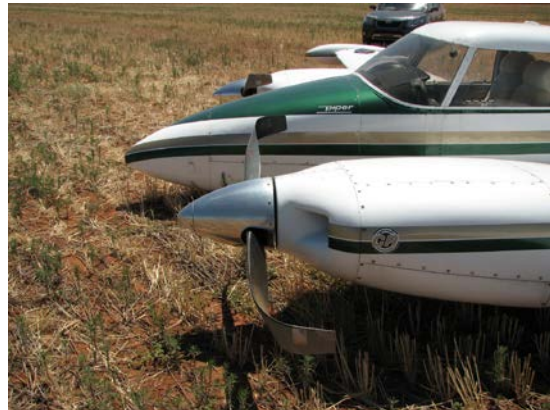
Figure 2: Accident site

An insurance representative attended the accident site (Figures 2 and 3) and noted that there was sufficient fuel remaining in the main fuel tanks to complete the flight. An assessment for contaminants such as water could not be undertaken at the accident site. The reason for the reported performance loss on either engine could not be definitively determined.

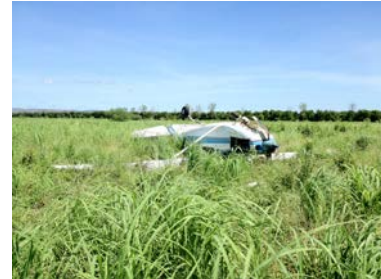
Accident site

When at about 100 ft above ground level, with insufficient runway distance remaining to abort the take-off, the pilot retracted the landing gear. Immediately after, the engine abruptly failed. Witnesses on the ground reported hearing a bang and the engine splutter.

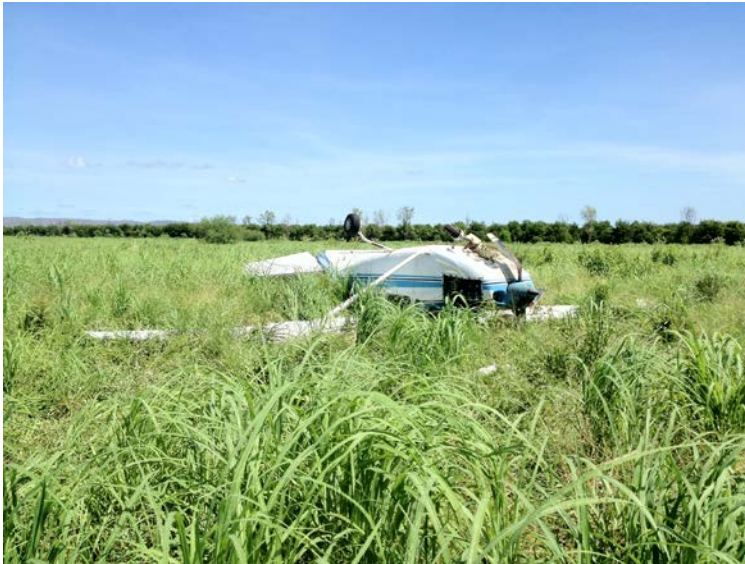
Figure 2: Aircraft at the accident site

The pilot then selected the auxiliary fuel pump on, but the engine did not respond. He lowered the landing gear and extended full flaps. The main landing gear touched down in long grass and the aircraft decelerated rapidly. When the nose gear touched down, it dug into boggy ground and the aircraft flipped over, coming to rest inverted (Figure 2). The pilot and passenger received minor injuries and the aircraft sustained substantial damage.

An engine tear down was not performed and the reason for the engine failure could not be determined.
