# Aviation Short Investigation Bulletin

Issue 19

AB-2013-079

Final – 29 May 2013

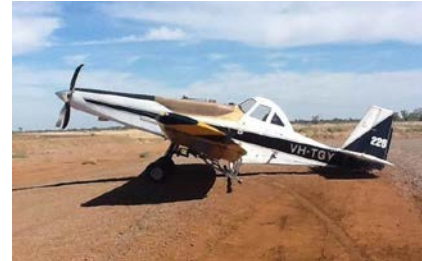
Damage to VH-TGY

When approaching the runway end at a reasonably slow speed, but faster than his normal taxi speed, the pilot of TGY suddenly observed mud spraying up from the aircraft's wheels. The aircraft then commenced sliding and turning to the left. When the left wheel contacted dry ground, the aircraft swung further left and tipped forward, resulting in the propeller contacting the ground. The aircraft then tipped backwards and the tail wheel assembly detached. TGY came to rest at 90° to the runway direction. The pilot of TGY exited and spoke to the mixers, who advised that the fire-bombing door in TZJ had malfunctioned and released the 2,700 L load, contaminating the runway. TGY sustained minor damage (Figure 2).

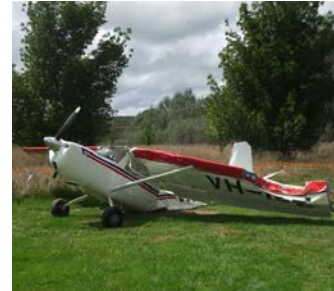
VH-ICE accident site

The pilot reported that the aircraft accelerated as normal, however during the take-off run he realised the aircraft would not clear the trees at the end of the landing area and elected to reject the take-off. The pilot reduced the power to idle and applied the brakes, however the remaining distance was insufficient and the left wing impacted a tree, the aircraft turned over and came to rest inverted. The pilot was uninjured and the aircraft sustained substantial damage (Figure 2).

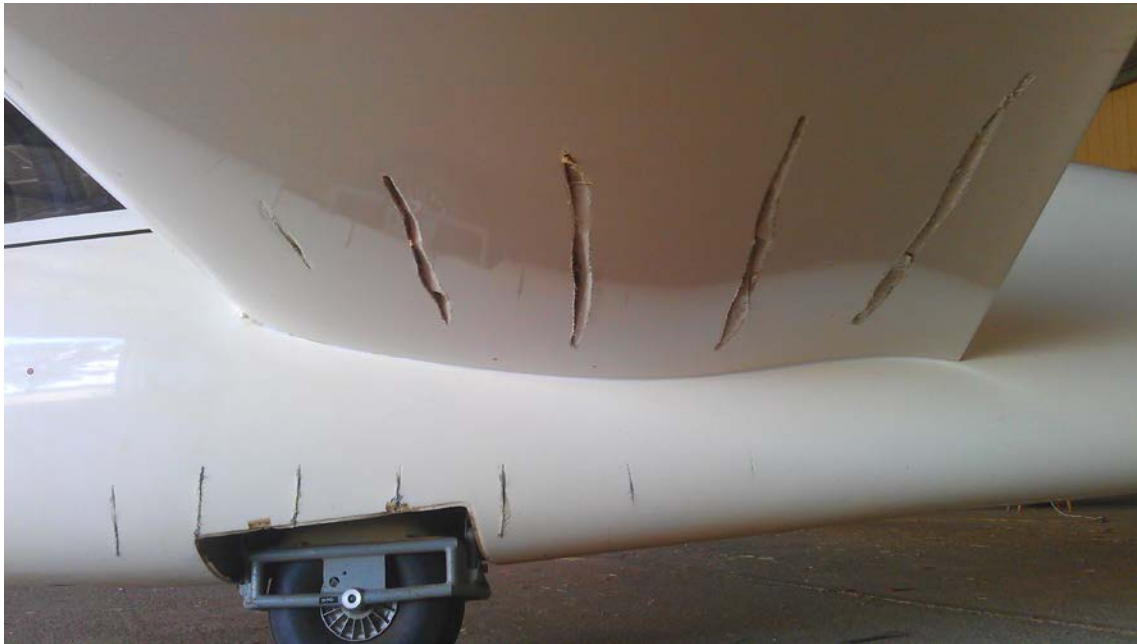
**Figure 1: Damage to VH-UIZ**

Both gliding clubs operated under the rules and procedures proscribed by the Gliding Federation of Australia (GFA). The investigation conducted by the GFA determined that glider and tug landed together with the glider on top. Propeller strikes caused damage to the underside of the glider's left wing and along the fuselage near the main landing wheel (Figure 1). There was no damage to the C150.

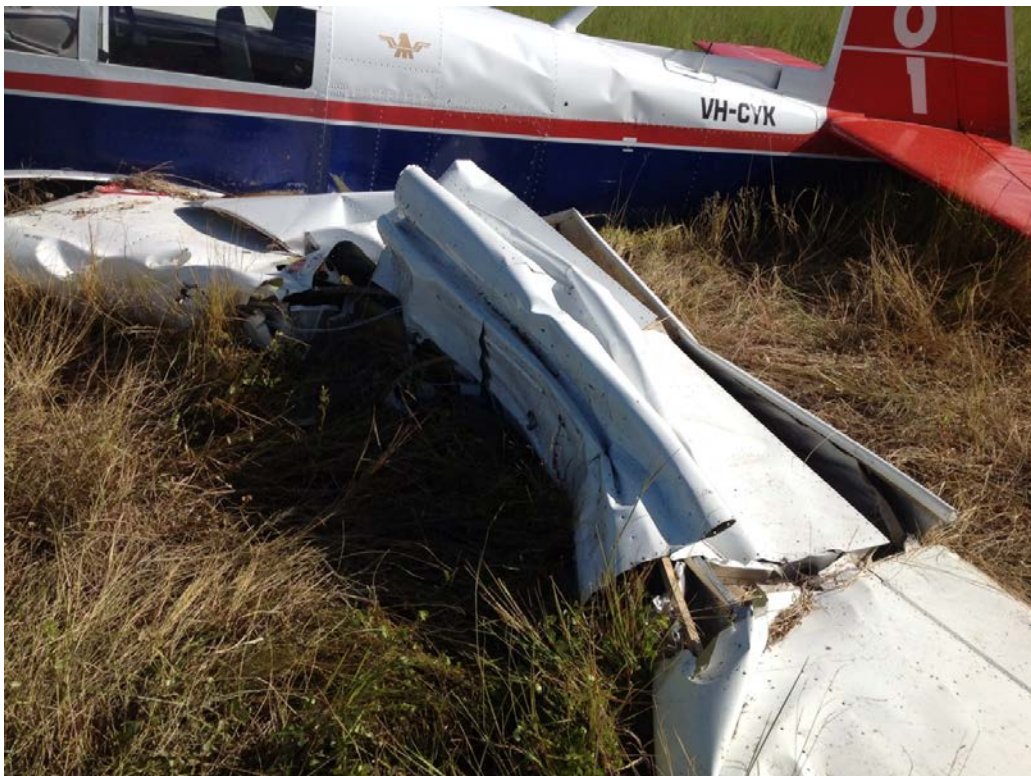
**Figure 1: Aircraft damage**

As the pilot reached over to raise the landing gear lever, the aircraft's left wing struck a bull. The aircraft then landed in the paddock. The pilot shut down the aircraft and the occupants exited. The aircraft sustained substantial damage (Figure 1) from hitting the bull and one passenger received minor injuries. The bull was put down as a result of the injuries it sustained.

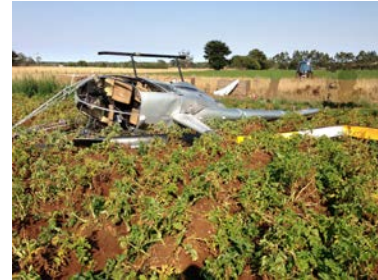
### Helicopter damage

As the helicopter approached the paddock from the south, at 50 kt and at spray height, the pilot remembered a wire that extended halfway across the southern boundary of the paddock to a pump house. The pilot judged that it was too late to attempt to pull up over the wire and attempted to avoid the wire by flying underneath it. The vertical stabiliser contacted the wire and the tail rotor gearbox separated from the tail boom. The nose of the helicopter momentarily pitched upwards before the helicopter began to spin to the right. The pilot closed the throttle in an attempt to recover control, but the helicopter landed hard and rolled over. The pilot was able to exit the helicopter with minor injuries. The helicopter was substantially damaged. There was no fire.
