Stevedore fatality on board the general cargo ship *Weaver Arrow*

at Newcastle, New South Wales | 23 September 2012

ATSB Transport Safety Report
Marine Occurrence Investigation
296-MO-2012-010
Final – 4 June 2013

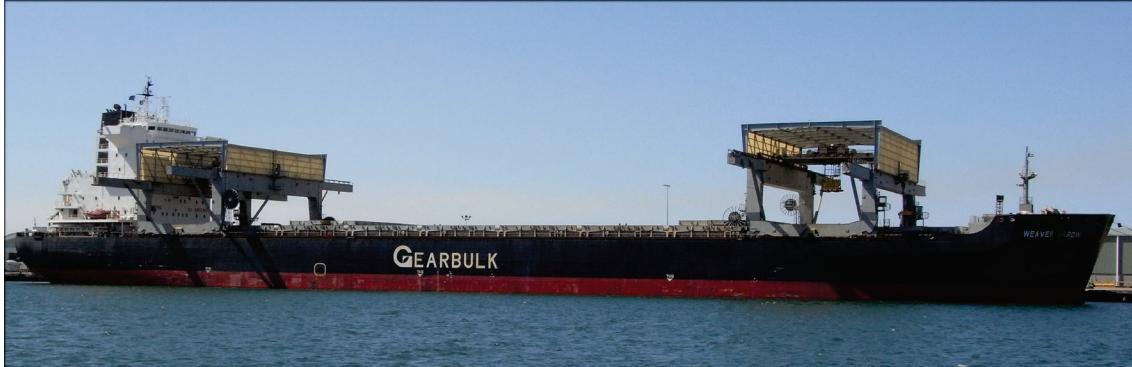
Figure 1: *Weaver Arrow* berthed in Newcastle

At 1800¹ on 22 September 2012, the 200 m long general cargo ship *Weaver Arrow* (Figure 1) berthed at number one berth, Eastern Basin in the port of Newcastle. The ship was to load a cargo of aluminium products, predominantly ingots for discharge in Japan and South Korea.

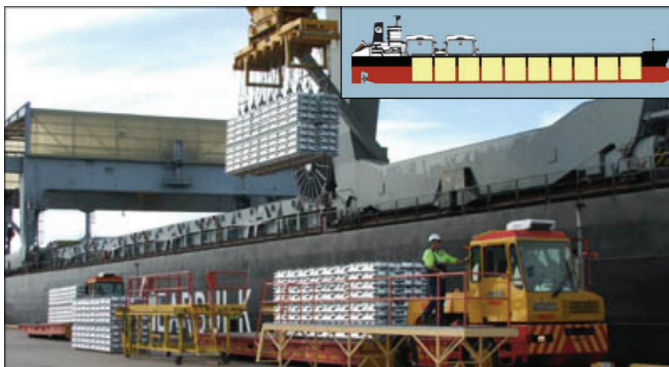
Figure 2: Ingot handling on same class of ship

At 2200 that evening, stevedores from Newcastle Stevedores began loading aluminium ingots using the ship's two gantry cranes. Trucks positioned pre-slung lifts of 880 or 1,056 ingots (each ingot weighing about 23 kg) on the wharf under the cranes (Figure 2). The two cranes allowed simultaneous loading of the 20 or 24 tonne lifts into two cargo holds.

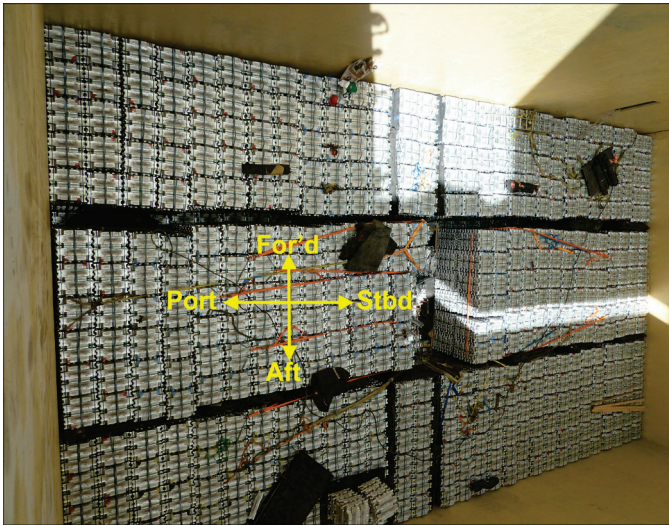
Figure 3: Ingots stowed in number two cargo hold

Cargo loading continued throughout the night of 22-23 September. Ingots were stowed in the cargo holds in three athwartships rows of 15 lifts each (Figure 3). Once a full tier of ingots had been stowed, the stevedores arranged timber planks (dunnage) before stowing the next tier (Figure 4). To prevent the cargo from shifting during the sea passage, the spaces between rows were filled with inflatable rubber bags (airbags) by the ship's crew.

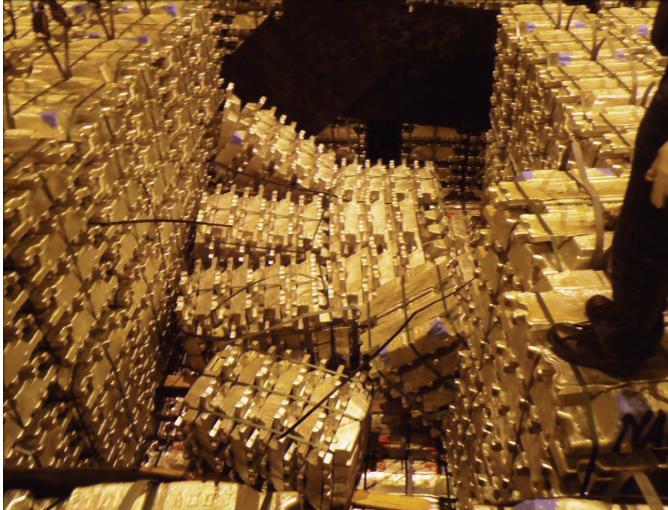
Figure 5: Collapsed ingot stacks (view looking aft)

The four aft inboard ingot stacks had collapsed in less than 5 seconds (Figure 5). The stevedore could partially see the head and an arm of the team leader, who appeared to be unconscious. Using the radio, he called the foreman ashore, reported the accident and asked for emergency services to be called. He then told the trainee to go and call the other stevedores while he remained in the hold to see how best to help the team leader. The crane driver, who had seen what had happened from above, also called the foreman and further explained the situation.

On 23 September, the stevedore team leader was climbing down the side of an ingot lift when stacks in it toppled. The stacks had become extremely unstable when the lift was 'hit-up' minutes before the accident. The aft belly strap and possibly the forward one had broken, and some stacks appeared slightly askew. The stevedores, including the crane driver, had seen those signs but did not think that this was unusual for a lift that had been 'hit-up' or consider that it might be unstable.

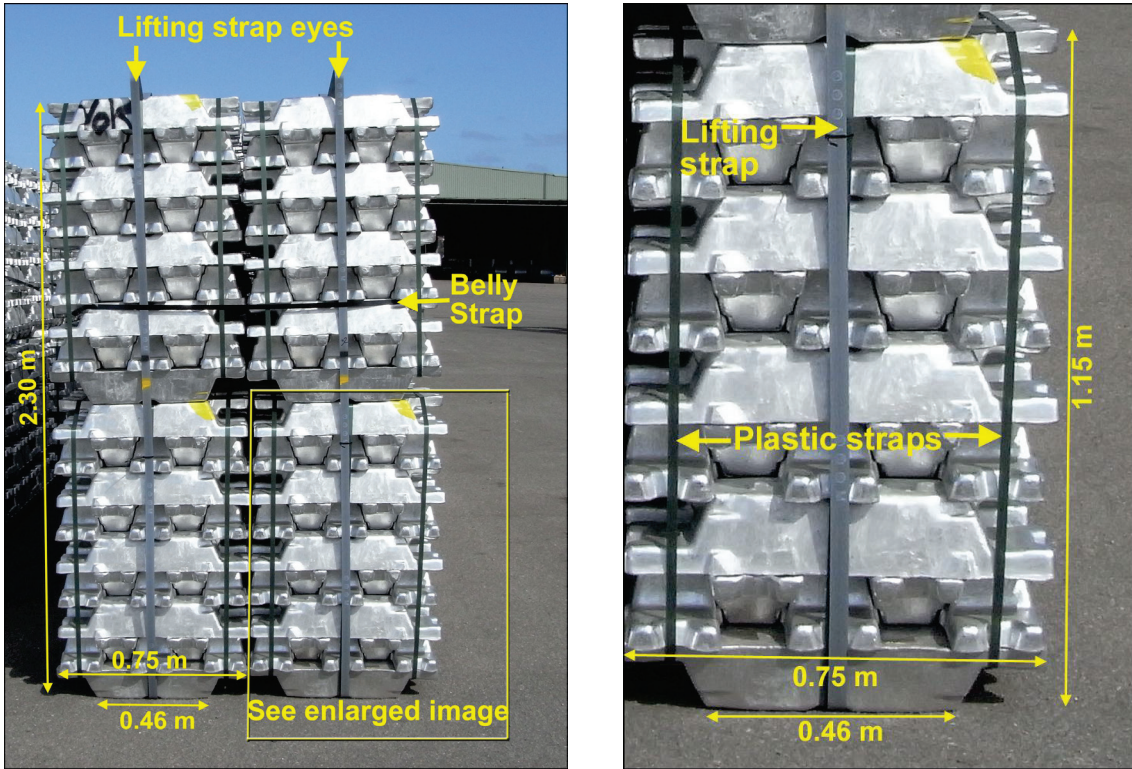
Figure 6: Aluminium ingot lift (view from one end) and a single pack (enlarged image)

¹⁰ The plastic straps, however, would be more exposed to contact and damage (see enlarged image in Figure 6).

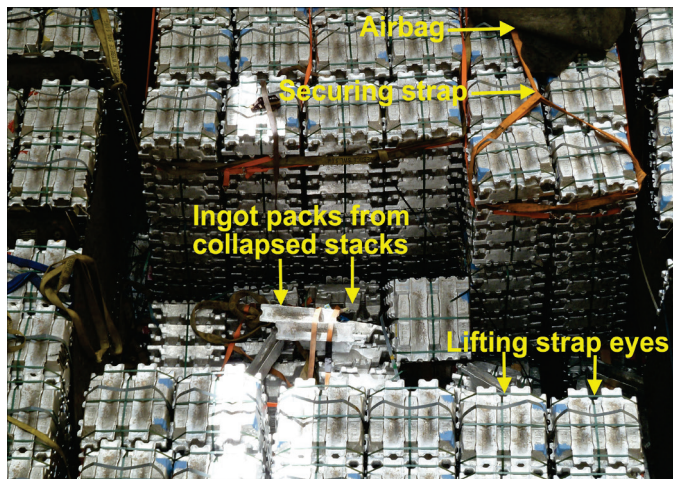
Figure 7: Ingots lifts adjacent to accident site

There is a significant risk of slips, trips and falls when stowing ingots in cargo holds. The working area formed by ingot lifts is not flat and there are many gaps and trip hazards (Figure 7). Lifting strap eyes, which project more than 10 cm above the ingots, are major trip hazards. As each strap has two eyes, there are three or four of these trip hazards per square metre of the working area. Gaps between ingots and between lifts are additional hazards. Hence, the likelihood of a trip or fall is high.

The other significant risks are related to the ingot cargo falling or toppling. A lift is made up of 880 to 1,056 ingots held together by many securing and lifting straps. The failure of one or more straps can result in part or the whole of the lift falling, collapsing or toppling. The size and weight of the ingots means that if one or more were to fall on a person, serious or fatal injury is almost certain.
