# Aviation Short Investigation Bulletin

Issue 21

**ATSB Transport Safety Report**  
Aviation Short Investigations  
AB-2013-117  
Final – 7 August 2013

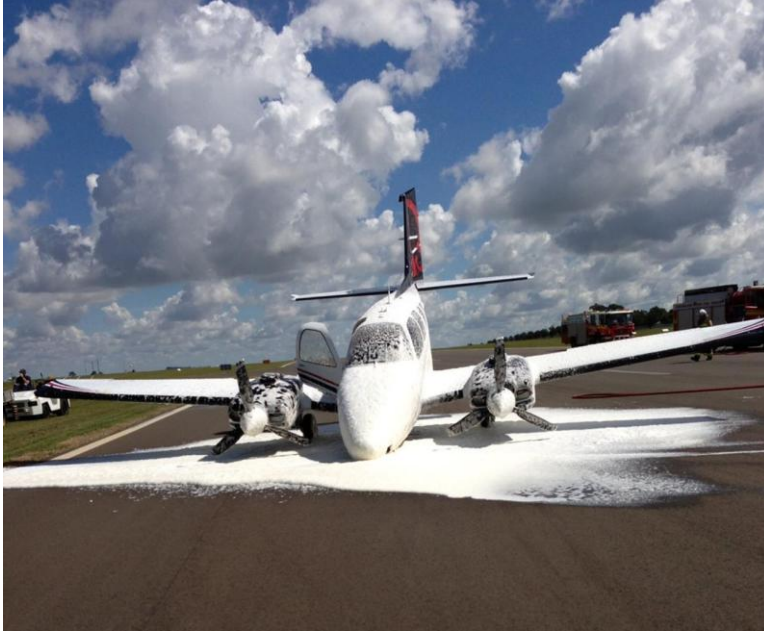
**Figure 1: VH-OMS after landing**

As the aircraft's main landing gear touched down, the copilot selected the fuel and mixture controls to off, while the PIC concurrently reduced the throttle settings to idle and turned the electrical system off. The aircraft's nose then lowered and slid along the runway. The aircraft came to a stop and the crew exited. As a precaution, the aircraft was covered with fire retardant foam, but no fire resulted. A video of the landing can be viewed at:

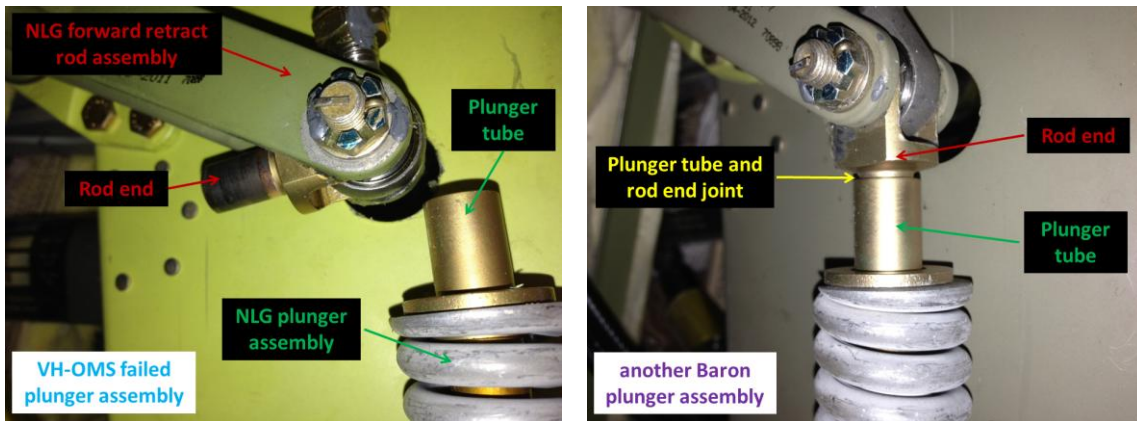
**Figure 2: VH-OMS and another Baron rod plunger assembly in situ**

The maintenance provider conducted an examination of the aircraft and determined that the rod end on the NLG forward retract rod assembly had separated from the plunger tube on the NLG plunger assembly (Figure 2). The initial examination suggested that there may have been a manufacturing issue that resulted in a defective joint between the rod end and plunger tube.

After the accident involving OMS, the NLG of a second Baron aircraft was inspected and it also showed signs of a similar defect (Figure 2). That aircraft was built in 2012 and had 127 hours total time in service.

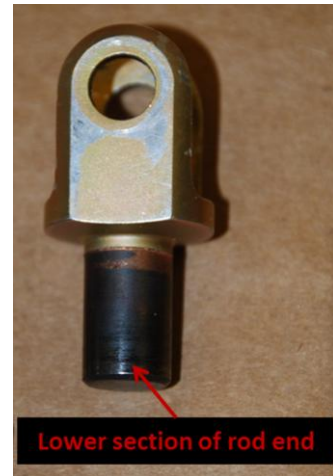
**Figure 3: VH-OMS rod end**

All new assemblies were required to be ‘pull tested’ to a 2,200 lb. test load. For the assemblies fitted to OMS, the aircraft manufacturer reported that a pull test had been conducted by the supplier; however, it could not be determined why that test did not reveal the lack of brazing. Two other assemblies manufactured by the supplier were pull tested and failed at about 6,000 lbs; the braze joint did not separate.

An improperly brazed rod end might separate from the plunger assembly during landing gear operation. The plunger assembly is part of the NLG extension/retraction system and a separated push-pull retract rod assembly plunger rod end might result in a NLG disconnect from the retraction system that could allow the nose landing gear to collapse on landing.

- **Mandatory Service Bulletin (MSB):** was released by the aircraft manufacturer on 6 May 2013 as a result of this accident: <http://csobeech.com/files/HBC-SB32-4125.pdf>. It was issued to inspect for, and if necessary, replace the specified nose landing gear plunger assemblies. This must be accomplished no later than 50 flight hours or 9 months from the issuance of the MSB, whichever occurs first.

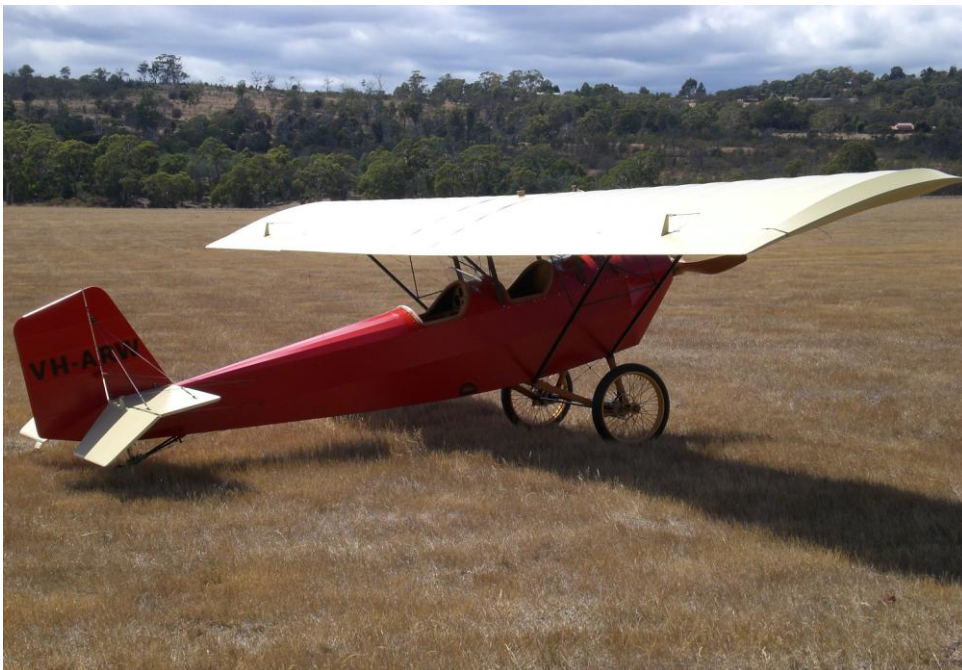
Figure 1: VH-ARW prior to the accident

The airspeed quickly decreased, as the pilot attempted to hold the wings level. After initially climbing to about 10 ft, ARW impacted the ground, breaking the landing gear. The aircraft skidded on its nose and then pitched over onto its back, breaking the propeller.

Both the pilot and the front seat passenger exited the aircraft without injury. On surveying the accident site, the pilot realised the aircraft's landing gear had caught the top wire of an electric fence he had not been aware of, located a short distance before the paddock's main fence.
