# Airspace related event involving Bombardier DHC-8-402, VH-QOB and Robinson R22, VH-HLY

Cloncurry, Queensland, 18 April 2013

**ATSB Transport Safety Report**  
Aviation Occurrence Investigation  
AO-2013-074  
Final – 7 August 2013

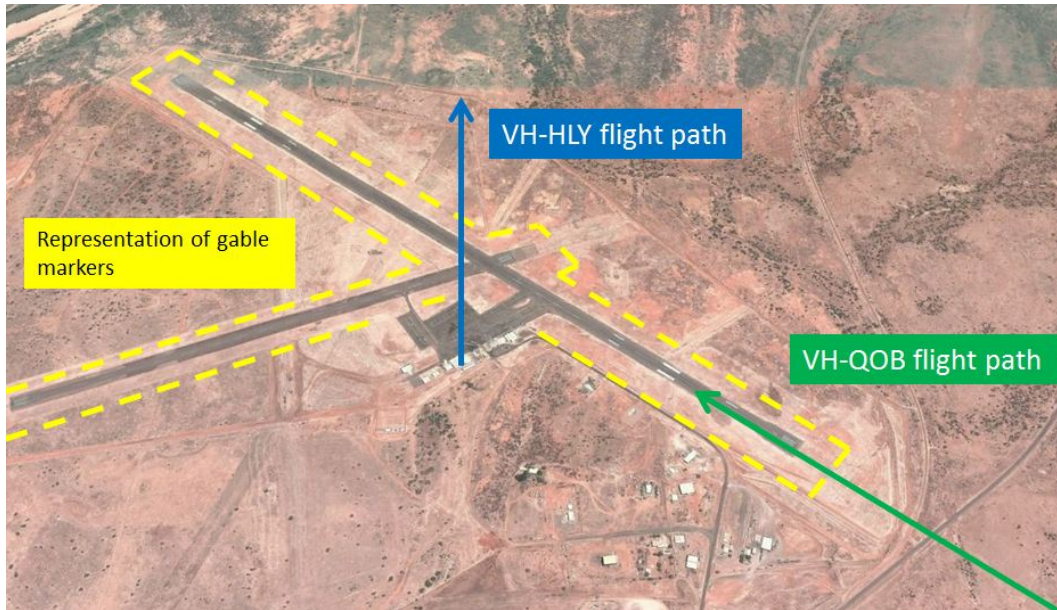
As the helicopter crossed the runway at a height of about 100 feet, the pilot realised that he had not heard a response from the aerodrome frequency response unit (AFRU) on the CTAF (see explanation below). Simultaneously, he heard a call from QOB, which was in the landing flare for runway 30, stating that he should get off the runway.

The pilot of HLY estimated that, when QOB had touched down, the distance between the aircraft and HLY was about 1,000 m horizontally. The PIC of QOB estimated that the horizontal separation reduced to about 200 m.

**Figure 1: Cloncurry aerodrome showing relative positions of VH-HLY and VH-QOB**

Helicopter pilots will hover at the gable markers prior to entering the runway and conduct a full visual inspection for aircraft.
