Aircraft proximity event between a Kawasaki BK117, VH-CSG and a Cessna 404, VH-XDA

22 km WNW of Townsville Airport, Queensland, 13 June 2012

ATSB Transport Safety Report
Aviation Occurrence Investigation
AO-2012-080
Final - 7 August 2013

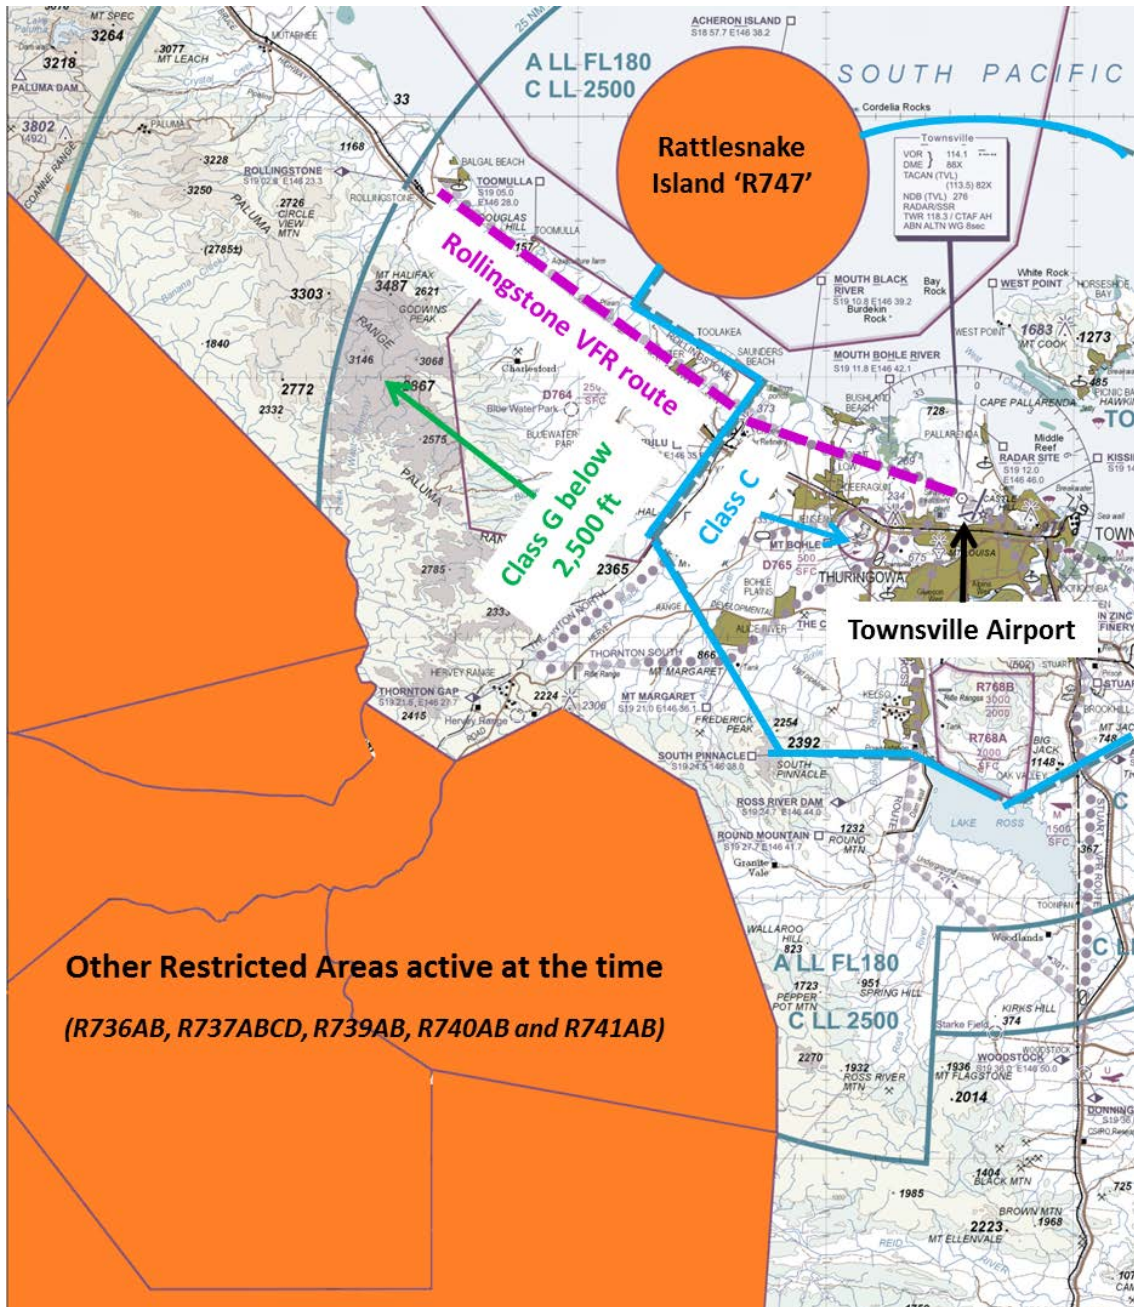
Figure 1: Townsville airspace

The initial section of the Rollingstone VFR route from Townsville was inside Townsville controlled airspace (Class C), while the latter part was outside controlled airspace (Class G)³ when operating below 2,500 ft (Figure 1).

The Townsville Approach position was responsible for controlling airspace out to 36 NM, up to flight level (FL)⁷ 220. On the day, there were a number of Restricted Areas active,⁸ including the Rattlesnake Island 'R747' area (Figure 1). When R747 was active, aircraft departing/arriving Townsville to/from the north, north-west were directed via the western VFR diversion, the Rollingstone VFR route. Consequently, CSG was cleared to leave and XDA was cleared to enter Townsville Class C airspace via the Rollingstone VFR route.

The Approach Training Commander reported that the activation of R747 was a rare occurrence and there were minimal options available to controllers for diverting aircraft around that area. This was the first time the Approach trainee had seen R747 active and had military jet aircraft operating in R740 and R741 (Figure 1).

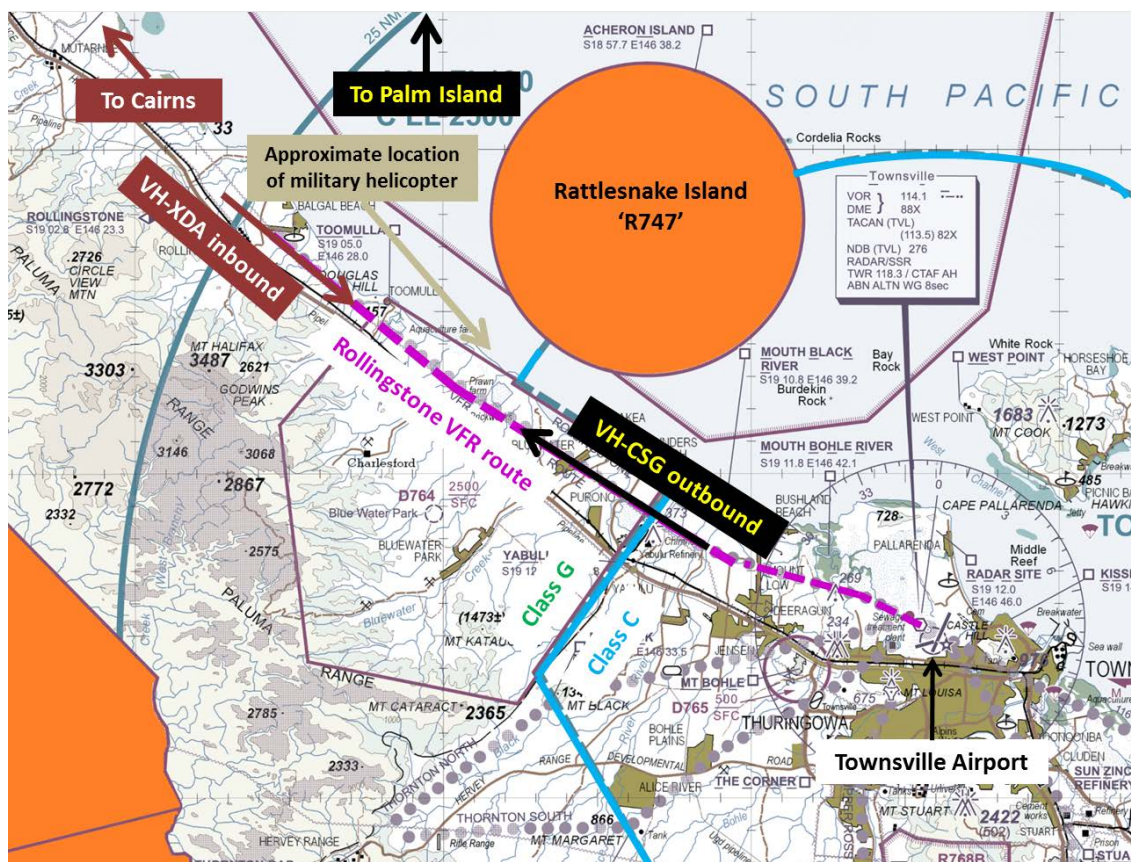
Figure 2: Positions along the Rollingstone VFR route

At this time, CSG and XDA were tracking along the Rollingstone VFR route in opposite directions, with about 15 NM lateral separation (Figure 2). The Approach trainee reported that, as CSG and XDA were more than 8 NM apart, the trainee intended to provide traffic information at a later stage, when the aircraft were close enough to be sighted by each pilot.
