Aircraft proximity event between Piper Chieftain, VH-EDV and Cessna 172 Hawk XP, VH-JQQ

9 km south of Moorabbin Airport, Victoria, 17 April 2013

ATSB Transport Safety Report
Aviation Occurrence Investigation
AO-2013-073
Final – 7 August 2013

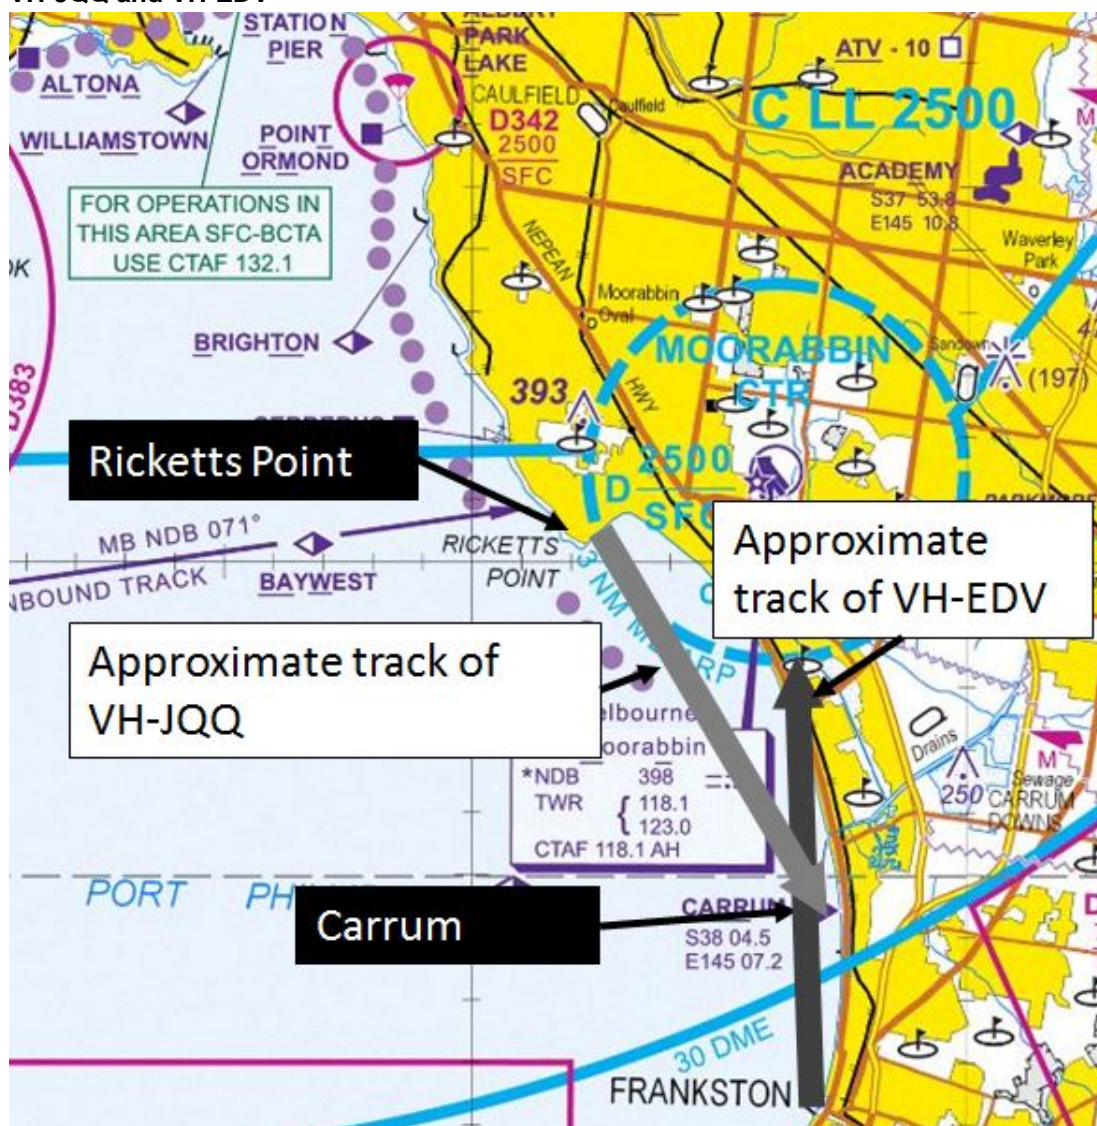
Figure 1: Excerpt from the Melbourne Visual Terminal Chart and approximate tracks of VH-JQQ and VH-EDV

At about the same time, a Cessna R172K (Hawk XP), registered VH-JQQ (JQQ), had departed Essendon Airport, via the Westgate Bridge and was heading southbound. The crew of the aircraft had completed a routine pipeline inspection in the Essendon control zone, and were in transit via the VFR Coastal Route (Figure 1) at 1,500 ft for another pipeline inspection in the Tyabb, Victoria area.

To remain in gliding distance of the coast, the pilot of the single-engine aircraft JQQ, elected to cross the coastline at Ricketts Point (Figure 1) and obtained a clearance from Moorabbin Tower to transit the western edge of the Moorabbin control zone. JQQ then proceeded to track about 1.5 NM off the coast, from Ricketts Point to Carrum at 1,500 ft.

Less than a minute later, at about 1022, just over 5 NM south-west of Moorabbin, the pilot of JQQ saw EDV on a reciprocal track and the ICUS pilot in EDV saw the lights of JQQ. EDV commenced a descending turn to the right, as JQQ commenced a climb to the right, resulting in JQQ passing over EDV with about 200 ft vertical separation.

The suggested published VFR Coastal Route annotated on the Melbourne VTC (Figure 1) is about 1 NM off the coast, and to allow for the Moorabbin control zone, increases up to about 2NM off the coast from Ricketts Point to Carrum.

The company is looking at the safest route to track from Westgate Bridge to Tyabb and have initiated consultation with Moorabbin Tower to determine the correct altitude for this leg.

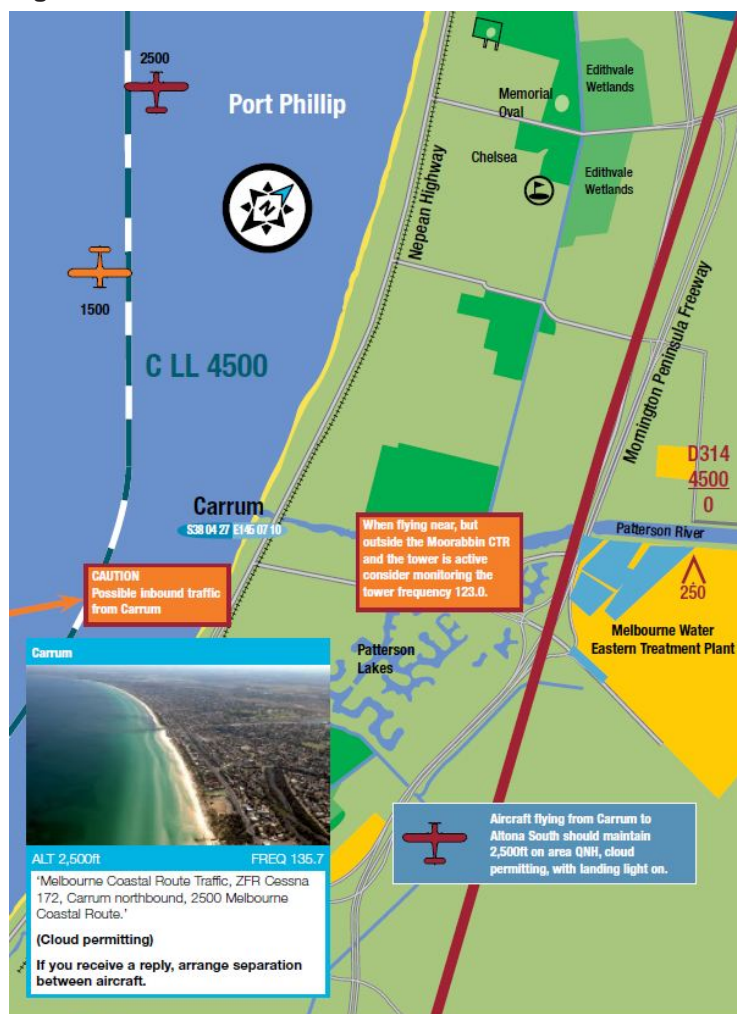
Figure 2: Extract of Visual Pilot Guide: Melbourne coastal route

The Visual Pilot Guide for the Melbourne Basin (Figure 2) states that aircraft inbound to Moorabbin should track via and report at one of the VFR reporting points at a recommended altitude of 1,500 ft. It also states that aircraft tracking southbound via the Melbourne coastal route should maintain 1,500 ft.
